2022 FACILITIES MASTER PLAN

City of Washougal

FACILITY CONDITION ASSESSMENT

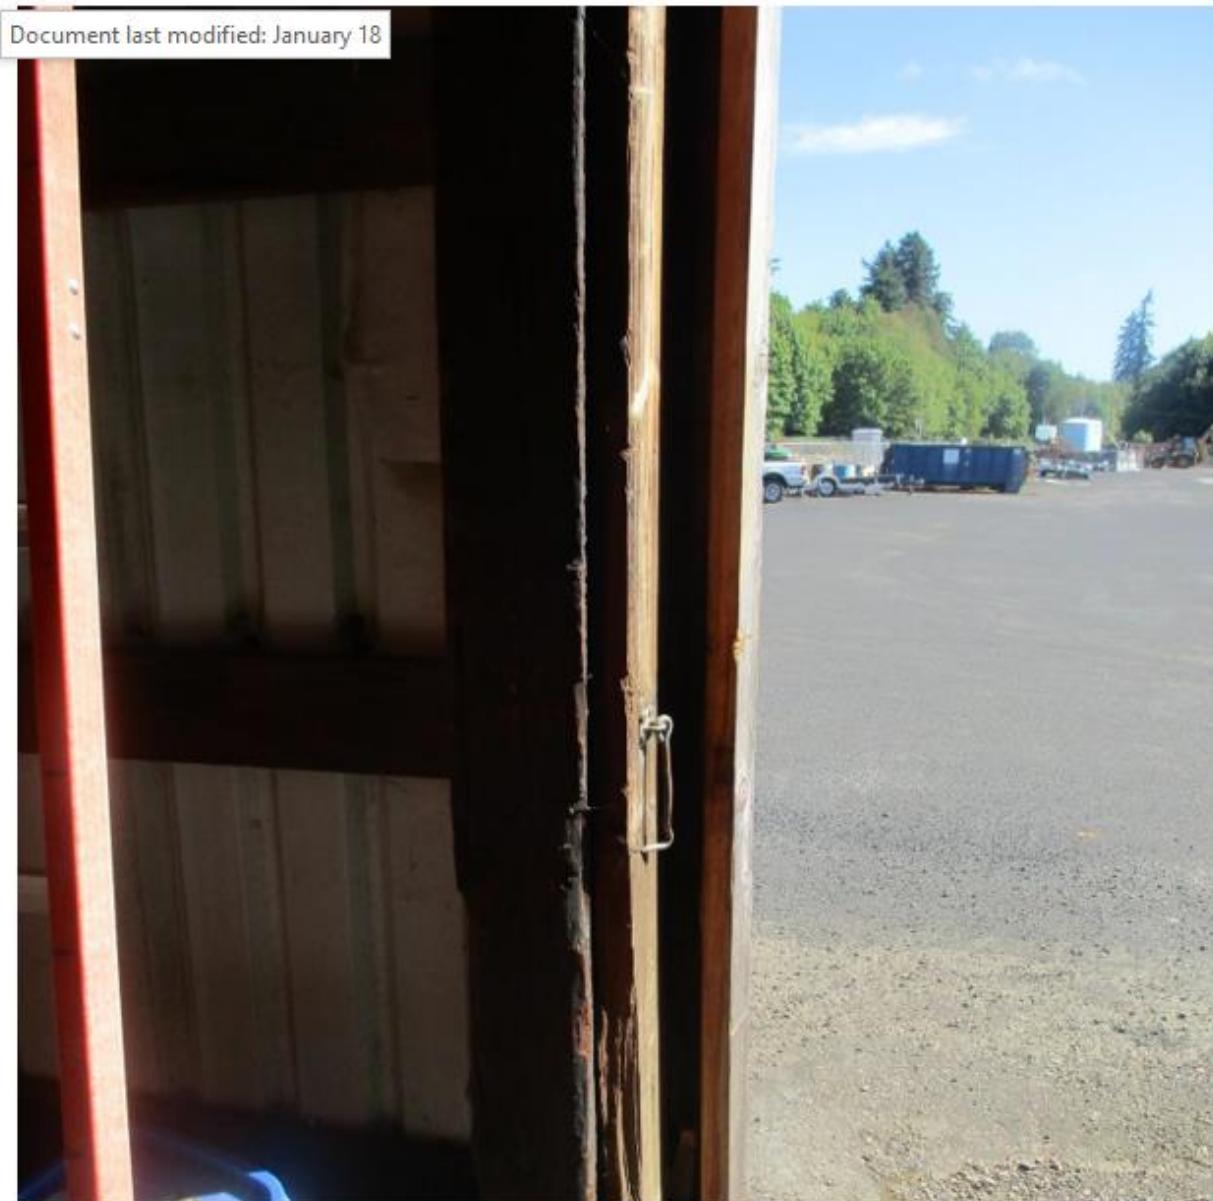
Figure 2.4. Example of Surface Damage

The northeast portion of the building is used for vehicle and equipment storage and has a dirt/gravel floor. This is the only area where the structural framing is visible. In most other areas, the structural framing has been hidden by partition walls and ceilings. Of the structural framing that is visible, it appears to be in good condition. Poles are of treated timber, which will prevent decay of the embedded portions. Some surface damage is

noted at the columns at the main door to the storage area, likely due to vehicle impact (see [Figure 2.4](#)). The roof sheathing shows no evidence of staining and leakage and appears to be in good condition. No sag is noted in the roof trusses that are visible.

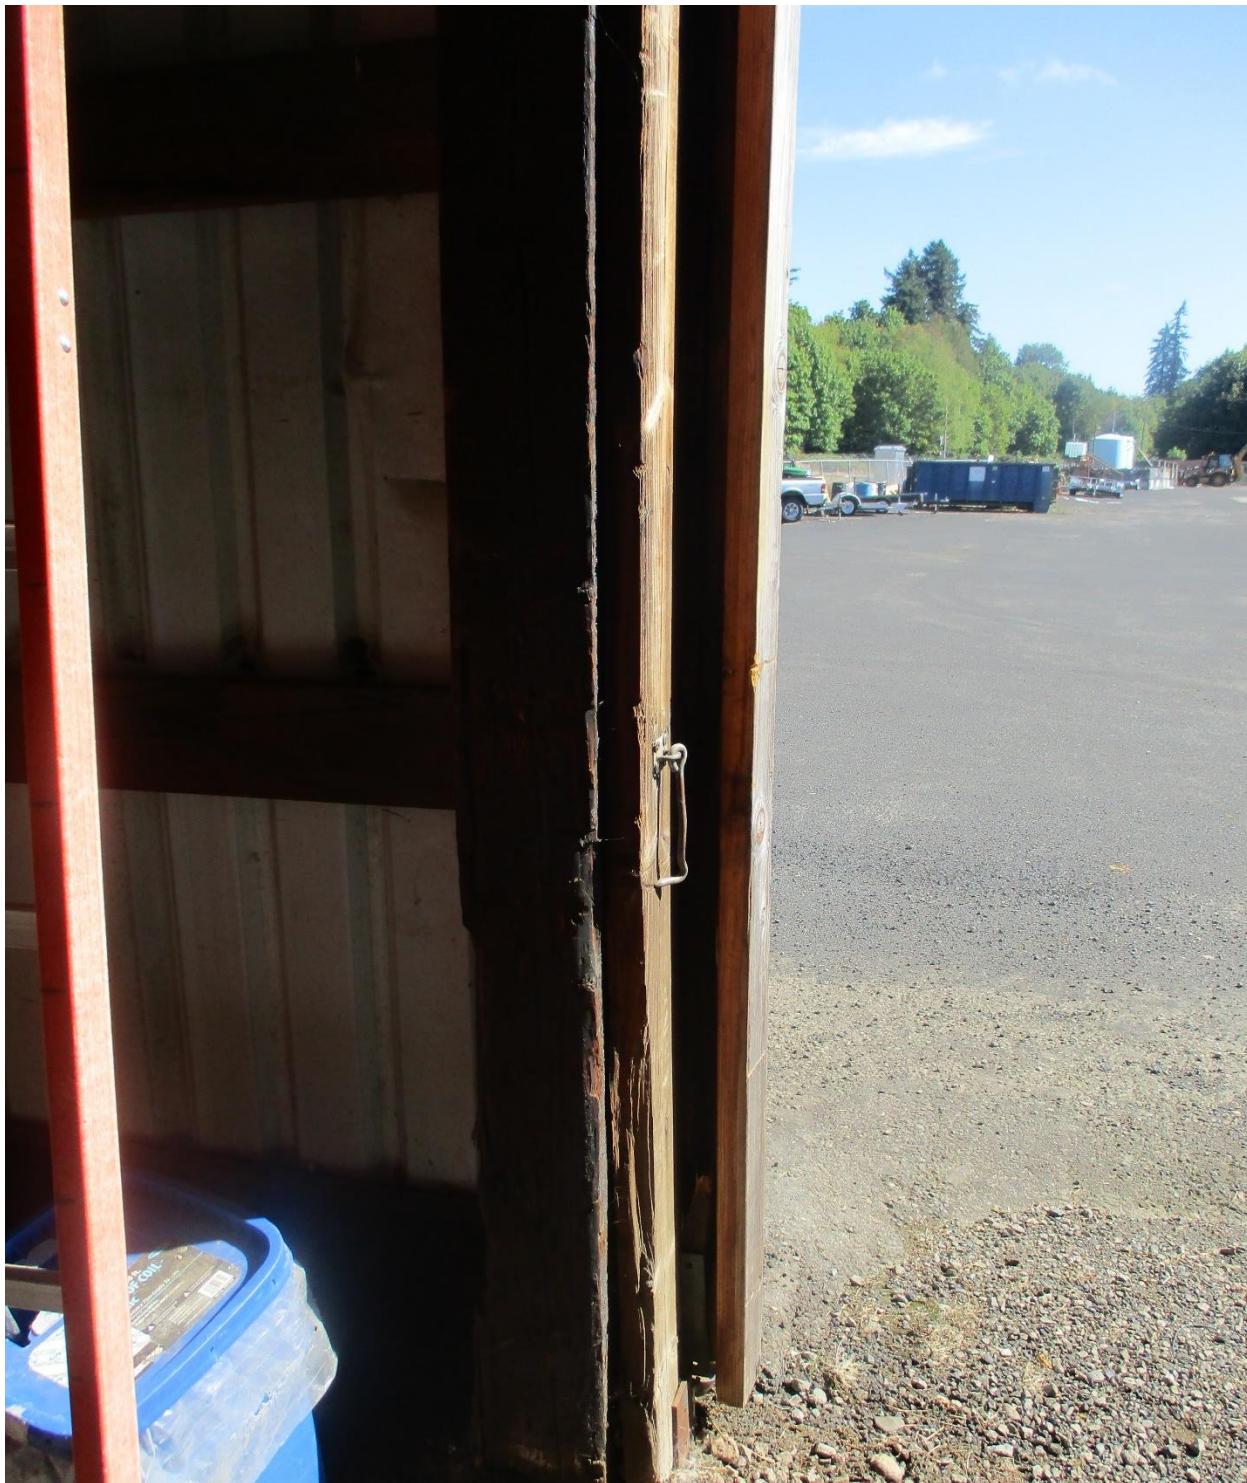
Figure 2.4. Example of Surface Damage

The northeast portion of the building is used for vehicle and equipment storage and has a dirt/gravel floor. This is the only area where the structural framing is visible. In most other areas, the structural framing has been hidden by partition walls and ceilings. Of the structural framing that is visible, it appears to be in good condition. Poles are of treated timber, which will prevent decay of the embedded portions. Some surface damage is

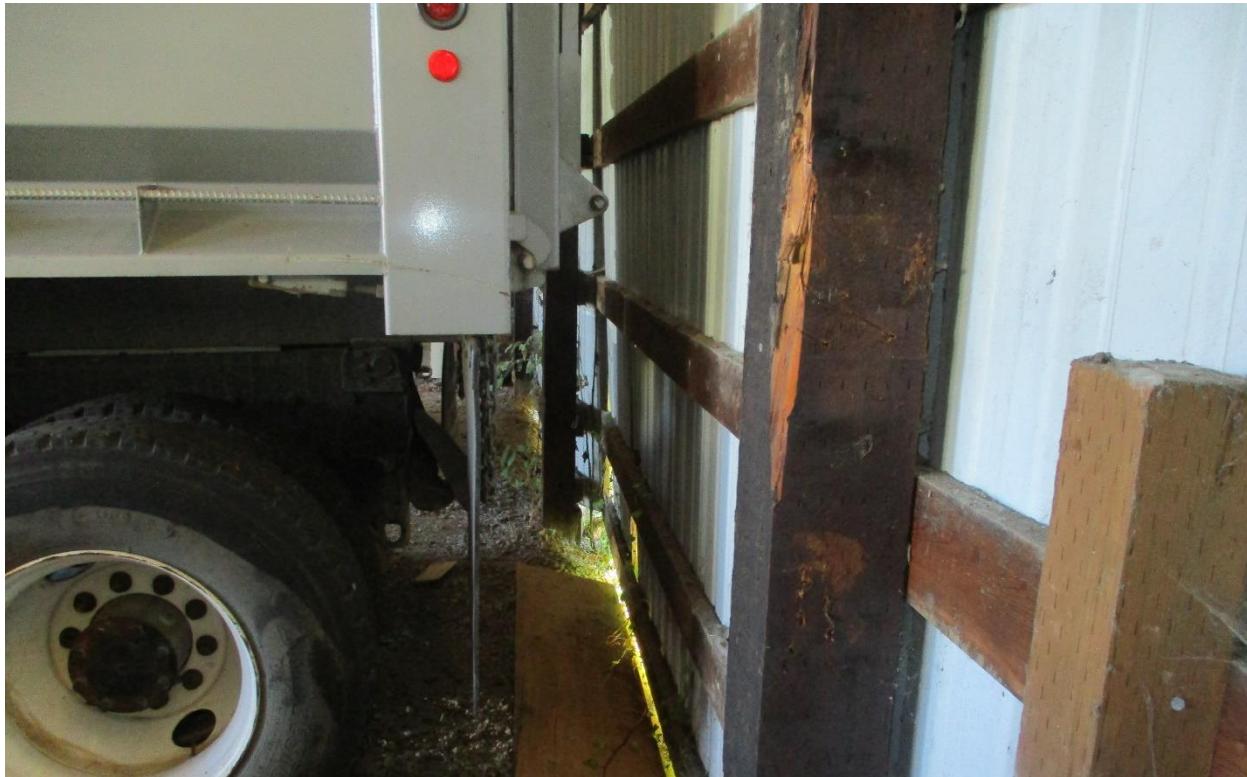
Figure 2.10. Damage on South Wall

The south wall of the third bay appears to have been damaged due to vehicle contact. The siding is bent and the wall purlins have detached from the column, with some purlins

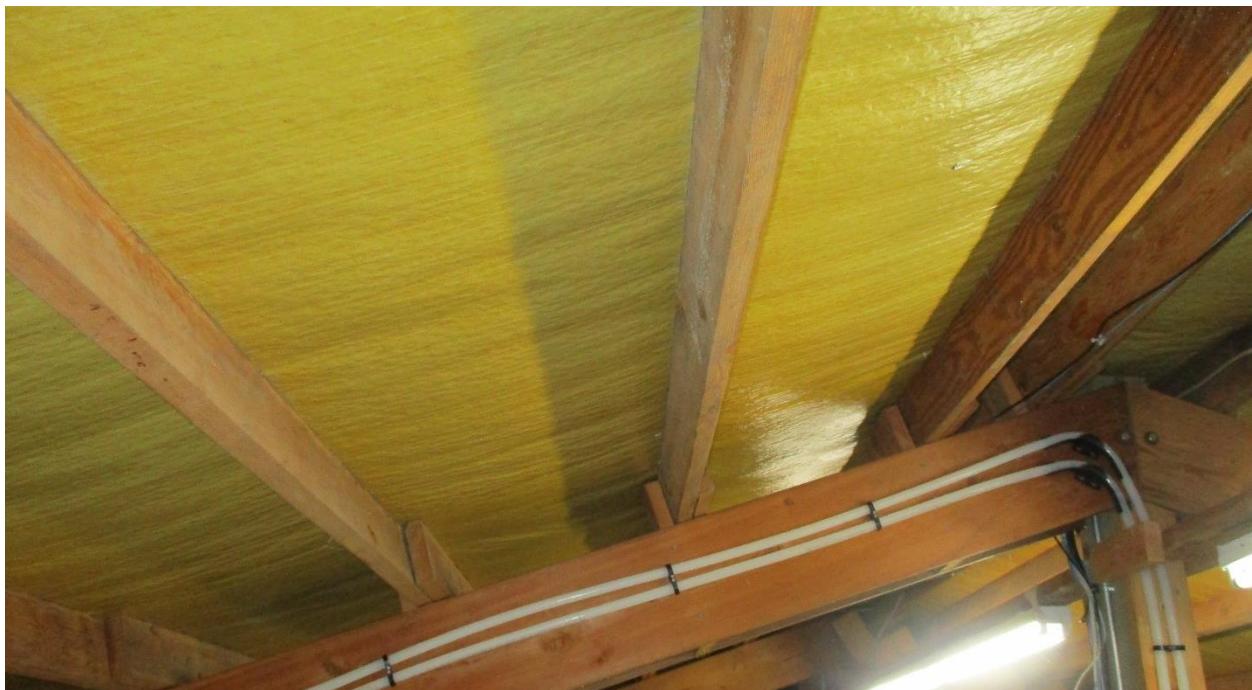
Figure 2.14. Insulation

Most of the structural elements are hidden from view by interior finishes, however, the portions of the structural framing that are visible from the loft area and in the storage area, appear to be in very good condition. The roof sheathing (if present) is hidden by insulation (see Figure 2.14). The joists supporting the loft area have had holes drilled in them for electrical wiring and plumbing (see Figure 2.15). These holes do not appear to be placed in compliance with best practices (away from ends, and away from top and bottom edges).

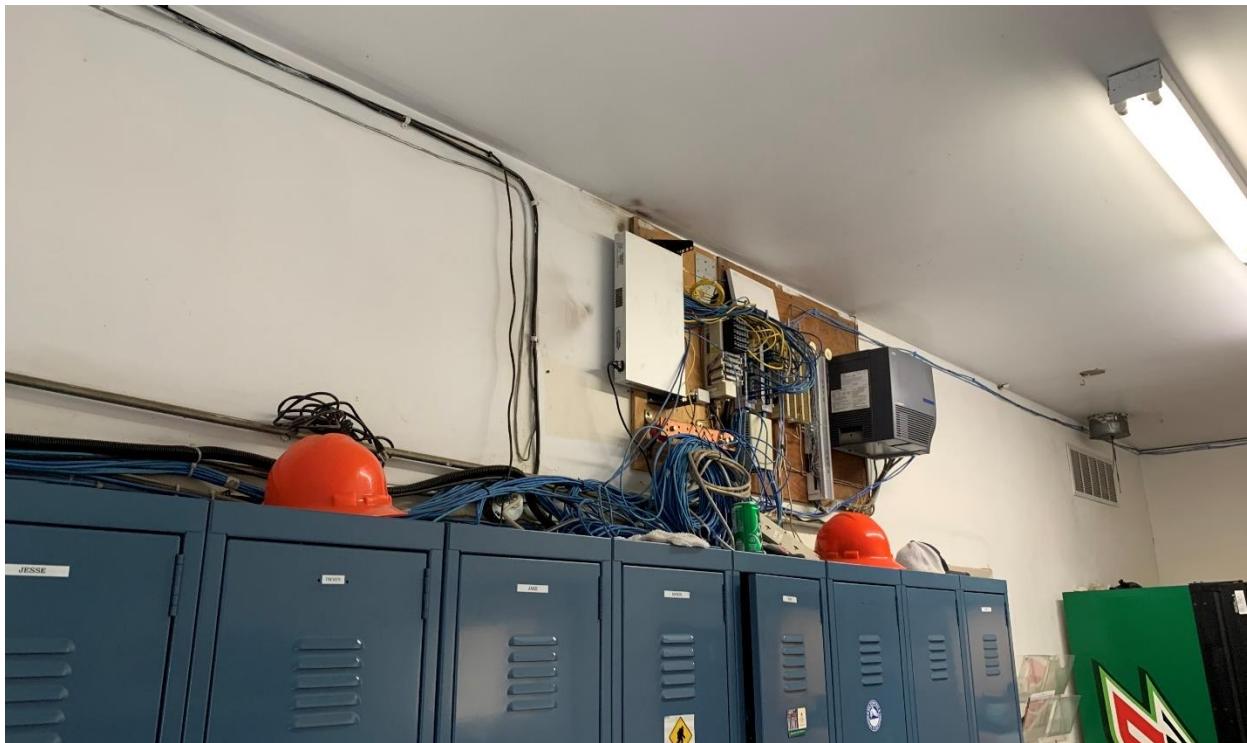
Figure 3.2. Exposed Communication Equipment

The building receives an overhead fiber optic communication line from Verizon Communication equipment. It is installed in the lobby above the lockers and is exposed as shown in [Figure 3.2](#) and [Figure 3.3](#). It is recommended that this equipment be installed in a dedicated space, such as a communication closet, or be installed in an enclosure for protection. The communication cables located in the attic space are loosely installed without adequate structural support as shown in [Figure 3.4](#).

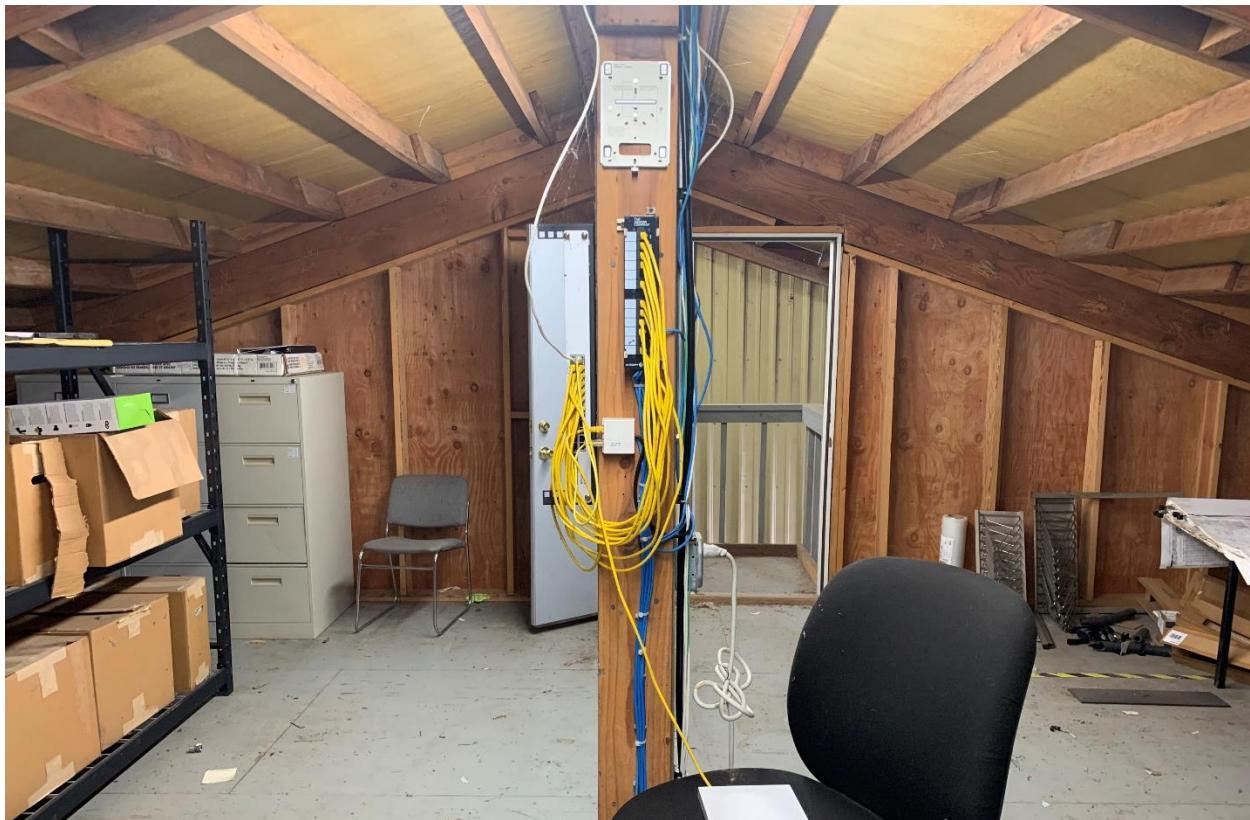
Figure 3.6. Networking hardware in Loft

Networking hardware is installed in the loft, as shown in Figure 3.6. It is recommended that this equipment be installed in a dedicated space, such as a communication closet, or be installed in an enclosure for protection. Some of the communication cables located in the loft space are loosely installed without adequate structural support, as shown in Figure 3.7.

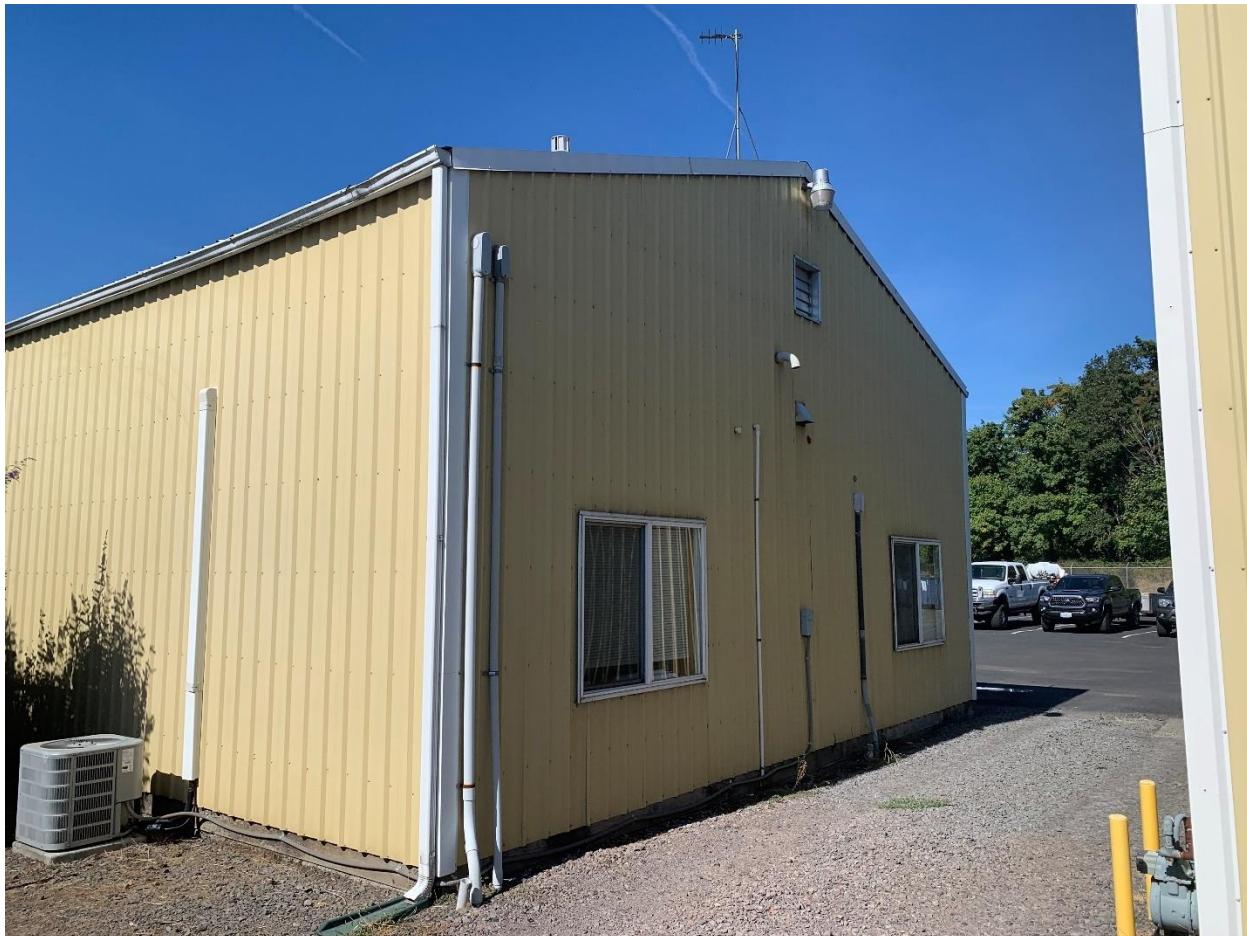
Figure 3.8. HVAC Unit and Disconnect Switch

An HVAC unit is installed outdoors on the south side of the building, and the electrical disconnect switch for this unit is installed on the east side of the building, as shown in Figure 3.8. Since the switch is not in sight of the HVAC unit, it is in violation of NEC requirements. A service outlet for the HVAC unit is also missing per NEC requirements.

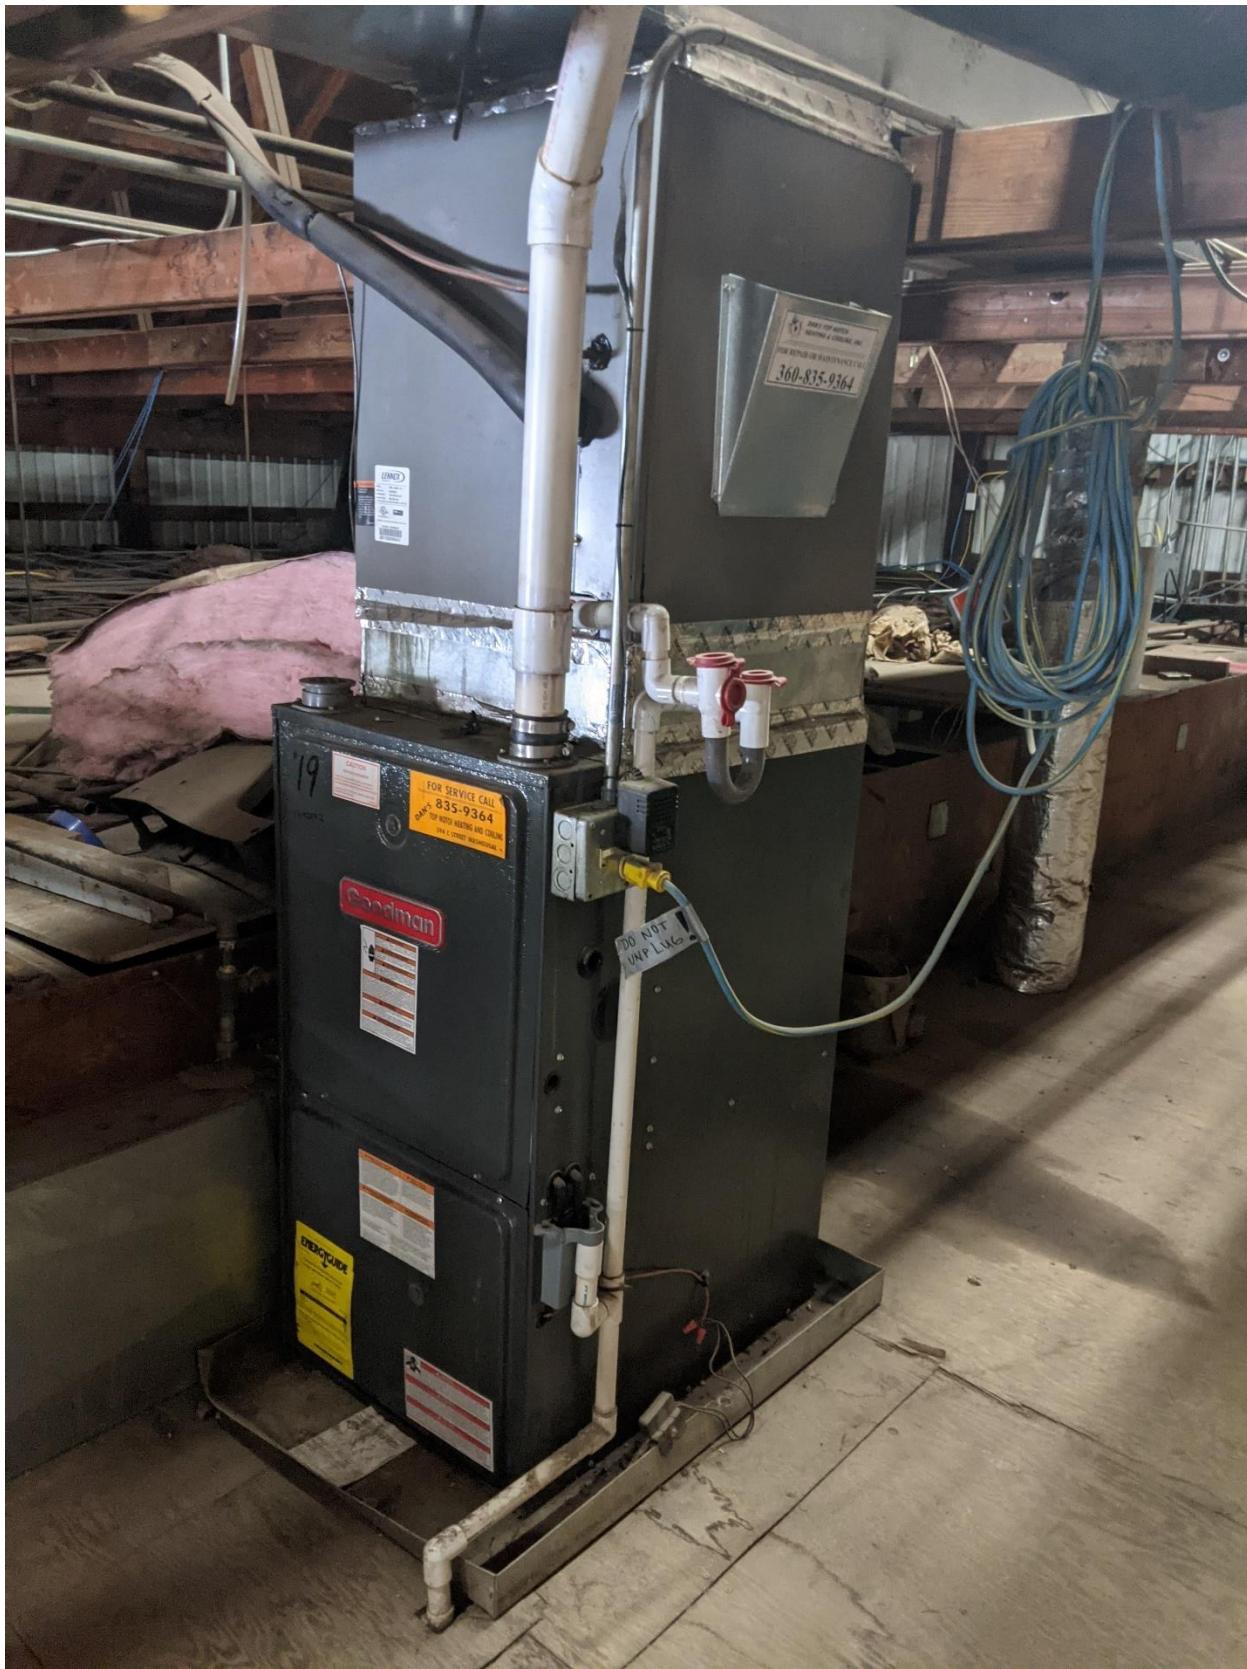
Figure 4.1. Building A Admin Furnace

This area is served by a residential style Goodman natural gas furnace with a 3.5-ton Lennox air conditioner (see [Figure 4.1](#) and [Figure 4.2](#)). The air conditioner was manufactured in 2015; it is unclear when the furnace was manufactured but assumed that it is the same age as the air conditioner and is in fair condition; although, there is a large air leak between the furnace section and the air conditioner coil (see [Figure 4.3](#)) that should be repaired to reclaim some of the system capacity within the occupied

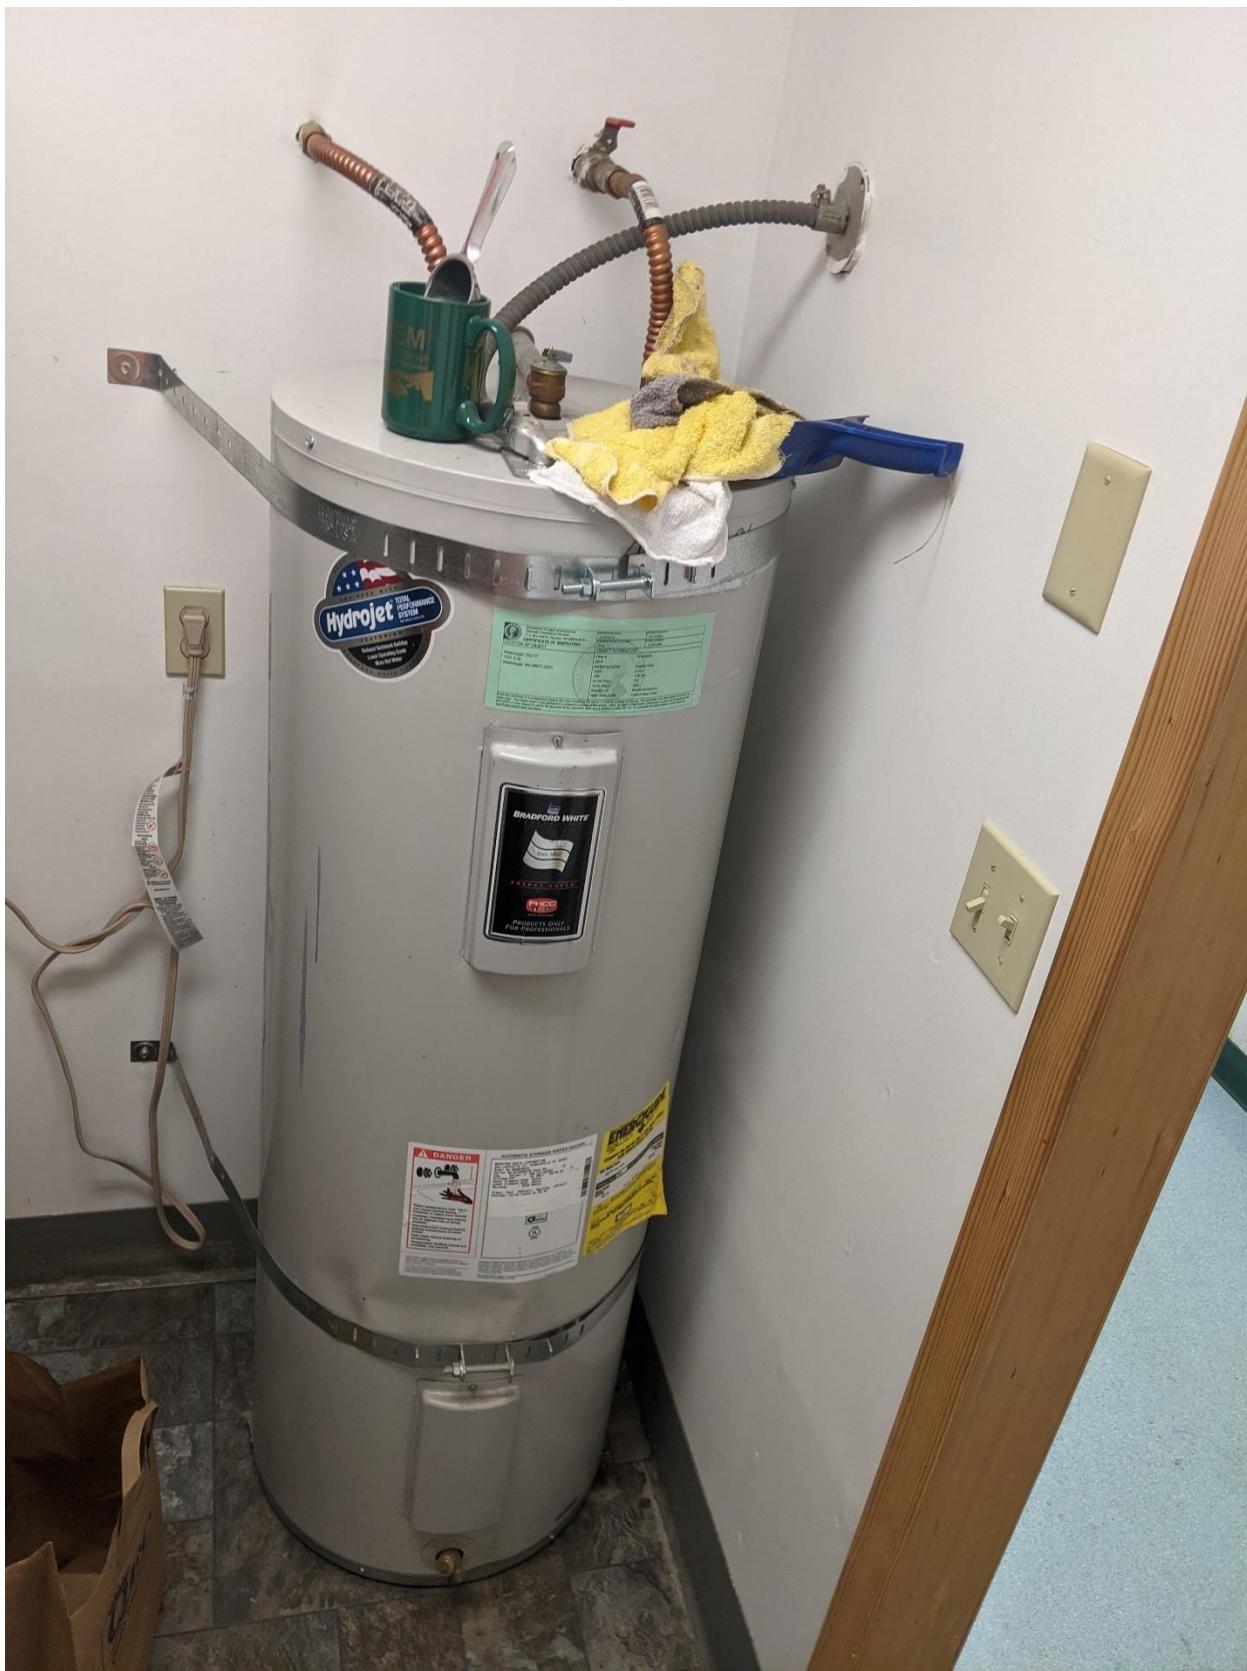
Figure 4.8. Building A Domestic Water Heater

Plumbing is limited to the break room and two restrooms in the administrative area. The restrooms appear to be in good condition and the fixtures were all working. A Bradford White electric domestic water heater from 2005 is in the alcove adjacent to the women's restroom (see Figure 4.8). This appears to be in working condition but is nearing the end of its expected service life and accommodations for replacement should be considered. There is also an ice maker in this space that appears to be in good working order. There was a large puddle of water on the floor of the alcove but upon asking, it sounds like this is due to ice spillage during transfer, not a failure in the ice maker.

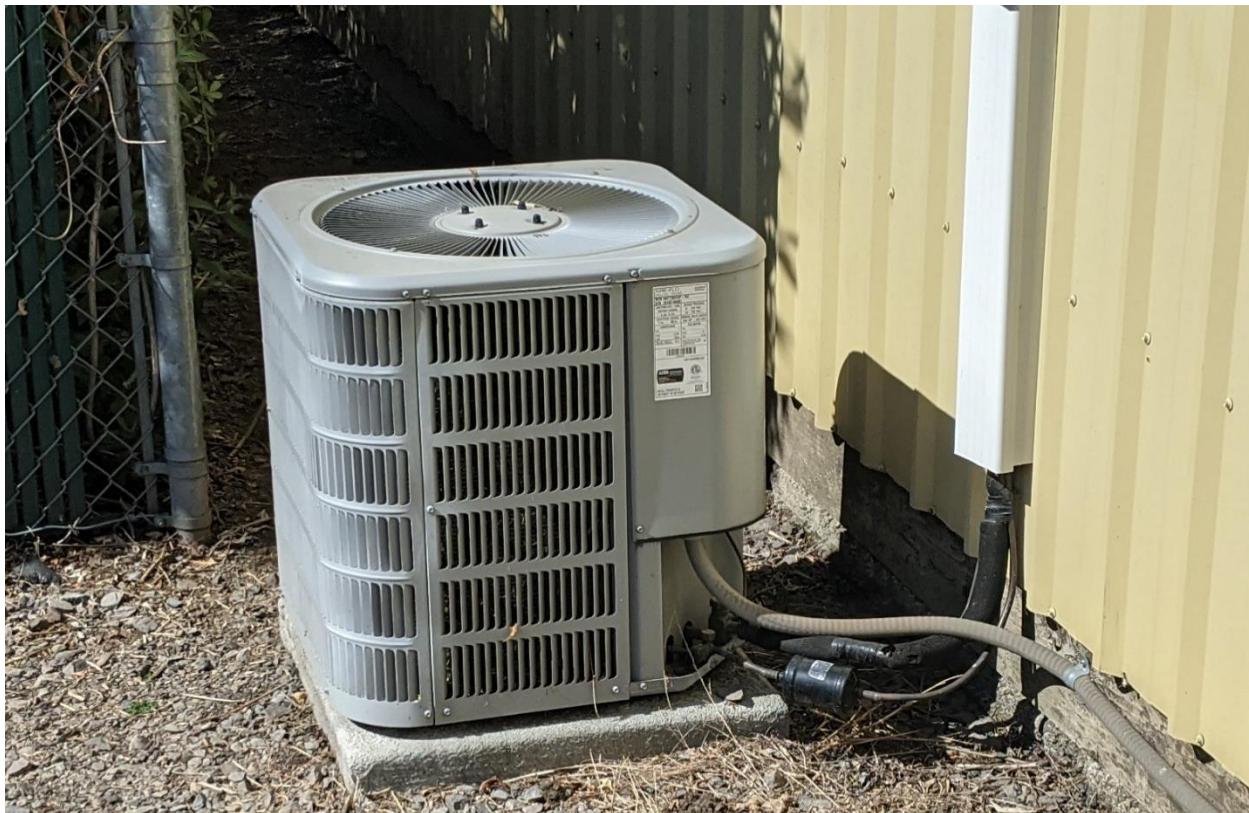
Figure 4.10. Building C A/C

Building C has an HVAC and plumbing system serving the main level with equipment located in the attic (see [Figure 4.9](#)). A horizontal Lennox furnace is installed on the floor of the attic and an Aire-Flo (Lennox subsidiary) air conditioner is installed at the rear of the building (see [Figure 4.10](#)).
