2022 FACILITIES MASTER PLAN

City of Washougal

FACILITY CONDITION ASSESSMENT

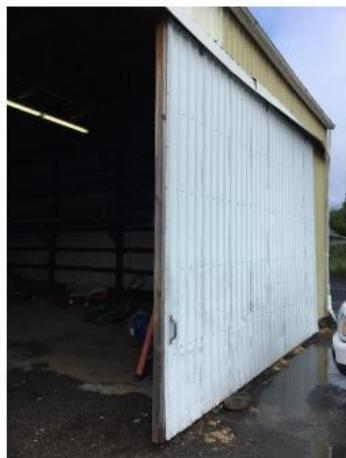
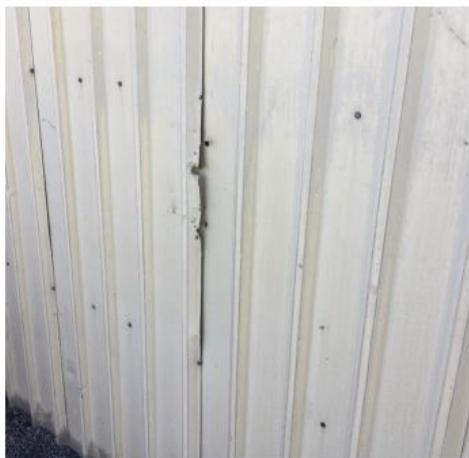
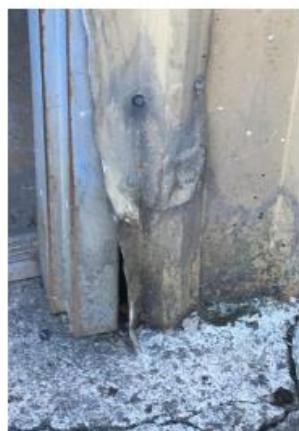
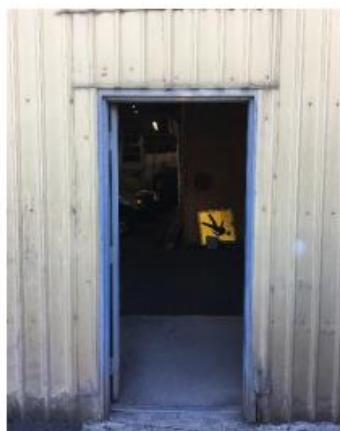
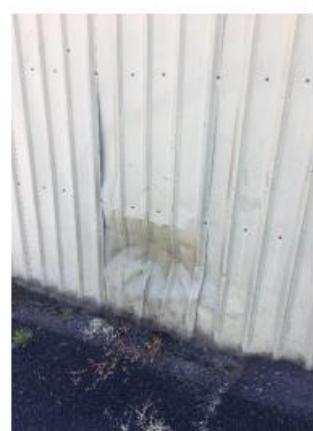
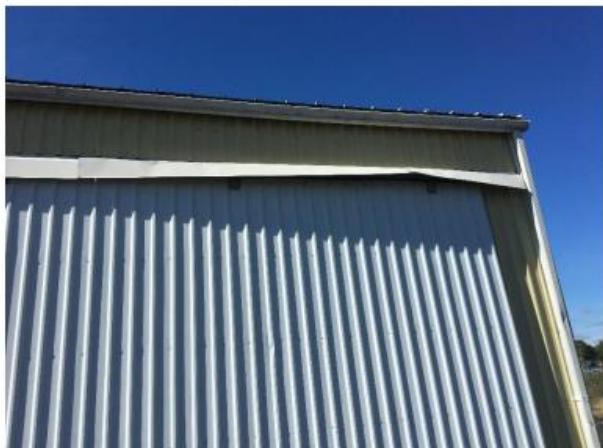
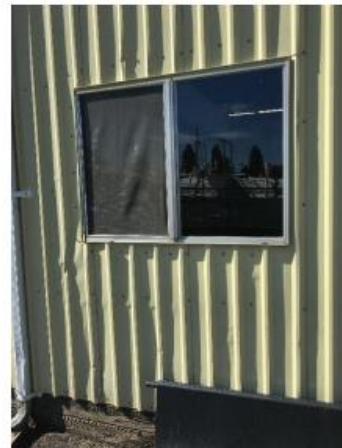
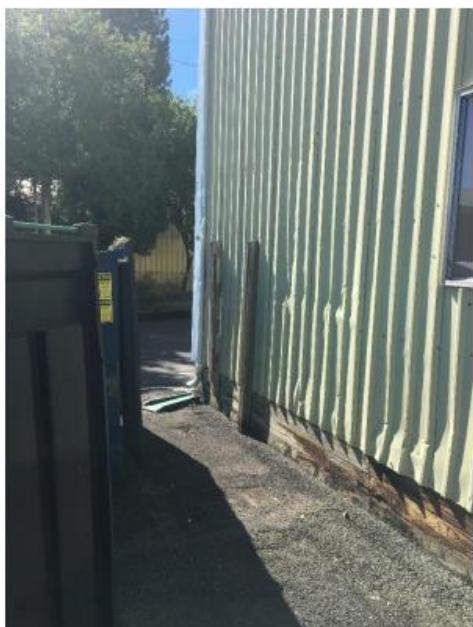
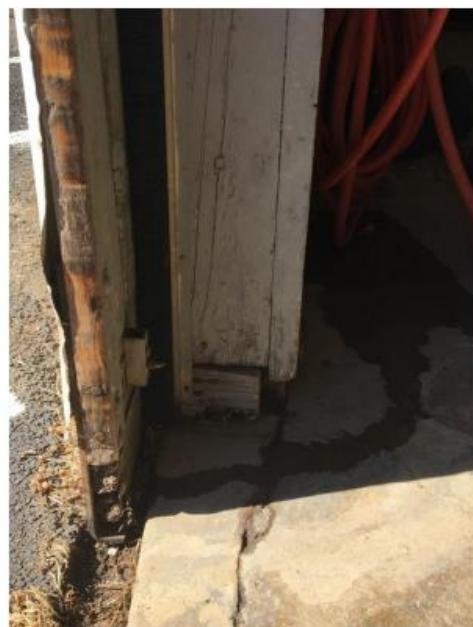
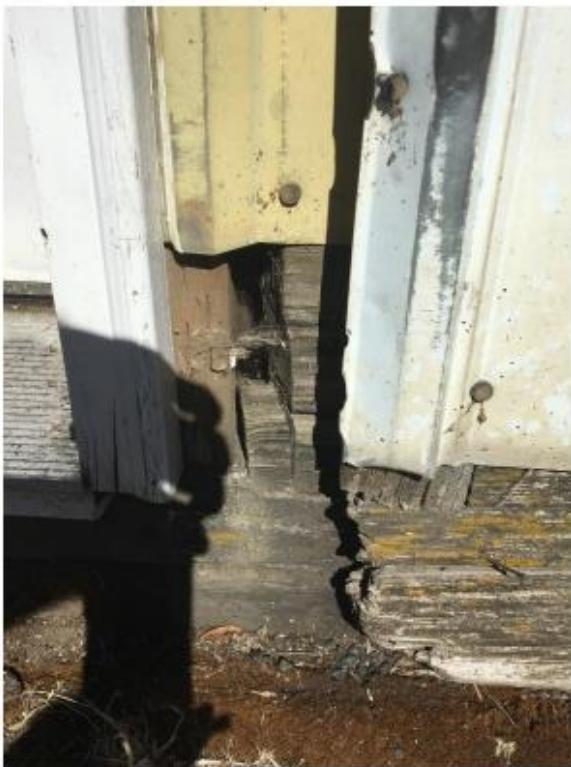
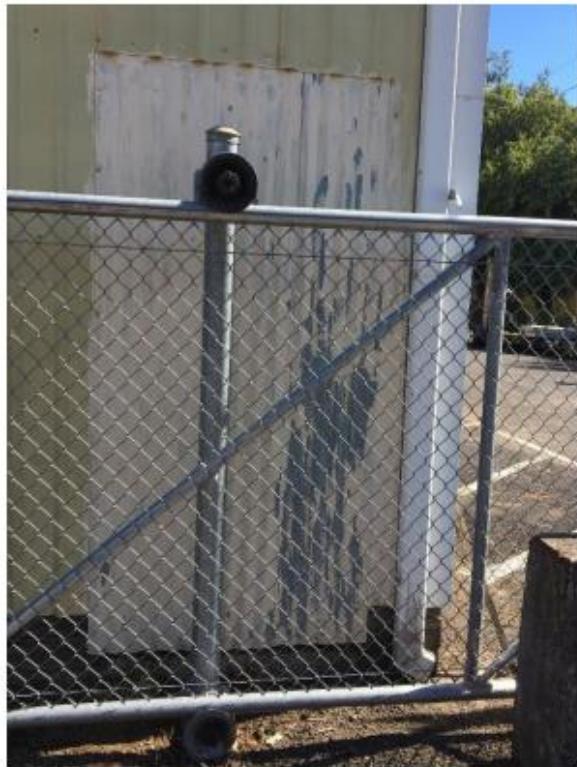
Building A Exterior Photos

- Wall exterior condition is below average
- Finish of the wall panels are generally intact o Multiple dents and locally deformed areas on metal panels were found

- Unsealed crack and holes were found at north façade and east façade
- Treated wood wall curbs are exposed without any protection
- Unfinished wall panels were used to patch at east façade

- Portion of the roof gutters is slightly deformed above the barn door at storage
- Wood fascia and wood blockings that support gutter systems are exposed and unprotected or Downspouts are functional even though some of them are deformed
- Downspouts are not tie to the storm drain system and most of them are without splash block
- All metal flashings are either deformed or not tightly flash around the door frames and windows frames. Metal flashings that are partially detached from claddings and exposed to weather are found at the north façade and south façade.

- Both double pane and single pane windows are found.
- Double pane vinyl windows appear in fair condition. Single pane window will have condensation issues in cold weather.
- Exterior wood doors and metal doors are used. Door thresholds are not appropriately applied.
- Uninsulated automatic overhead rolling door at shop is in fair condition.
- Manual uninsulated sliding barn door is in below average condition.
- Manual bi-parting uninsulated sliding door at the south façade is in below average condition. The wood framing of the door leaf is rotted.

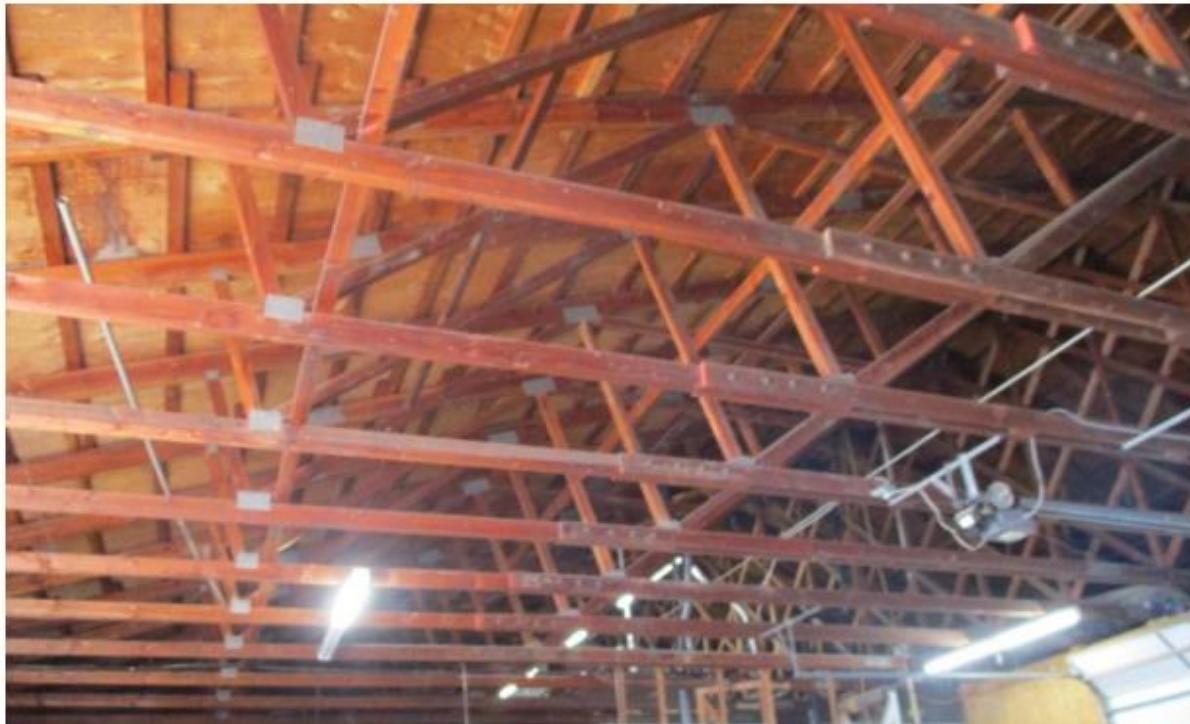
Figure 2.1. Wood Trusses Supporting Roof

Building A is an 8,500 square foot structure, constructed with wood post frame (pole barn) type construction. The roof is supported by wood trusses, as shown in [Figure 2.1](#). The majority (approximately 2/3) of the building has had partition walls installed to create office and shop space. These areas have had concrete floors installed. In general, these concrete floors are in fair condition, however some cracking and damage is noted in the floor at the roll up door on the south side of the building. This is likely due to the rough transition between the asphalt and the concrete, as shown in [Figure 2.2](#) and [Figure 2.3](#).

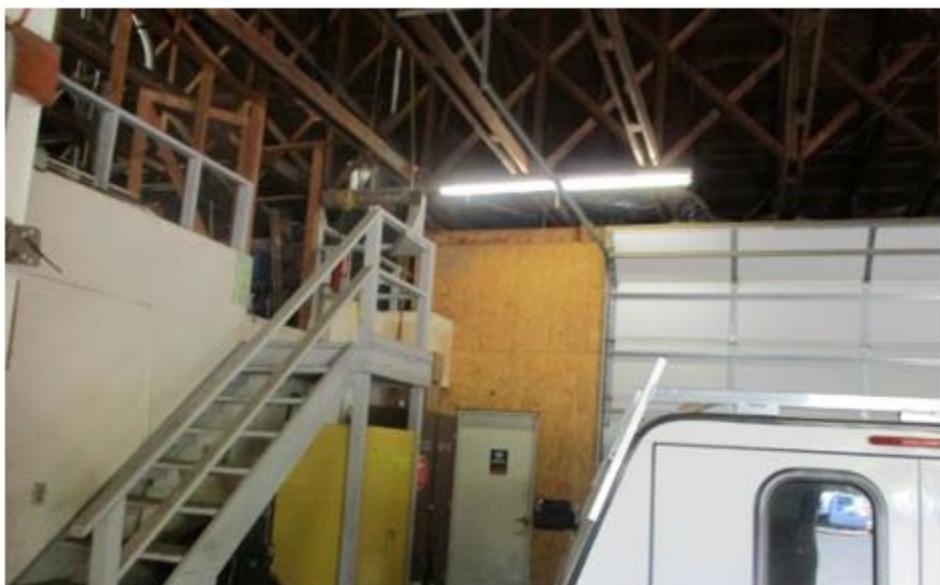
Figure 2.5. Area Used for Storage

The area above the main office space is accessible by a staircase in the gravel floor storage area. It appears this area is used for storage and mechanical equipment (see [Figure 2.5](#) and [Figure 2.6](#)). A sign is posted at the top of the stairs indicating a 20 psf load limit (see [Figure 2.7](#)). This meets the current code requirement for uninhabitable attic spaces with storage. Code defines this as uninhabitable due to the low head clearance. The floor exhibits some softness when walking around. No signs of distress are obvious. The deflection felt in the floor is likely due to the ceiling structure of the atticspace not being adequately designed to limit deflection. Care should be taken to limit what is placed in this storage area so as not to exceed the load limitation.

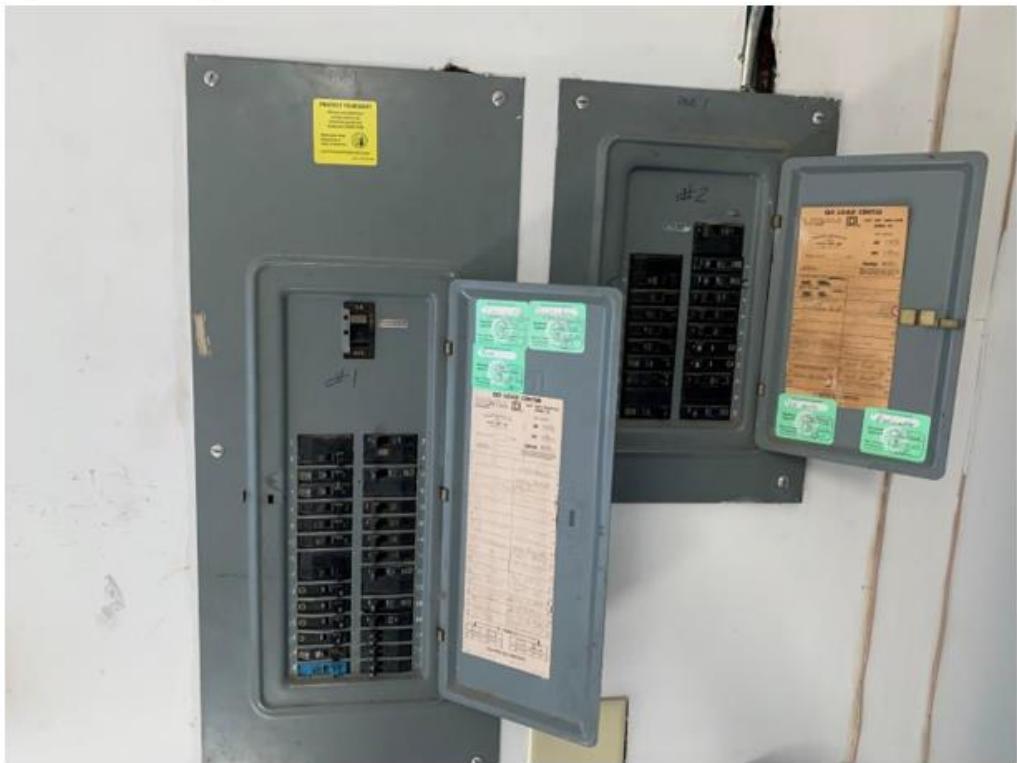
Figure 3.1. Building A Panelboard

Building A is provided with a 120/240-volt, 1-phase, 200-amp, electrical service via an overhead line from Clark PUD. The building includes a 200-amp main panelboard with 30 spaces and a 100-amp subpanel with 20 spaces, as shown in [Figure 3.1](#). Every circuit in these panels appears to be in use with no space for future loads. The panels are Square D QO load centers from the original construction. The panels appear to be in fair condition, however, replacement of these panels should be considered as they are beyond the end of the typical lifespan of 40 years. There is no standby power provided to the building.

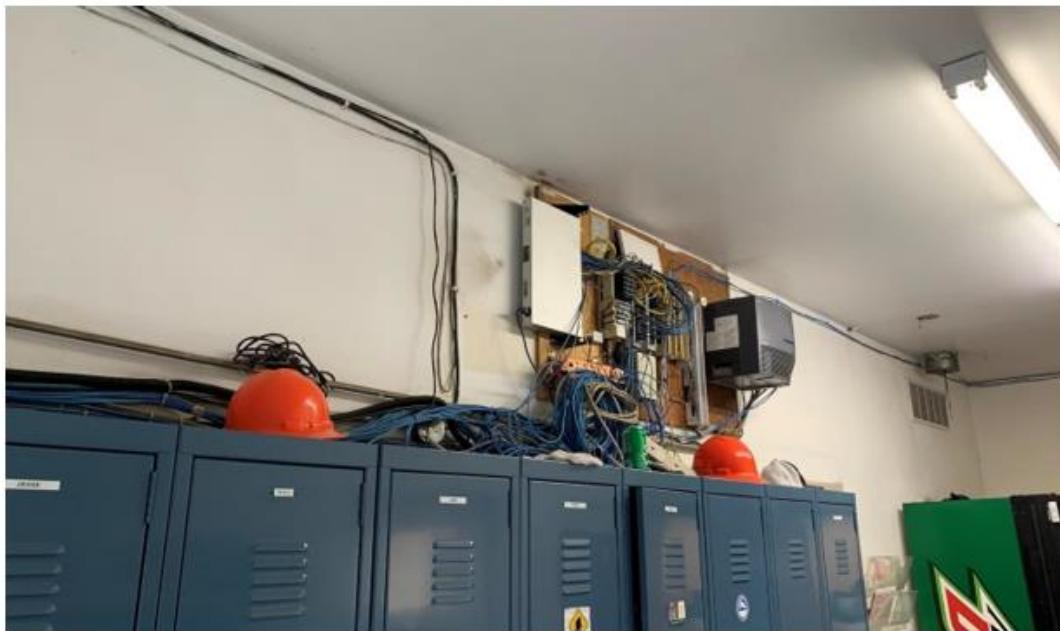
Figure 3.2. Exposed Communication Equipment

The building receives an overhead fiber optic communication line from Verizon Communication equipment. It is installed in the lobby above the lockers and is exposed as shown in [Figure 3.2](#) and [Figure 3.3](#). It is recommended that this equipment be installed in a dedicated space, such as a communication closet, or be installed in an enclosure for protection. The communication cables located in the attic space are loosely installed without adequate structural support as shown in [Figure 3.4](#).

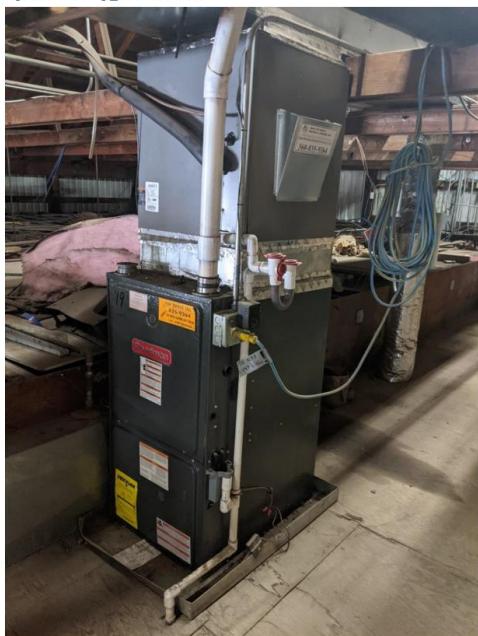
Figure 4.1. Building A Admin Furnace

This area is served by a residential style Goodman natural gas furnace with a 3.5-ton Lennox air conditioner (see [Figure 4.1](#) and [Figure 4.2](#)). The air conditioner was manufactured in 2015; it is unclear when the furnace was manufactured but assumed that it is the same age as the air conditioner and is in fair condition; although, there is a large air leak between the furnace section and the air conditioner coil (see [Figure 4.3](#)) that should be repaired to reclaim some of the system capacity within the occupied

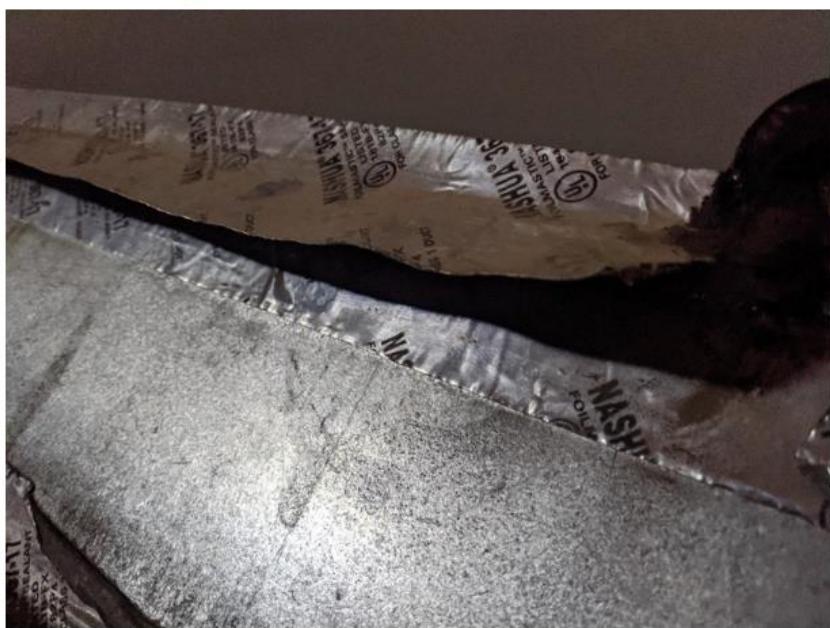
Figure 4.3. Building A Air Leak

spaces. Most of the visible ductwork in this area is flexible ductwork and will have higher pressure drop than a well-designed rigid ductwork system.

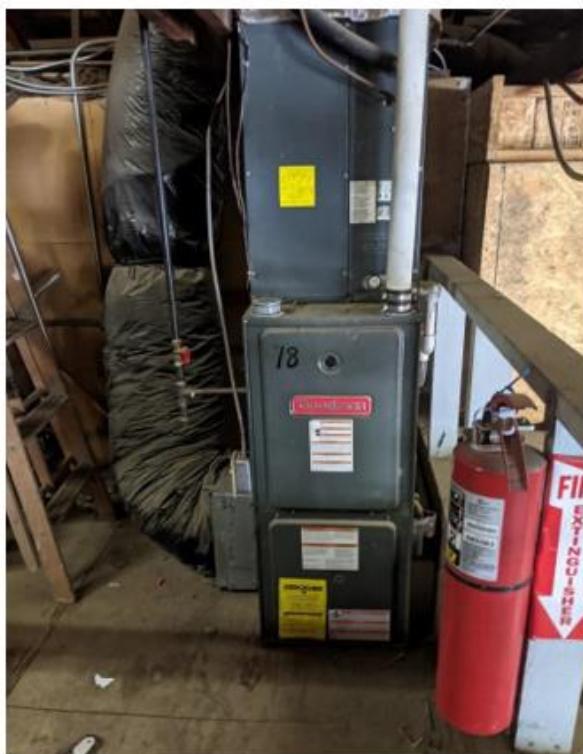
Figure 4.4. Building A Workshop Furnace

The west side of the building has a mechanic's shop that is served by a second Goodman furnace that has a 3-ton Goodman heat pump from 2007 (see [Figure 4.4](#) and [Figure 4.5](#)). This heat pump is an R-22 unit and while not visibly failing is near the end of its expected service life (15-20 years per ASHRAE) and planning should include replacing this unit in the near future.

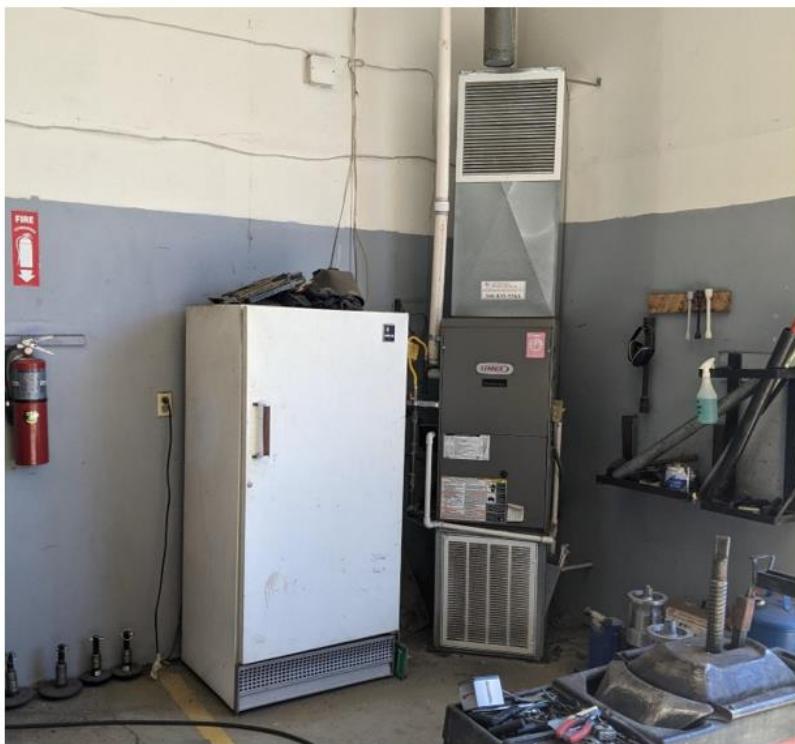
Figure 4.6. Building A Shop Furnace

The southwest corner of the building is another shop that also has a small, elevated office and a couple parts storage areas. This shop has a Lennox furnace in the southeast corner. It does not have any cooling capacity (see [Figure 4.6](#)).

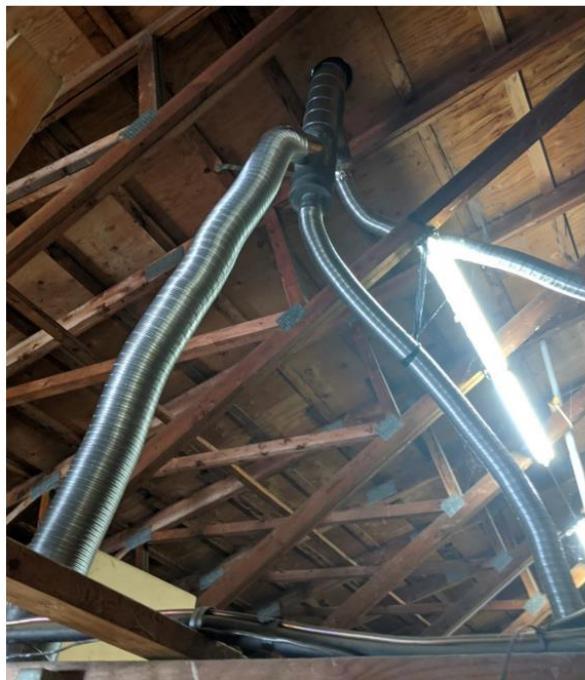
Figure 4.7. Building A Exhaust Connections

There are several exhaust systems connected into a single roof penetration (see [Figure 4.7](#)). None of these ducts are insulated and may have condensation issues since they are located in the unheated portion of the building.

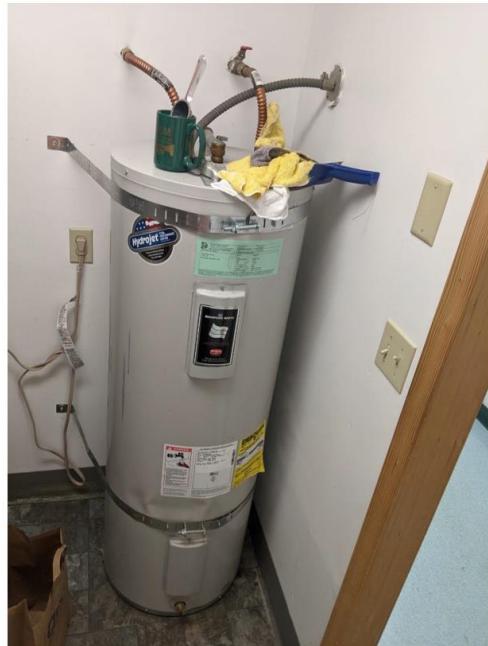
Figure 4.8. Building A Domestic Water Heater

Plumbing is limited to the break room and two restrooms in the administrative area. The restrooms appear to be in good condition and the fixtures were all working. A Bradford White electric domestic water heater from 2005 is in the alcove adjacent to the women's restroom (see [Figure 4.8](#)). This appears to be in working condition but is nearing the end of its expected service life and accommodations for replacement should be considered. There is also an ice maker in this space that appears to be in good working order. There was a large puddle of water on the floor of the alcove but upon asking, it sounds like this is due to ice spillage during transfer, not a failure in the ice maker.

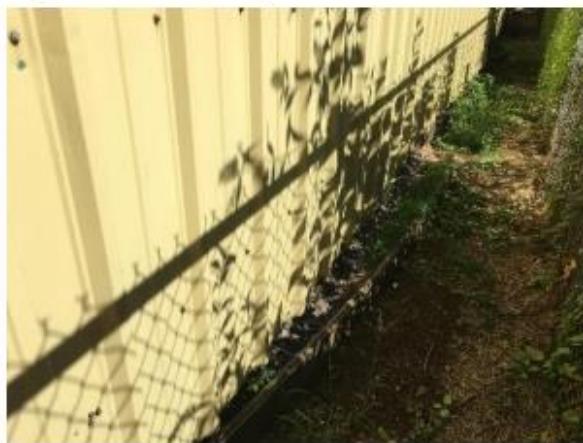
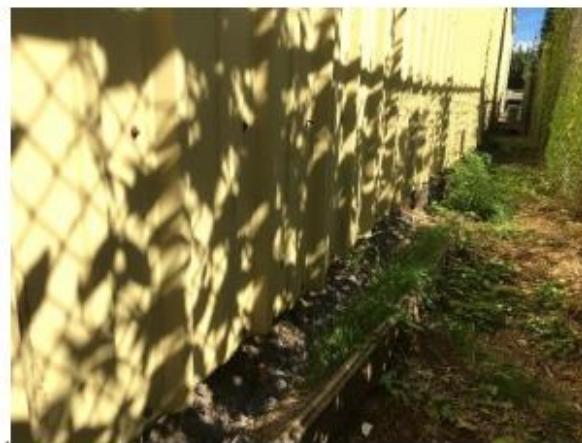
Building B Exterior Photos

- Metal roof and roof fascia system are in fair condition
- No obvious wear and tear marks on the roof were found
- Detached roof panels are noted near interface with Building C roof
- Leakage from the roof is expected

- Wall exterior condition is below average
- Finish of the wall panels are generally intact
- Multiple dents and locally deformed areas on metal panels are found
- Back wall panels and horizontal wall girts are detached and left opening at the back of the building caused by impact from vehicle
- Aged, corrugated fiberglass wall panels are in fair condition

- Wood fascia and wood blockings that support gutter systems are exposed and unprotected
- Downspouts are functioning
- Water may migrate from the back at the detached wall panels

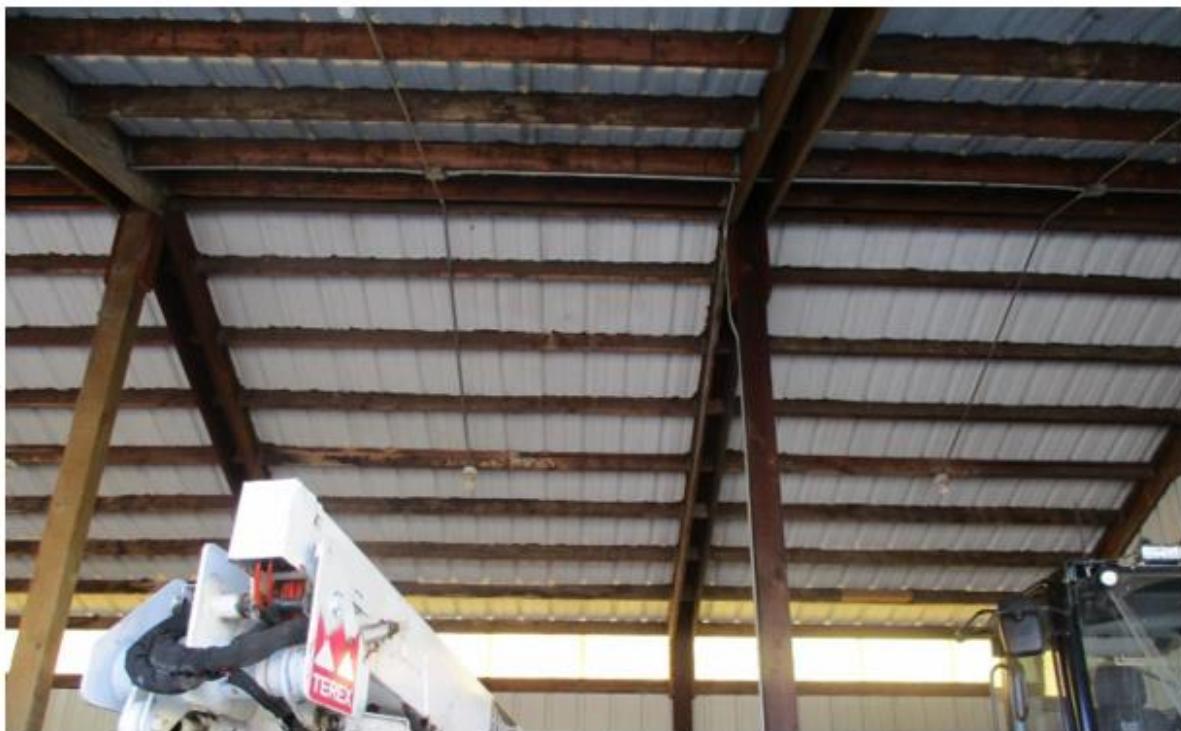
Figure 2.8. Remnants Between Roof Joints and Metal Roof Decking

Building B is an open wood post frame building that is used for vehicle storage. The structure is in fair condition. According to City staff on site, the particleboard sheathing was removed due to water damage and decay. Remnants can be seen between the roofjoists and the metal roof decking (see [Figure 2.8](#)). This will significantly hamper the structural performance of the roof system during a windstorm or in a seismic event, as there is no structural diaphragm present. Additionally, this causes the roof deck to sit just proud of the joists and leaves a small gap at the edges (see [Figure 2.9](#)). This could allow rain to be blown into the building, however, in general, it appears that the interior stays reasonably dry. Roof joists and most other structural connections appear to have been made using metal timber connectors.

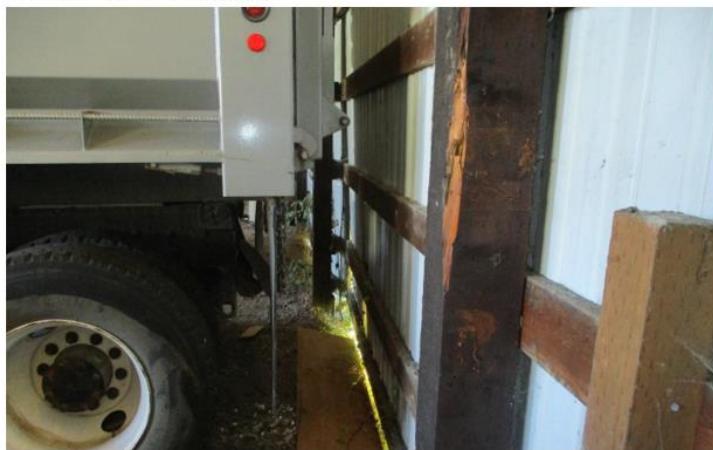
Figure 2.10. Damage on South Wall

The south wall of the third bay appears to have been damaged due to vehicle contact. The siding is bent and the wall purlins have detached from the column, with some purlins broken, as shown in [Figure 2.10](#). The column has also suffered damage, however, this is limited to the surface and appears to be cosmetic in nature. No decay is noted.

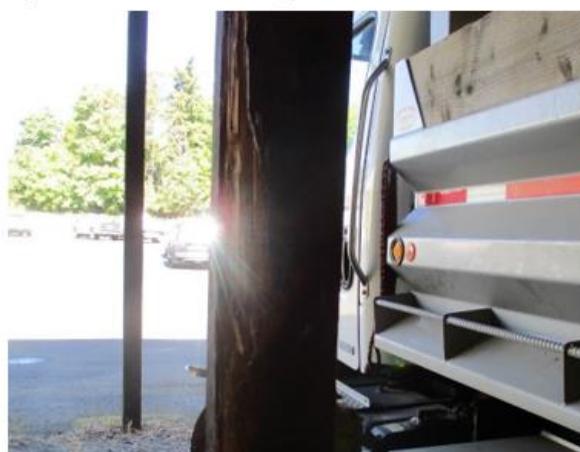
Figure 2.11. Column Damage

One column between the third and fourth bay shows damage due to vehicle impact, as shown in [Figure 2.11](#). No decay was noted in this, or any other, of the columns. Other than the damaged purlins in the third bay, all other purlins appear to be in good condition. No signs of decay are noted in the roof system, however with only the metal roofing to protect the members, the roof system is at a greater risk of getting wet and decaying over time.

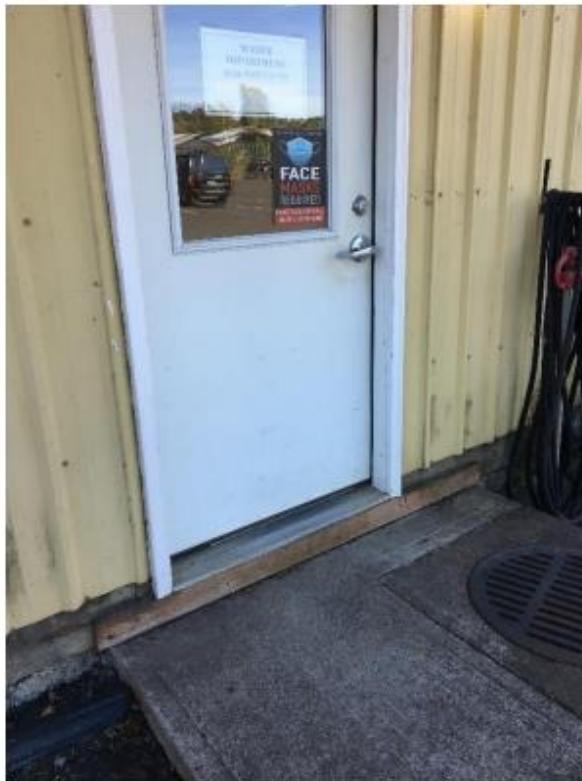
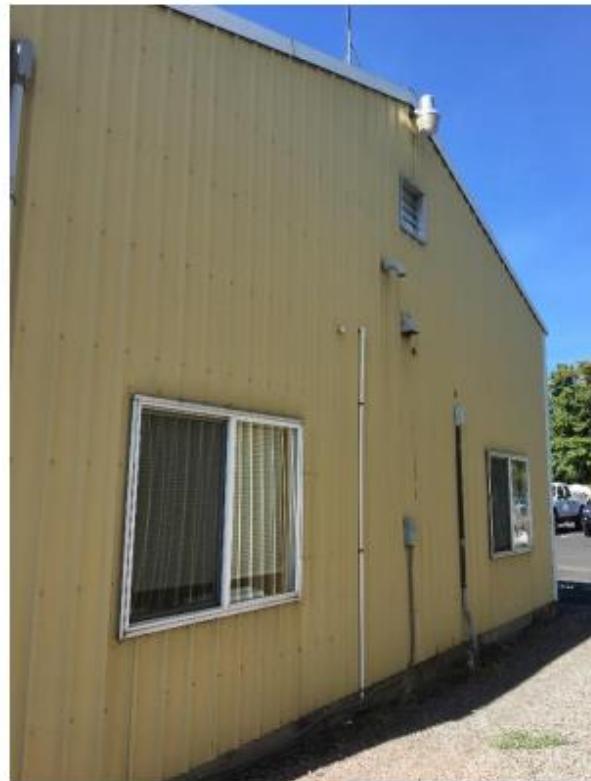
Building C Exterior Photos

- Wall exterior condition is aged and below average
- Finish of the wall panels are generally intact
- Dents and locally deformed areas on metal panels were
- Treated wood wall curbs are exposed without flashing transition or protection

- Portion of the roof gutters is slightly deformed above the barn door at storage
- Wood fascia and wood blockings that support gutter systems are exposed and unprotected
- Downspouts are functioning
- Downspouts are not tied to the storm drain system and most of them are without splash block
- Oversize metal flashing and trim above vehicle access door to the shop is in fair condition. Metal flashings above windows function but are in poor condition.

- Double pane windows are provided at north and east walls and they are in fair condition
- Water migration likely occurs at the windows due to poor flashing details. They function but are in bad condition.
- In-swing exterior egress door is not insulated
- Manual uninsulated sliding rolling door at garage is deformed but functioning. It is in poor condition.

The slab under the office space section is exposed at grade and does not have a turndown at the edges, which is required to ensure adequate frost depth (see [Figure 1.8. Building C Exterior Photos](#)). Frost depth at this location is 12 inches. It is likely that this slab was poured after the building was erected and does not work to provide structural support to the building. If frost damage to the slab were to occur, such as heaving, it could lead to damage to the floor finishes and partition walls.

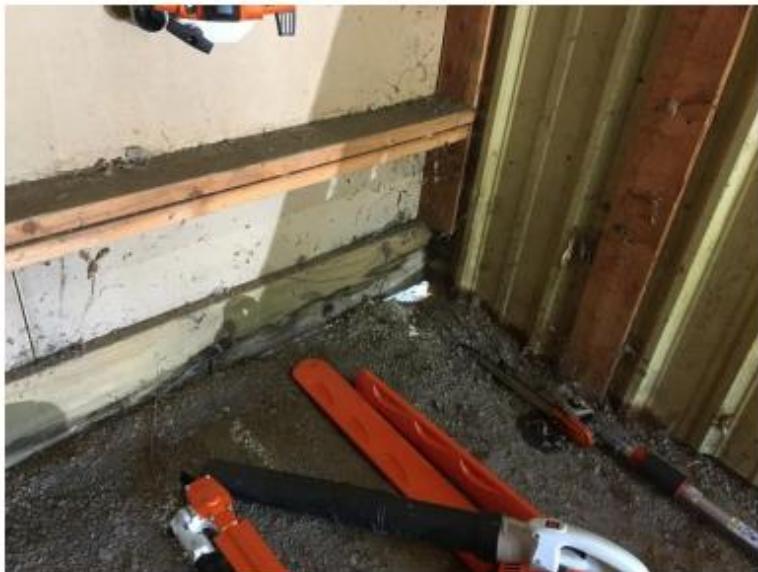
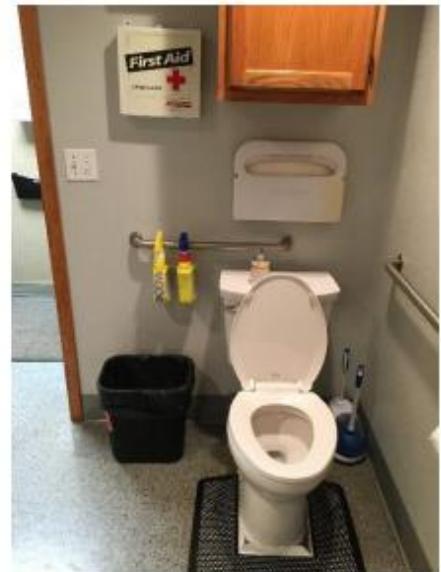
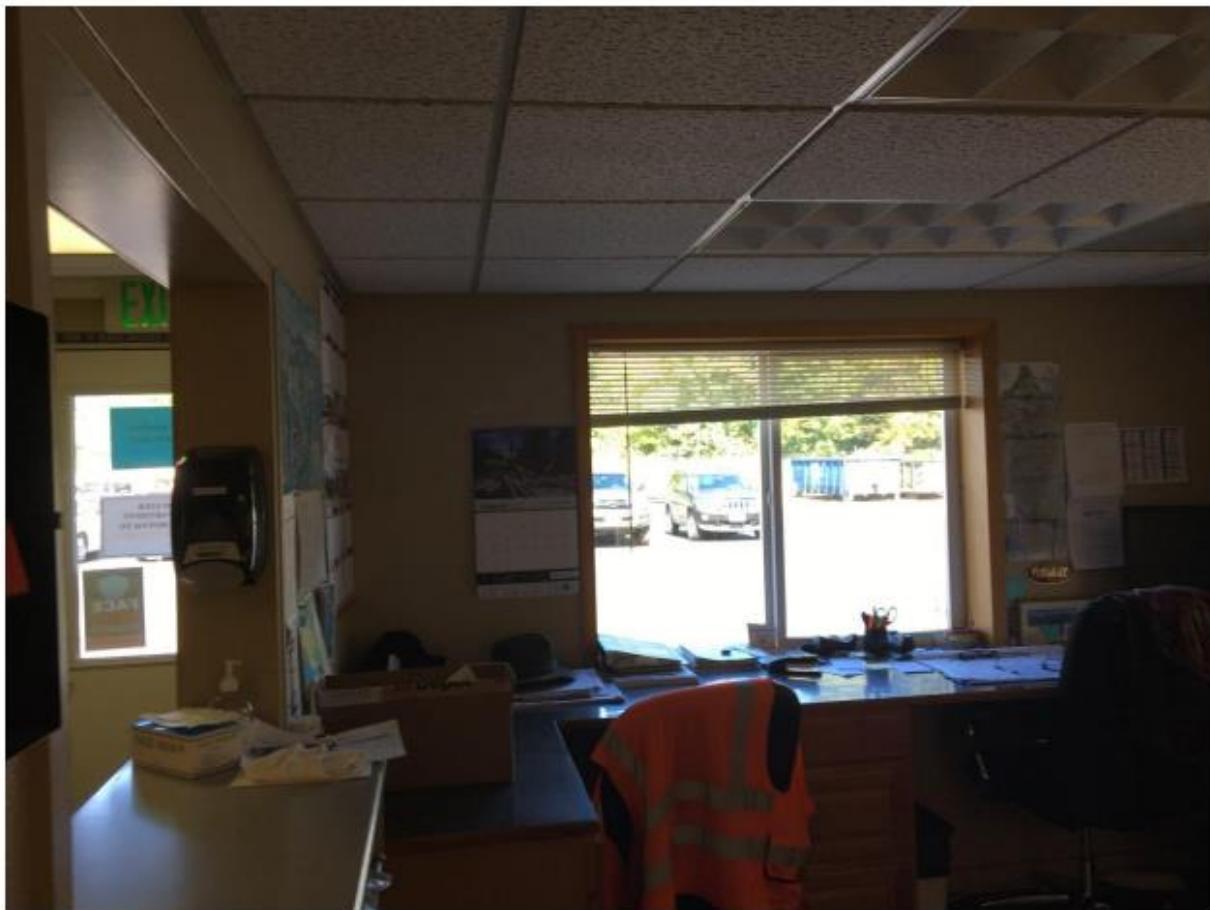
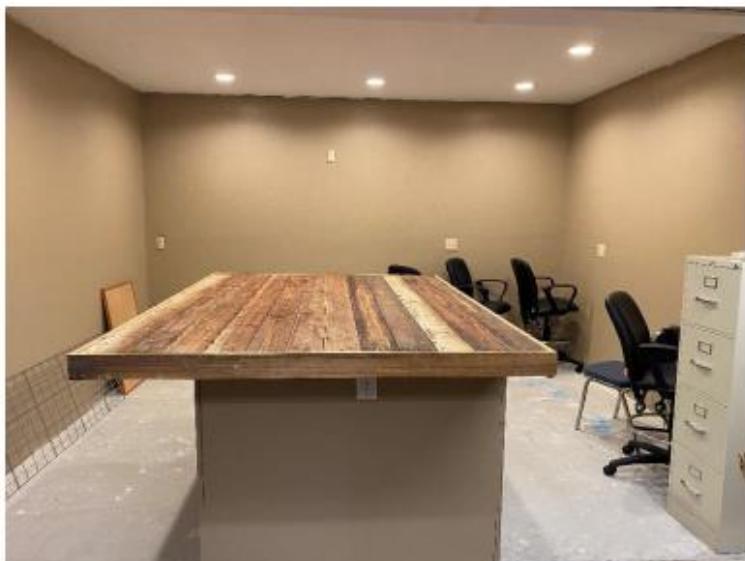
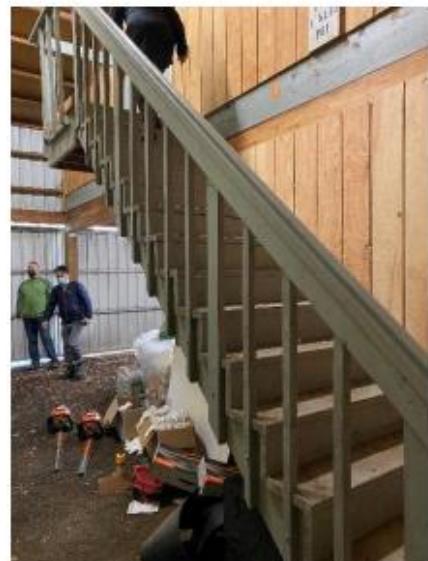
Building C Interior Photos

- Multiple water stains are found at the ceiling likely caused by condensation.
- Partition finishes are painted gypsum walls. They are in fair condition. Insulation value at perimeter partitions cannot be confirmed. Partition insulation at business area stop at the ceiling height based on observation at attic above.

- Ceiling is exposed structure with roof underlayment with liner. Low clearance at approximately 6 foot height with uninsulated perimeter walls.
- Floor is constructed with painted plywood and is in fair condition.
- Attic space has a maximum allowable load of 15 pounds per square foot.
- Security is a concern for the space because of the poor condition of the sliding door to the garage.
- Access control is through door locks

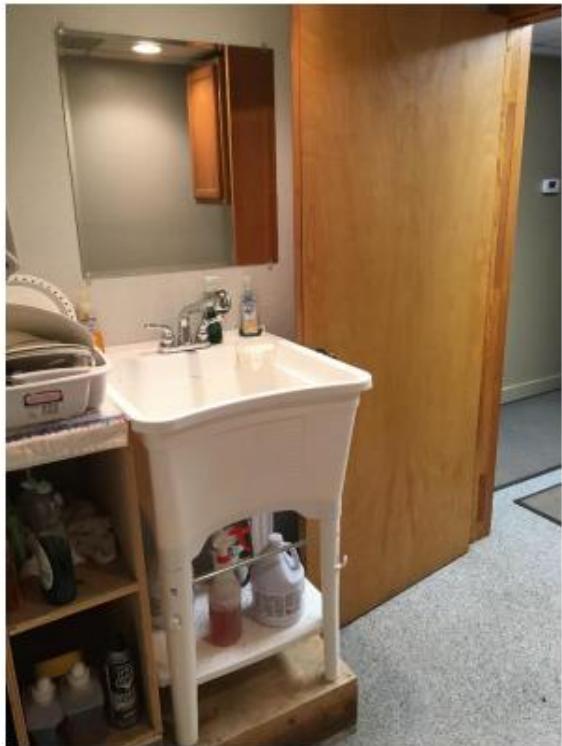
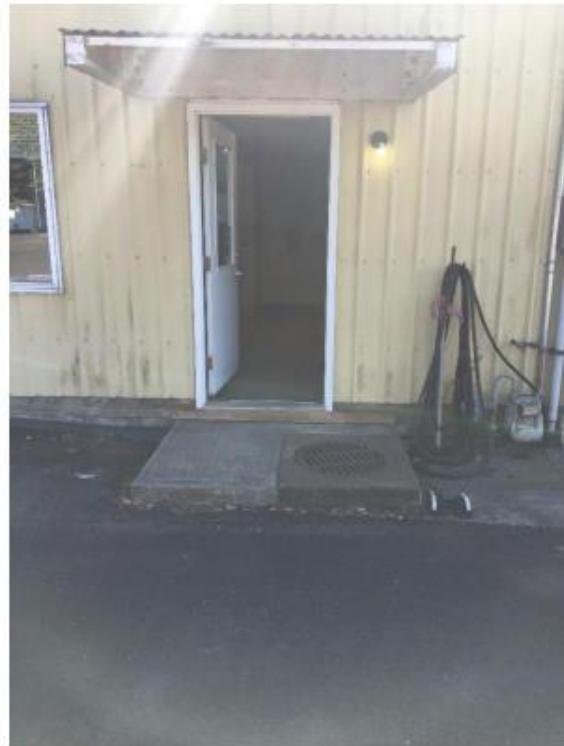
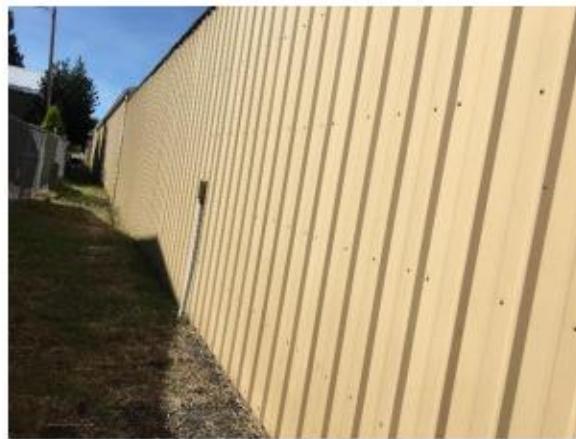
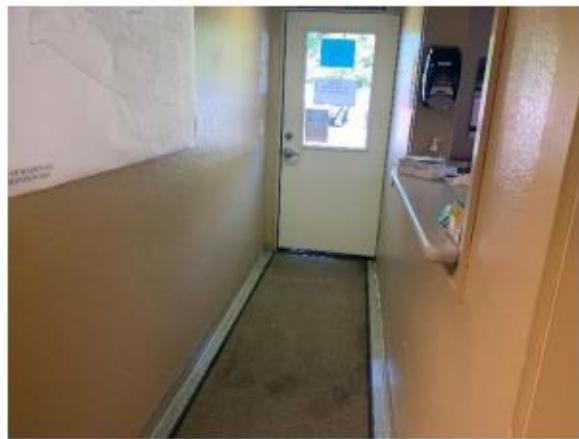
Building C Code Photos

- It appears that there was no fire alarm system in the building
- Horns and strobes are not provided at shops
- Fire extinguishers are located at various spaces
- Exit Signs and Exit plans that indicate fire extinguishers' locations are provided

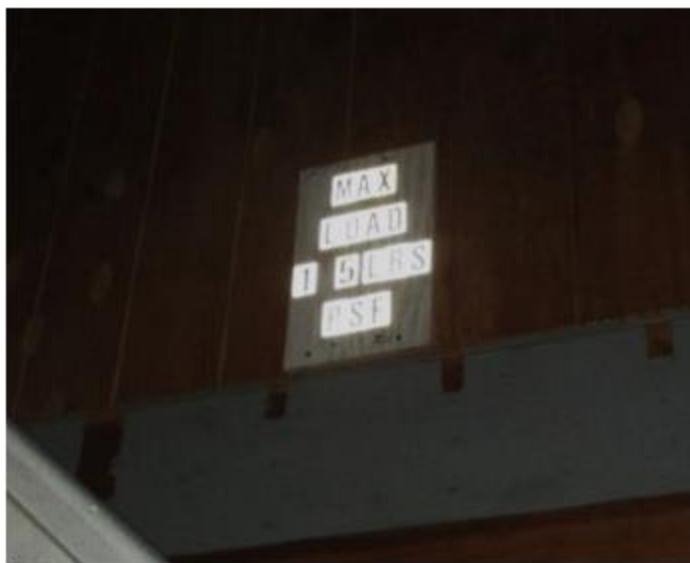
Figure 2.12. Sign at Top of Stairs

A sign at the top of the stairs indicates a maximum load limitation of 15 psf for the loft space (see [Figure 2.12](#)). The floor in this area does not exhibit unexpected deflections when walking around. However, the code minimum loading requirement for a habitable attic space such as this is 30 psf. As 15 psf is a value that is very easy to exceed, a thorough evaluation of the items stored in this space and its layout is required to ensurethat the design load is not exceeded, particularly where the heavy-duty shelving is located (see [Figure 2.13](#)).

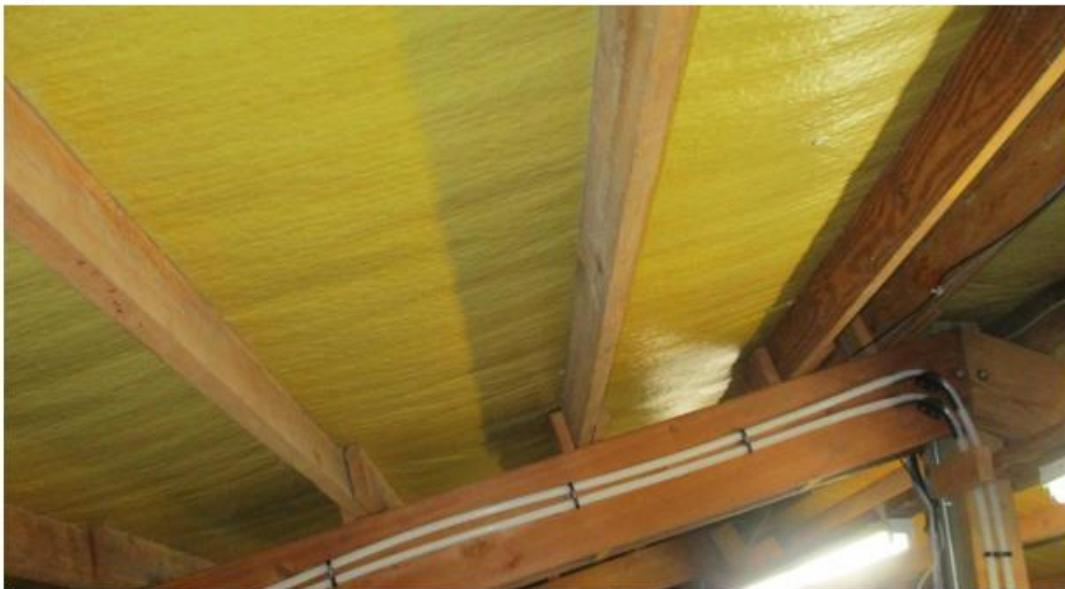
Figure 2.14. Insulation

Most of the structural elements are hidden from view by interior finishes, however, the portions of the structural framing that are visible from the loft area and in the storage area, appear to be in very good condition. The roof sheathing (if present) is hidden by insulation (see [Figure 2.14](#)). The joists supporting the loft area have had holes drilled in them for electrical wiring and plumbing (see [Figure 2.15](#)). These holes do not appear to be placed in compliance with best practices (away from ends, and away from top and bottom edges).

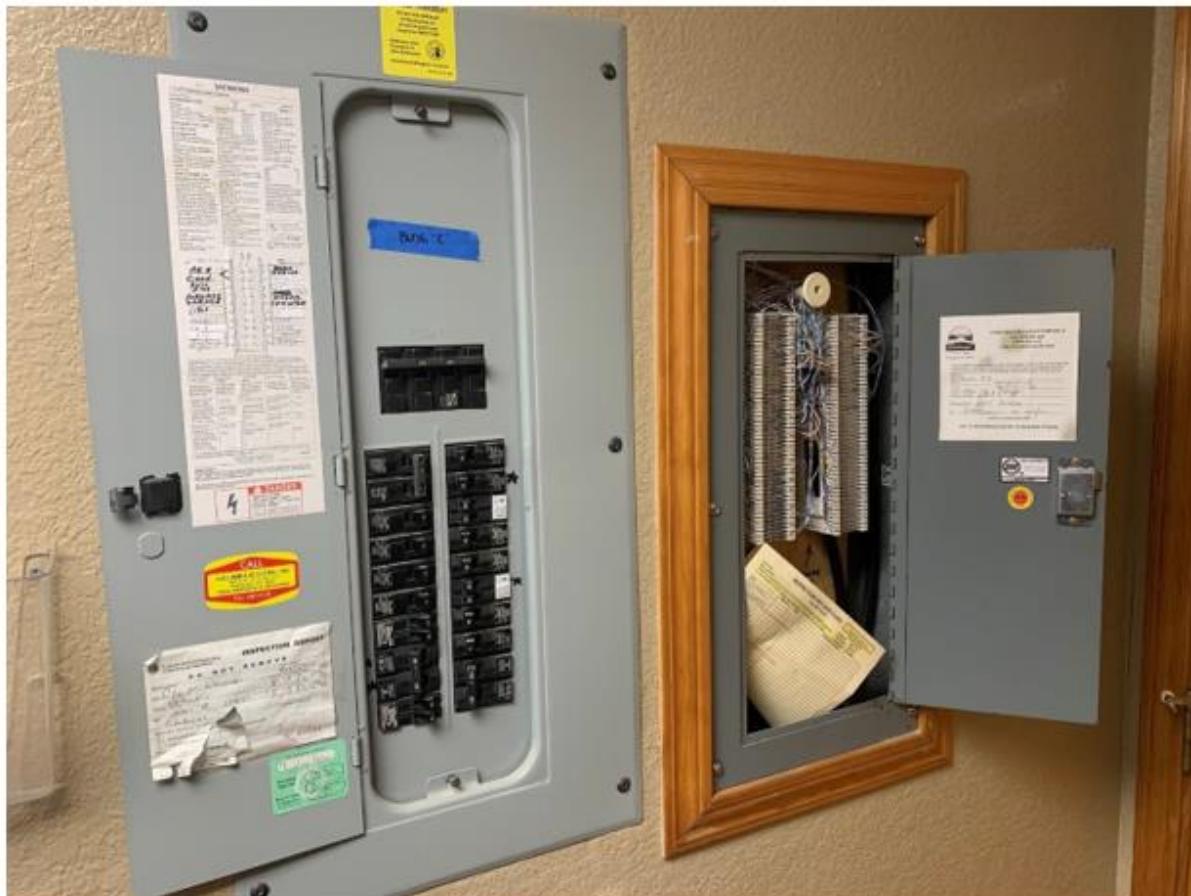
Figure 3.5. Building C Panelboard

Building C is provided with a 120/240-volt, 1-phase, 200-amp electrical service from Clark PUD. The building includes a 200-amp main panelboard with 20 spaces, as shown in [Figure 3.5](#). Every circuit in these panels appears to be in use with no space for future

loads. The panel is a Siemens ITE load center and appears to be in good condition. There is no standby power provided to the building.

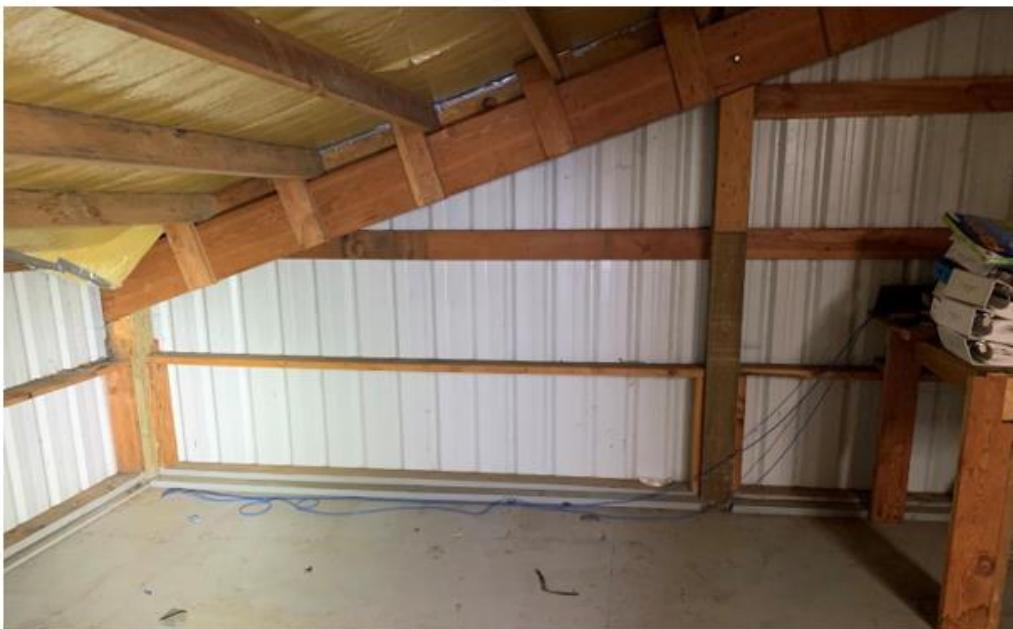
Figure 3.7. Communication Cables in Loft Space

Networking hardware is installed in the loft, as shown in [Figure 3.6](#). It is recommended that this equipment be installed in a dedicated space, such as a communication closet, or be installed in an enclosure for protection. Some of the communication cables located in the loft space are loosely installed without adequate structural support, as shown in [Figure 3.7](#).

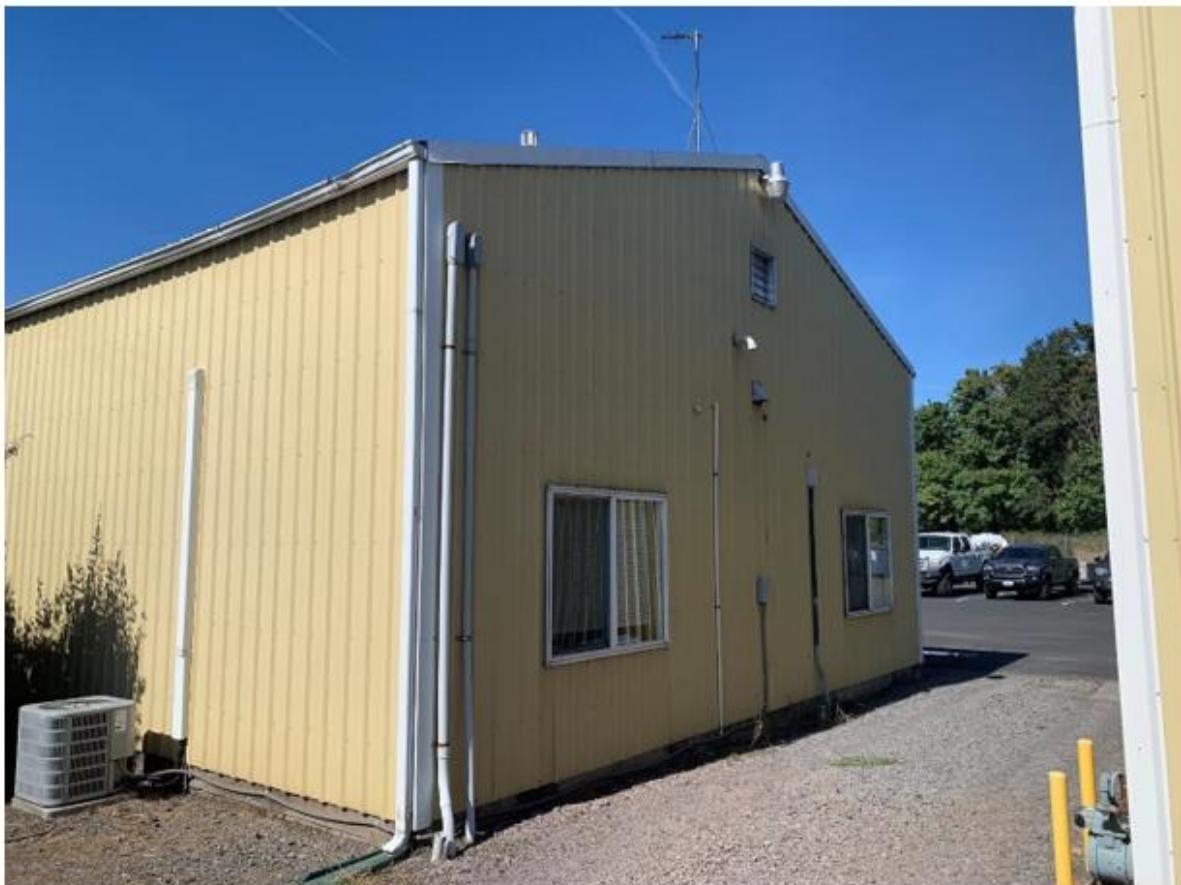
Figure 3.8. HVAC Unit and Disconnect Switch

An HVAC unit is installed outdoors on the south side of the building, and the electrical disconnect switch for this unit is installed on the east side of the building, as shown in [Figure 3.8](#). Since the switch is not in sight of the HVAC unit, it is in violation of NEC requirements. A service outlet for the HVAC unit is also missing per NEC requirements.
