2022 FACILITIES MASTER PLAN

City of Washougal

FACILITY CONDITION ASSESSMENT

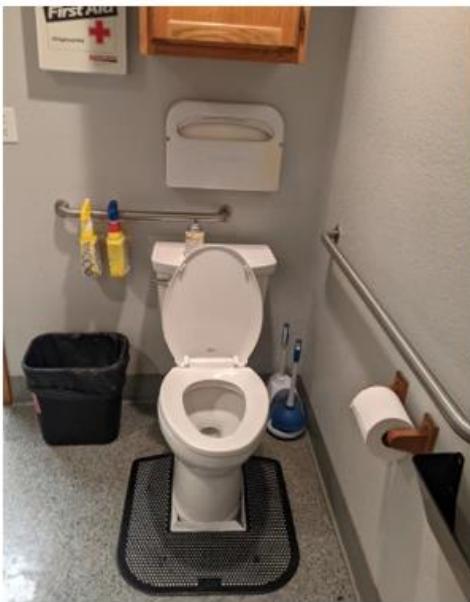
Figure 4.11. Building C Water Closet

The restroom has a shower, water closet, and service sink which is not ADA accessible, (see [Figure 4.11](#), [Figure 4.12](#), and [Figure 4.13](#)). A Bradford White natural gas water heater is in the attic (see [Figure 4.14](#)). This unit is dated 1993 per the Washington LNI Certificate of Inspection. There are signs of previous leaks in the drain pan below the unit and the unit is well beyond the expected life of 10 to 15 years. The plumbing piping was recently modified to serve a partially constructed new room in the back of the building using PEX piping; this new room is not complete and is not in compliance with the current codes. The natural gas meter is in fair condition showing some surface rust.

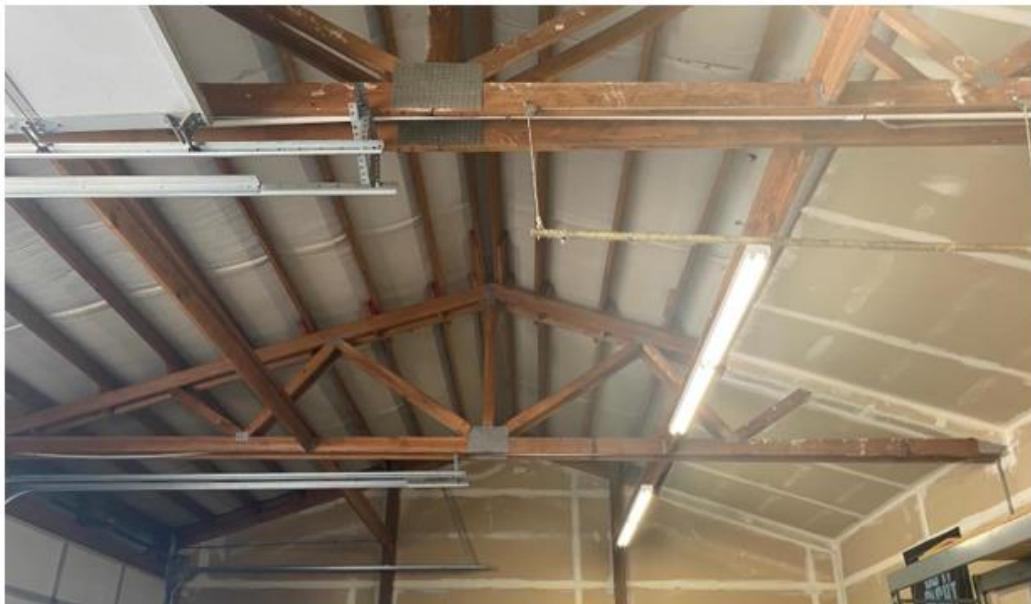
Figure 2.16. East Timber Trusses

Building D is a wood post frame building that is primarily used for vehicle storage on the west end and general purpose storage on the east half. The east and west halves have slightly different roof heights, and it appears that the two portions of the building were built at different times, as the truss designs are similar, but not identical. The east timber trusses are shown in [Figure 2.16](#), with the west trusses are shown in [Figure 2.17](#). It is likely that the west portion of the building is older. Both portions of the building appear to be in good condition. Building posts are constructed from treated timber. No evidence of decay or structural distress is evident. Some minor checking is noted in the columns of the west half.

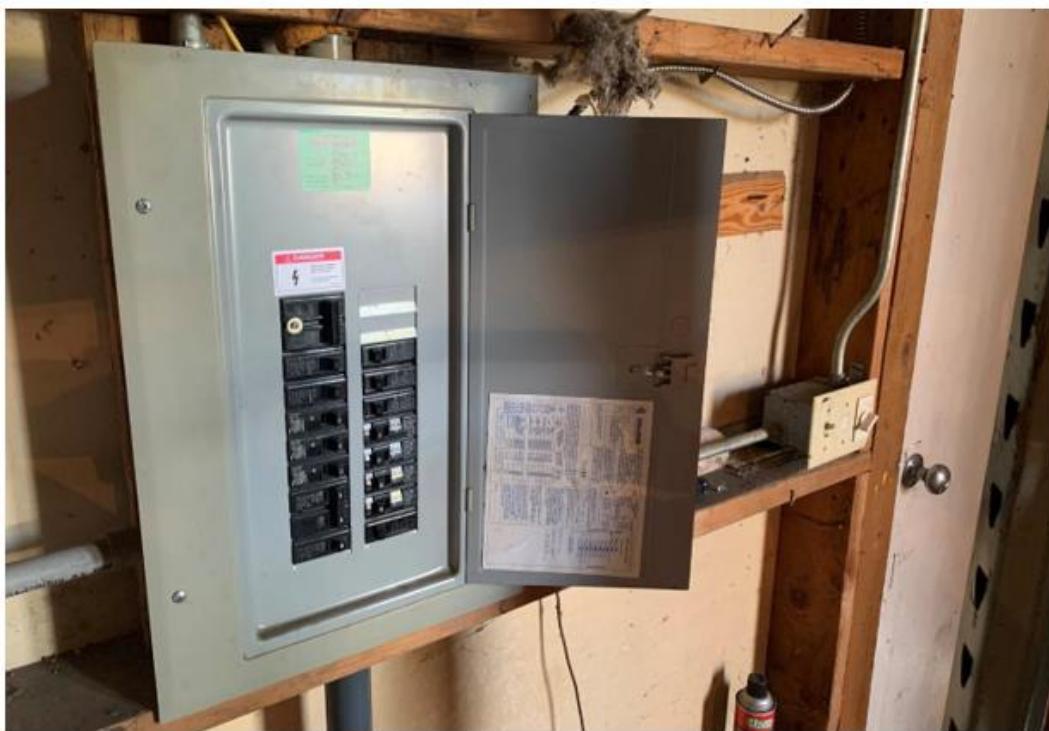
Figure 3.9. Building D Panel

Building D is provided with a 120/240-volt, 1-phase, 125-amp electrical sub panel that is fed from a circuit from Building C. The panel is a Challenger load center with 20 spaces, as shown in [Figure 3.9](#), and appears to be in good condition. A large metal shelf is installed in front of the panel, as shown in [Figure 3.10](#), which is in violation of NEC requirements for clear working space in front of electrical equipment. The panelboard circuit directory is missing, which is a violation of NEC requirements.

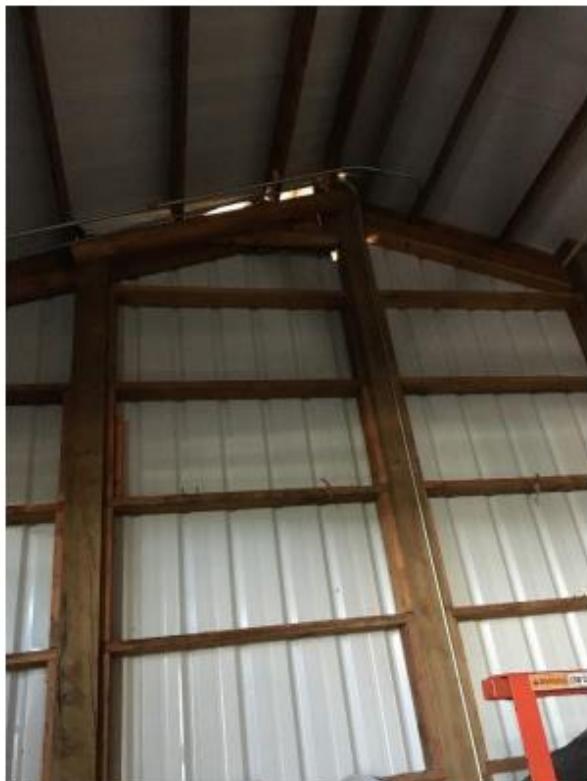
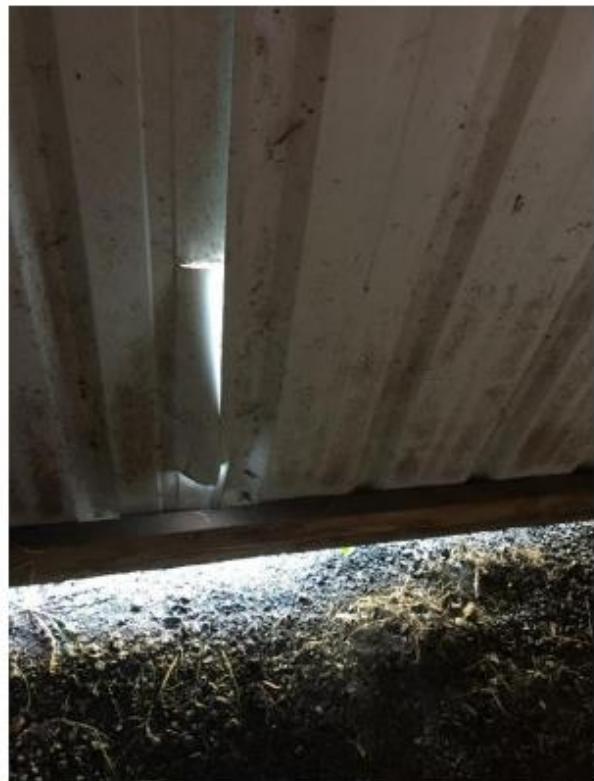
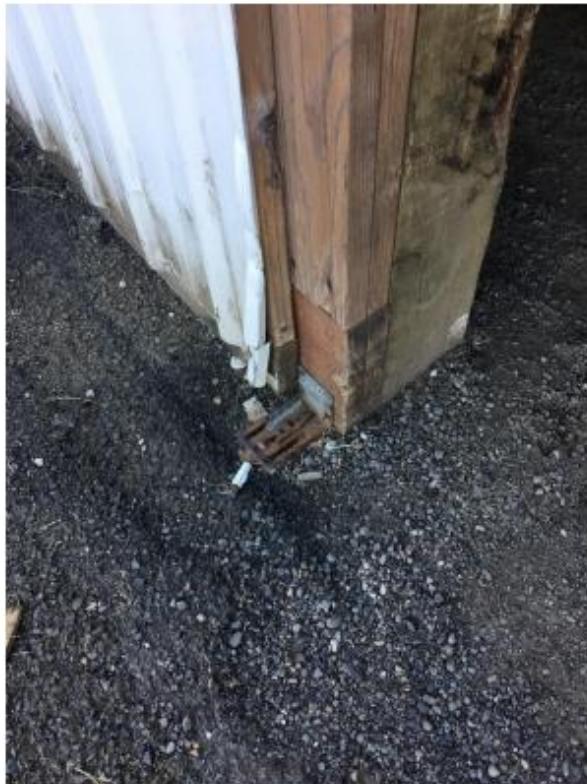
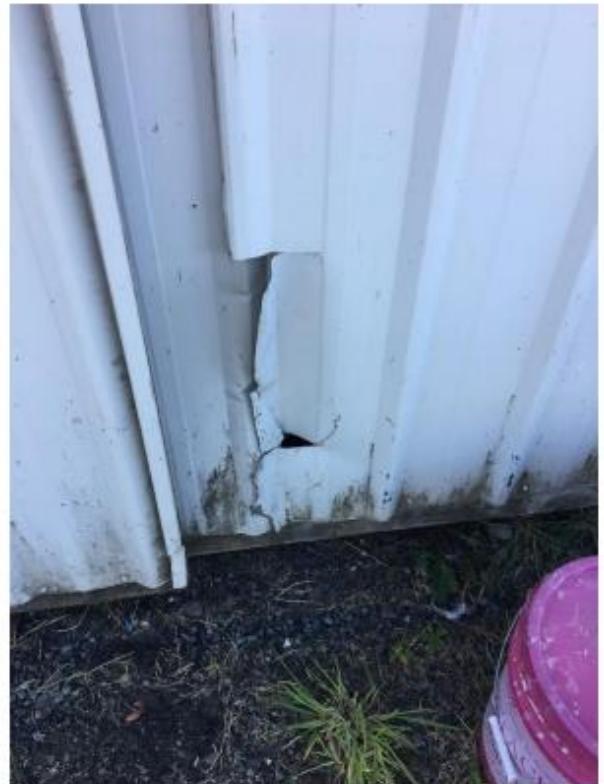
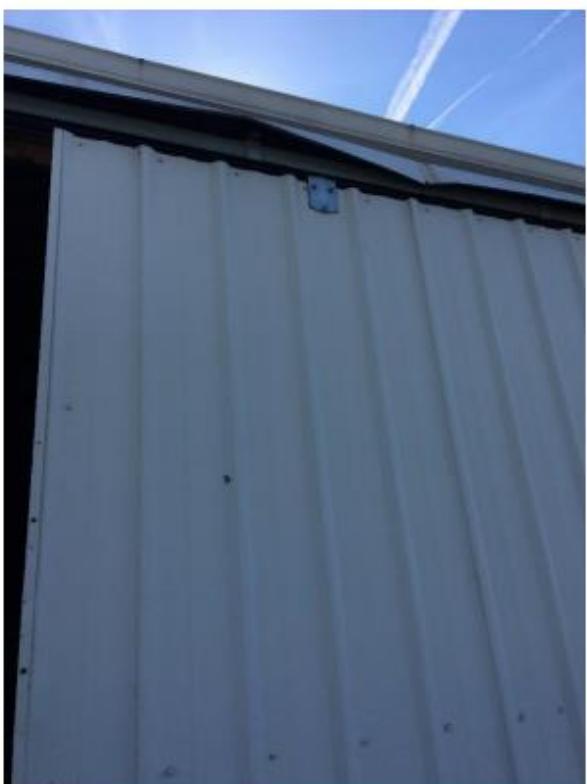
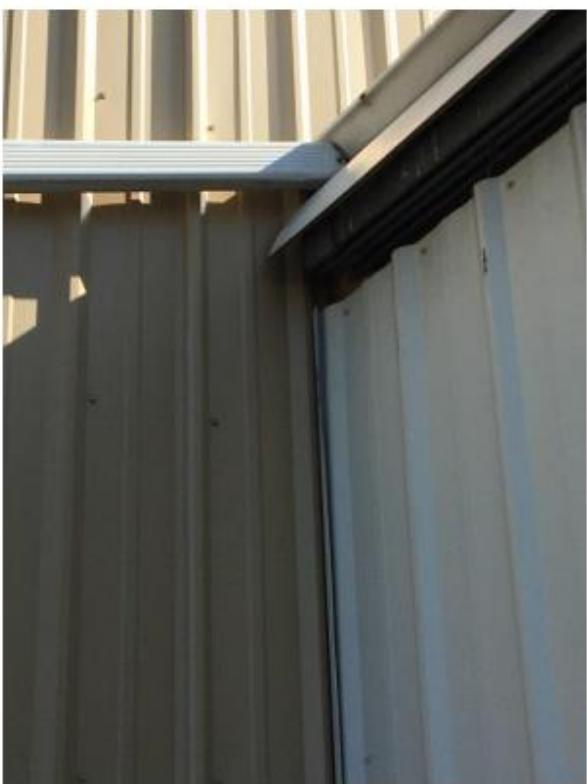
Building E Exterior Photos

- Metal roof and roof fascia system are in fair
- No obvious wear and tear marks on the roof panels were found o Unsealed opening on the roof panels was found at the area near Building F
- Leakage likely occurs from the roof

- Wall exterior condition is aged and in fair condition
- Finish of the wall panels are generally intact
- Dents and locally deformed areas on metal panels were found
- Treated wood wall curbs are exposed without flashing transition or protection

Doors: Manual uninsulated sliding doors at Storage are deformed but functioning. They are in poor condition.

Security: With poor condition of the vehicle sliding doors, security of the building is concerning.

HDR conducted a visual assessment of Building E. The overall condition of the building is average. The roof and the walls are aged. Reasonable wear and tear is noted. Timber sill plates for exterior walls with direct ground contact are not recommended for industrial buildings. Detached roof panels caused by poor workmanship or detail is noted near interface with Building E roof. Leakage from the roof is expected. Deformed wall panels and sliding doors shall be repaired.

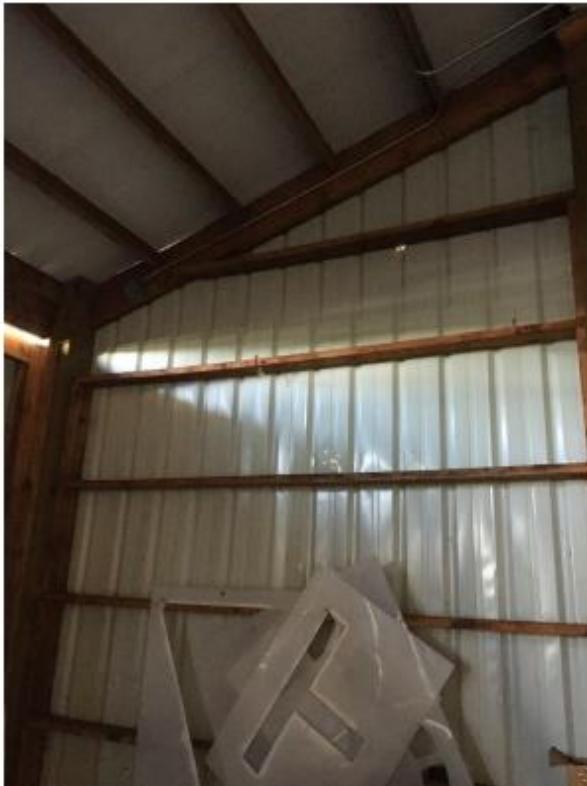
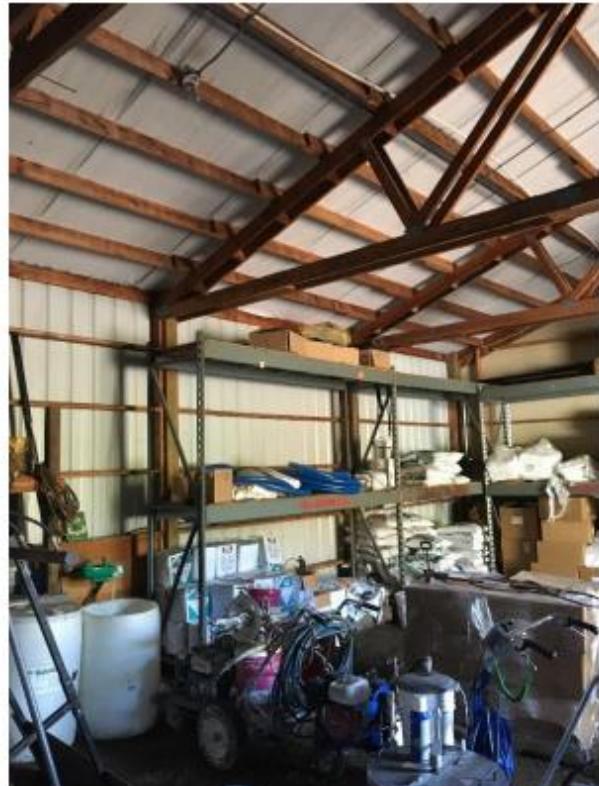
Building E Interior Photos

- Ceiling is exposed structure. Roof underlayment with liner is exposed. Approximately 13 to 14 feet at high point.
- Walls are uninsulated and exposed metal panels and wall girts o Floor is composed of gravel and soil

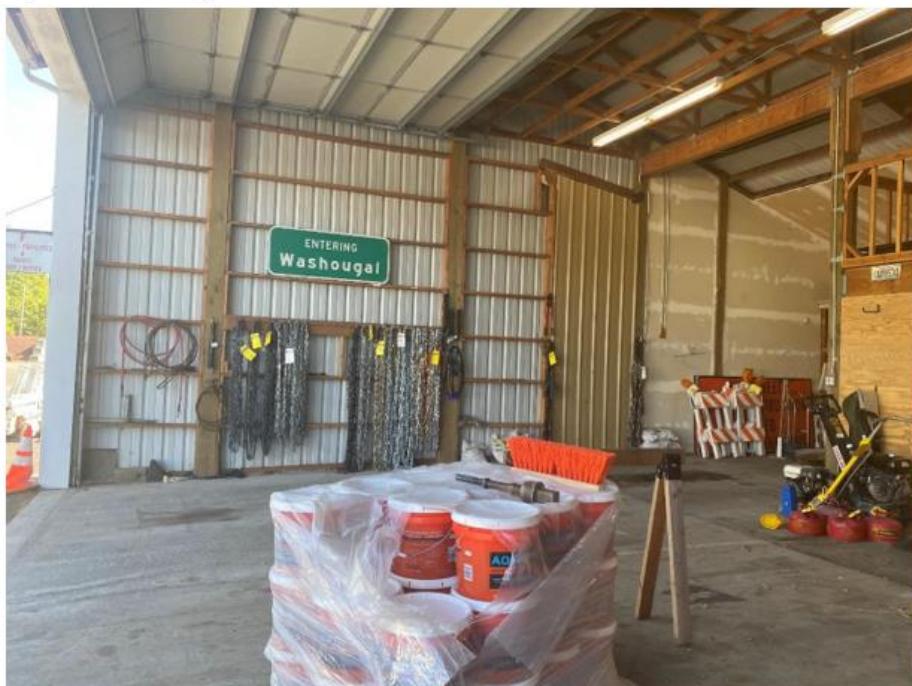
Figure 2.18. Building E Structure

Building E is a wood post frame building that is primarily used for general purpose storage with a concrete floor. It is unknown if the slab meets frost depth requirements. The roof is supported by wood trusses. The west wall is shared with Building D and the east wall is partially shared with Building F. In general, the exposed structure appears to be in good condition. Based on the construction methods used and the coloration of the treated timber elements, it appears this structure is one of the newer structures on the site. Photos are shown in [Figure 2.18](#) and [Figure 2.19](#).

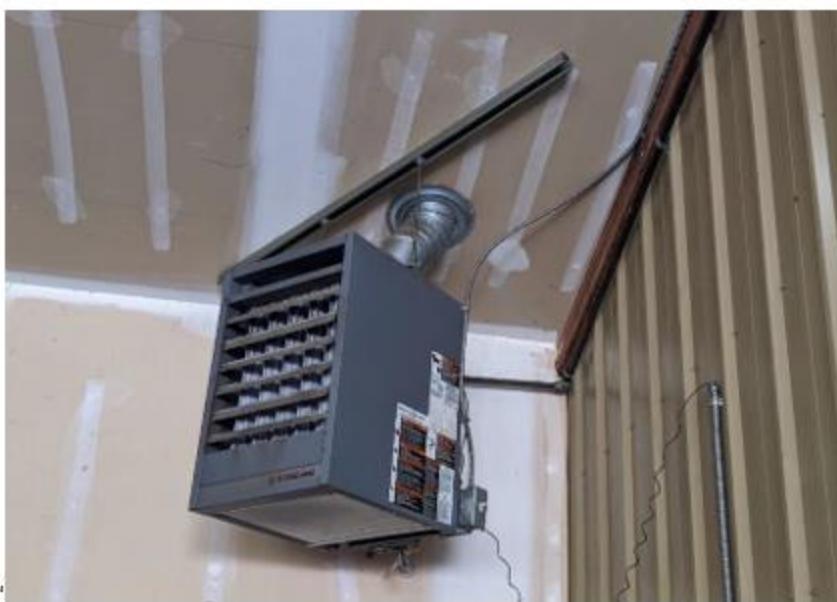
Figure 4.17. Building E Unit Heater

Building E has a single unit heater in the southwest corner, fed by natural gas from Building D (see [Figure 4.17](#)). The thermostat for this unit has been disassembled and may not be functioning (see [Figure 4.18](#)). There are visible gaps around the perimeter of this space, most noticeably at the joint between Building D and Building E that allow air and water to infiltrate the building. These gaps should be repaired to maximize heating system efficiency.

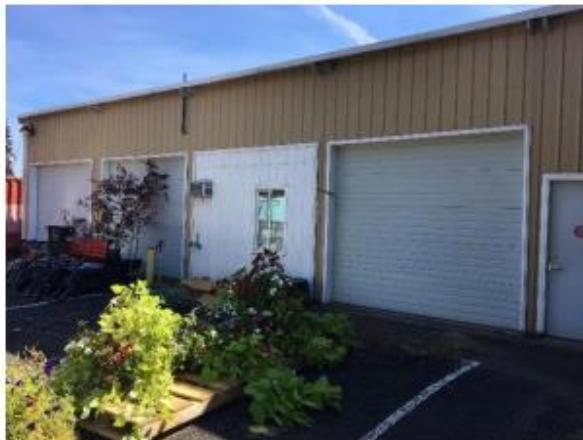
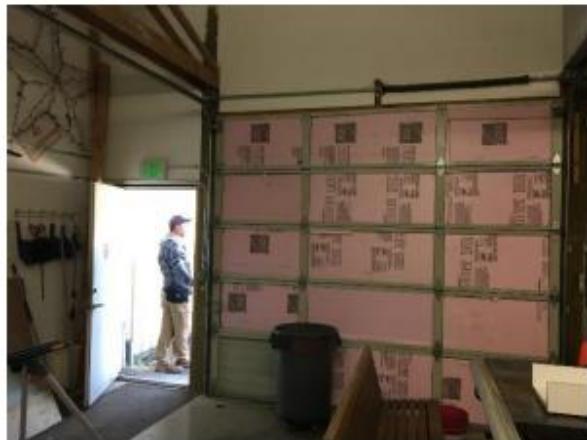
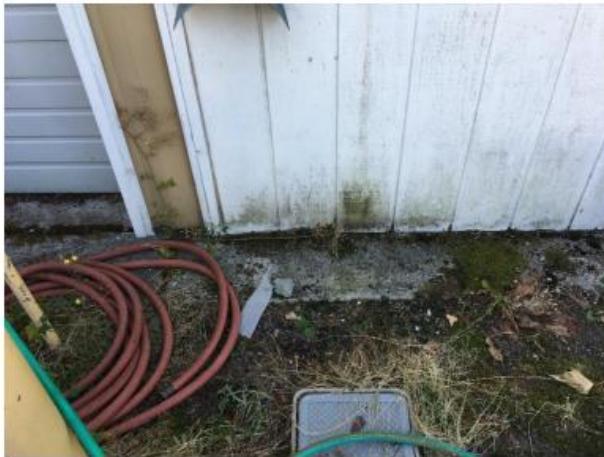
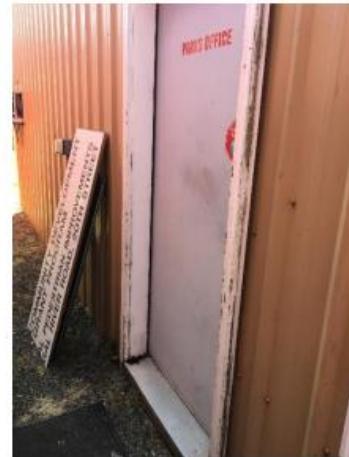
Building F Exterior Photos

- Uninsulated metal roof and roof fascia system are in fair condition
- No obvious wear and tear marks on the roof panels were found
- No unsealed openings on the roof were found

- Wall exterior condition is aged but in fair condition
- Finish of the wall panels are generally intact
- Dents and locally deformed areas on metal panels were found
- Treated wood wall curbs are covered by wall panels and flashing

- Manual overhead sectional doors are in good condition. They appear to be non-insulated type at the shop.
- Manual overhead sectional doors are block off at the shop area. Rigid insulations are applied at the sectional doors, but it is partially completed. o Egress single doors are metal doors in fair condition.

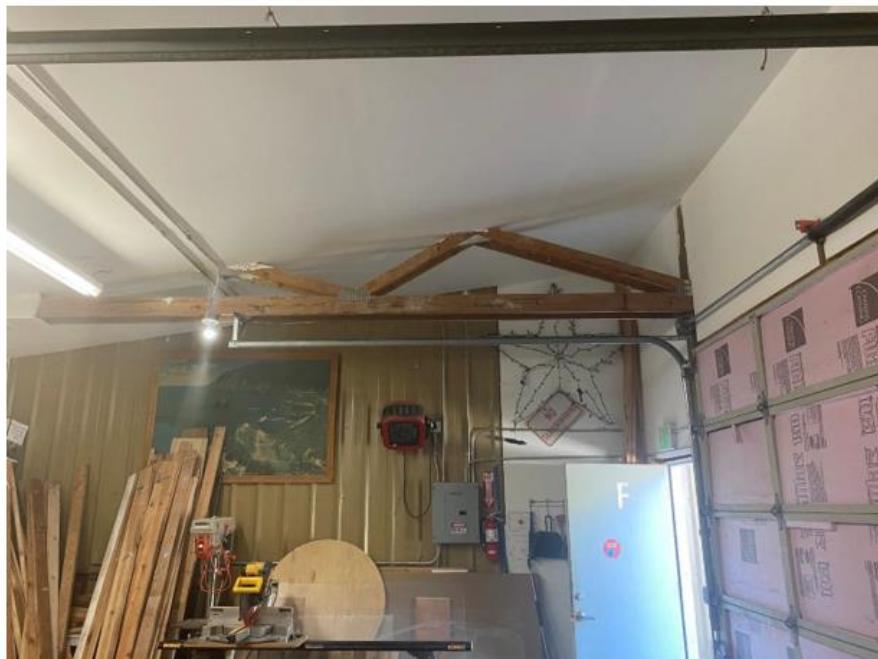
Building F is a building that is primarily used for storage and workshop space. It is assumed to be of wood post type construction, similar to all of the other buildings on site, however, the structure is hidden by drywall. The roof appears to be supported by timber trusses. The majority of the roof structure has been hidden with drywall, with only small portions of the trusses exposed (see [Figure 2.20](#)). This building has a concrete floor slab that is in good condition. It is unknown if this slab has turndowns to meet frost depth requirements. The condition of the structure cannot be evaluated as the structure is fully hidden, however, no obvious signs of distress, such as cracking in the drywall or out of squareness of doorways is noted.

Figure 2.20. Roof Structure Hidden with Drywall

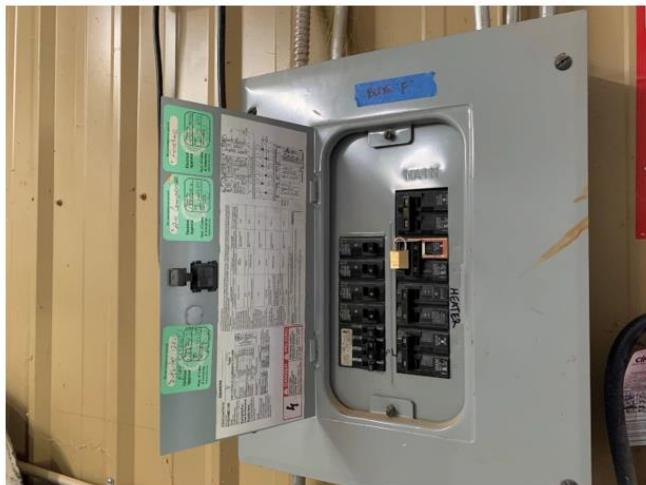
Figure 3.11. Building F Panel

Building F is provided with a 120/240-volt, 1-phase, 100-amp electrical sub panel. This building does not include a separate electrical service from Clark PUD. During the site visit it was undetermined where this panel is being fed from. The panel is a Siemens loadcenter with 12 spaces, as shown in [Figure 3.11](#), and appears to be in good condition. A large amount of scrap materials is being stored in front of the panel, as shown in [Figure 3.12](#), which is in violation of NEC requirements for clear working space in front of electrical equipment.

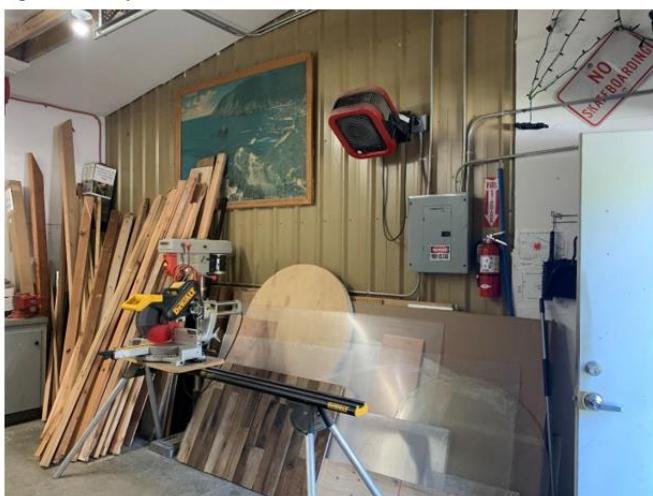
Figure 3.12. Scrap Materials Stored in Front of Panel

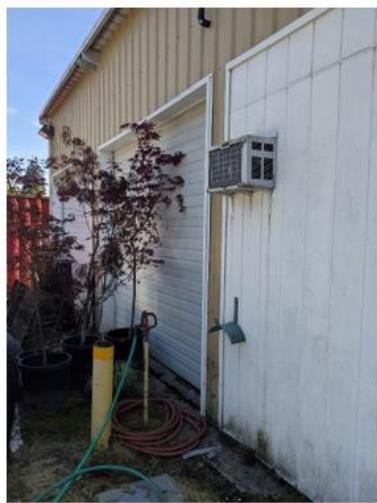
Two wall-mounted air conditioners serve the entry area shop (see [Figure 4.21](#)), and the parks office in the southeast corner (see [Figure 4.22](#)). Neither unit is in use and they are both blocked by stored items on the inside.

Figure 4.21. Building E A/C in Entry Area Shop

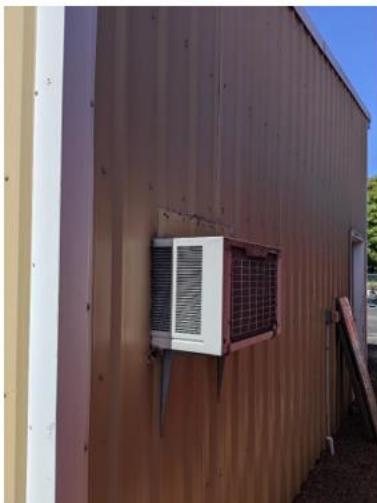
Figure 4.22. Building E A/C in Parks Office

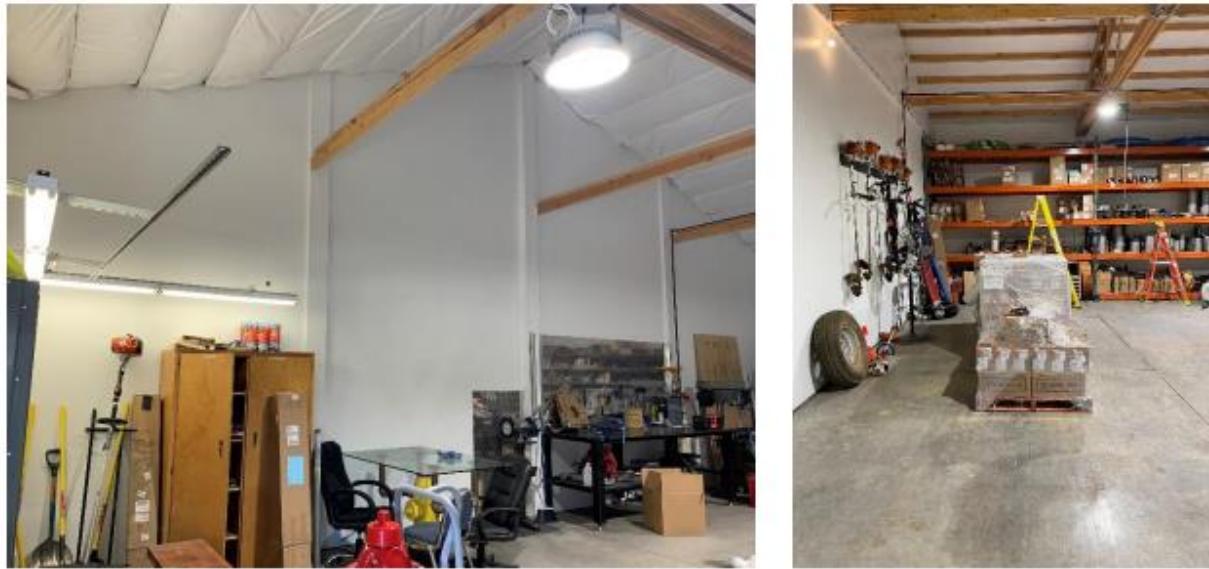
Building G Interior Photos

- Ceiling is exposed wood structure with insulated ceiling liners to form the vaulted ceiling. Approximately 18 feet at the ridge of the high point.
- Partitions are covered by either painted gypsum board or painted plywood
- Floor is composed of sealed concrete slab in good condition
- Access control is through door locks

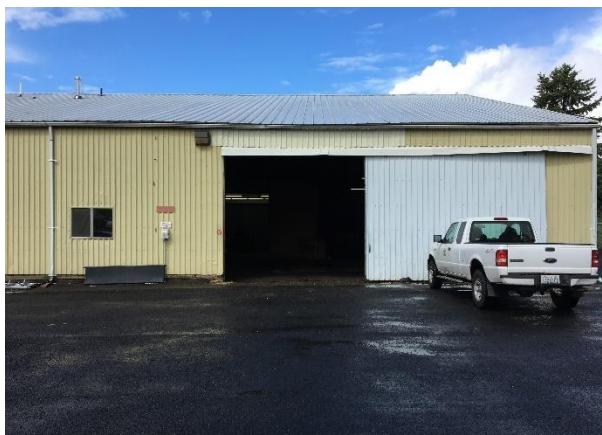
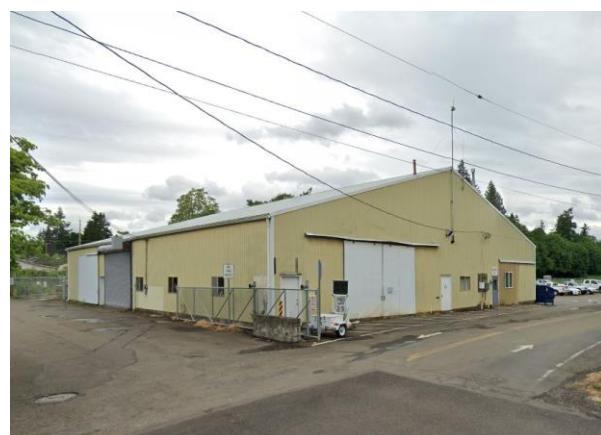
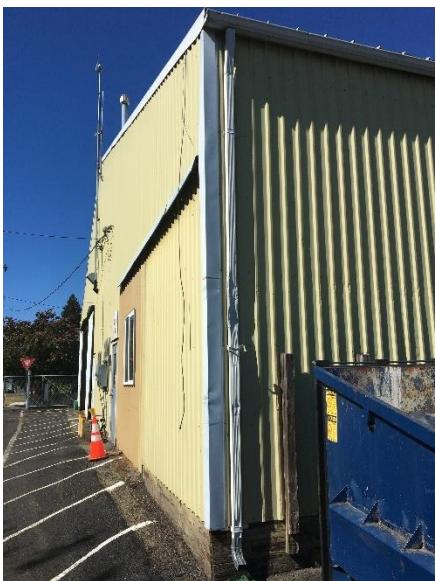
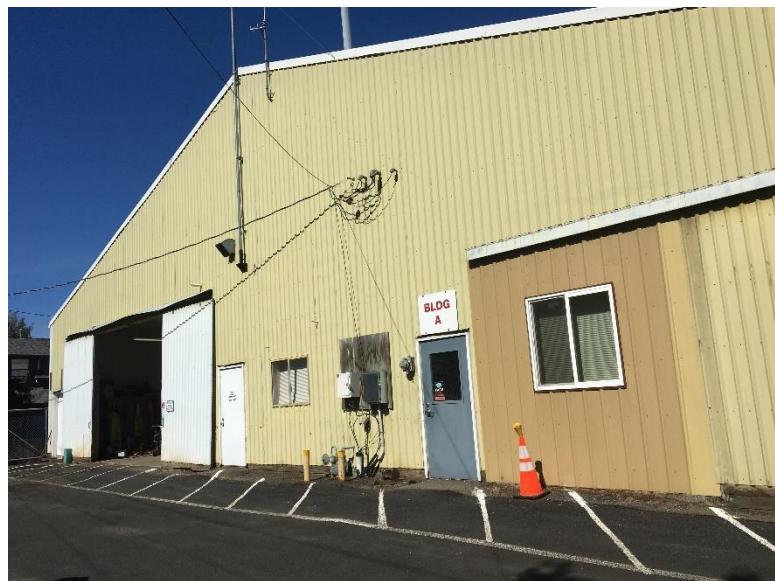
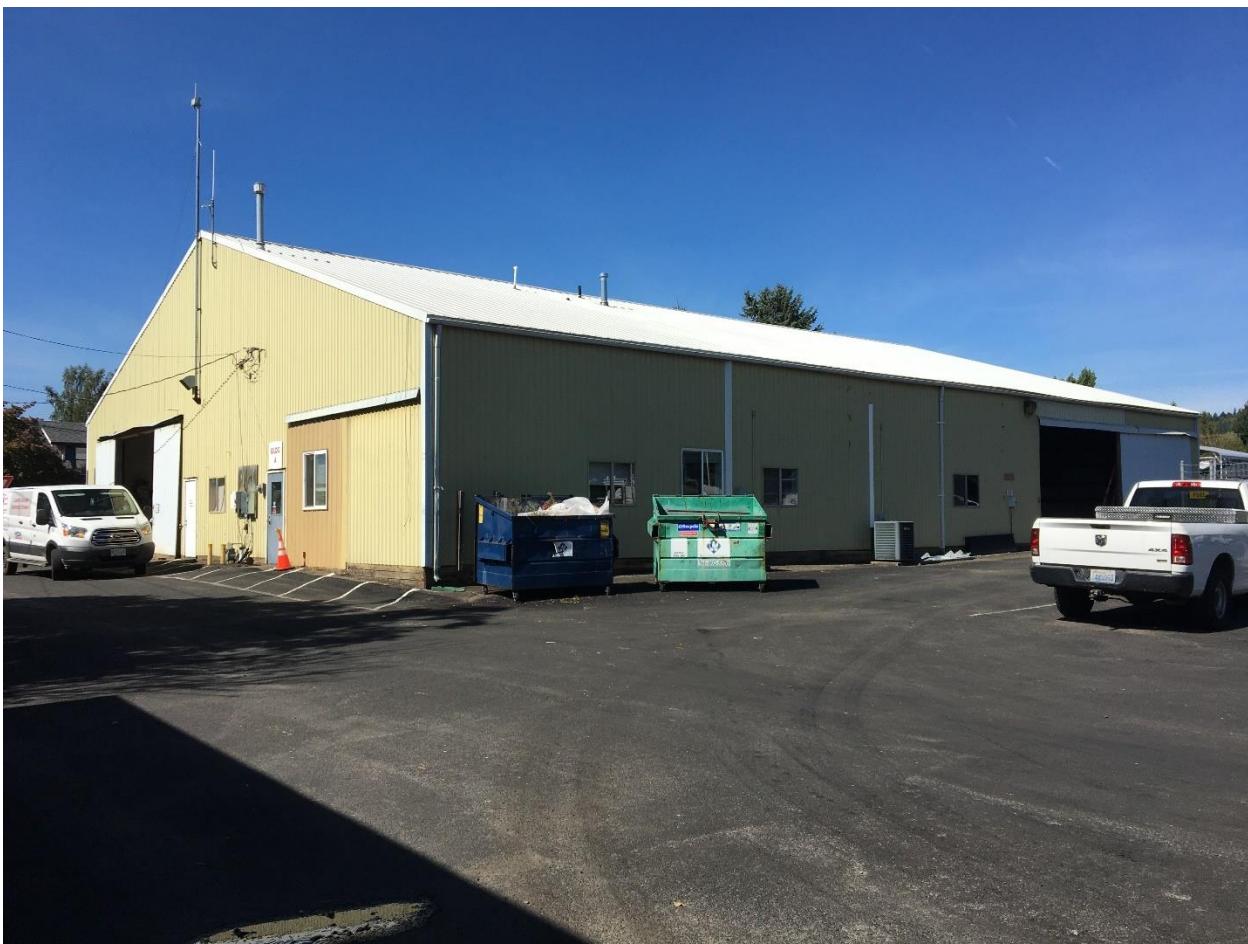
Figure 1.1. Building A General Photos

- Size: Approximately 50 feet by 100 feet. The longitudinal axis of the building is north-south direction.
- Style: Building A is a rectangular barn building

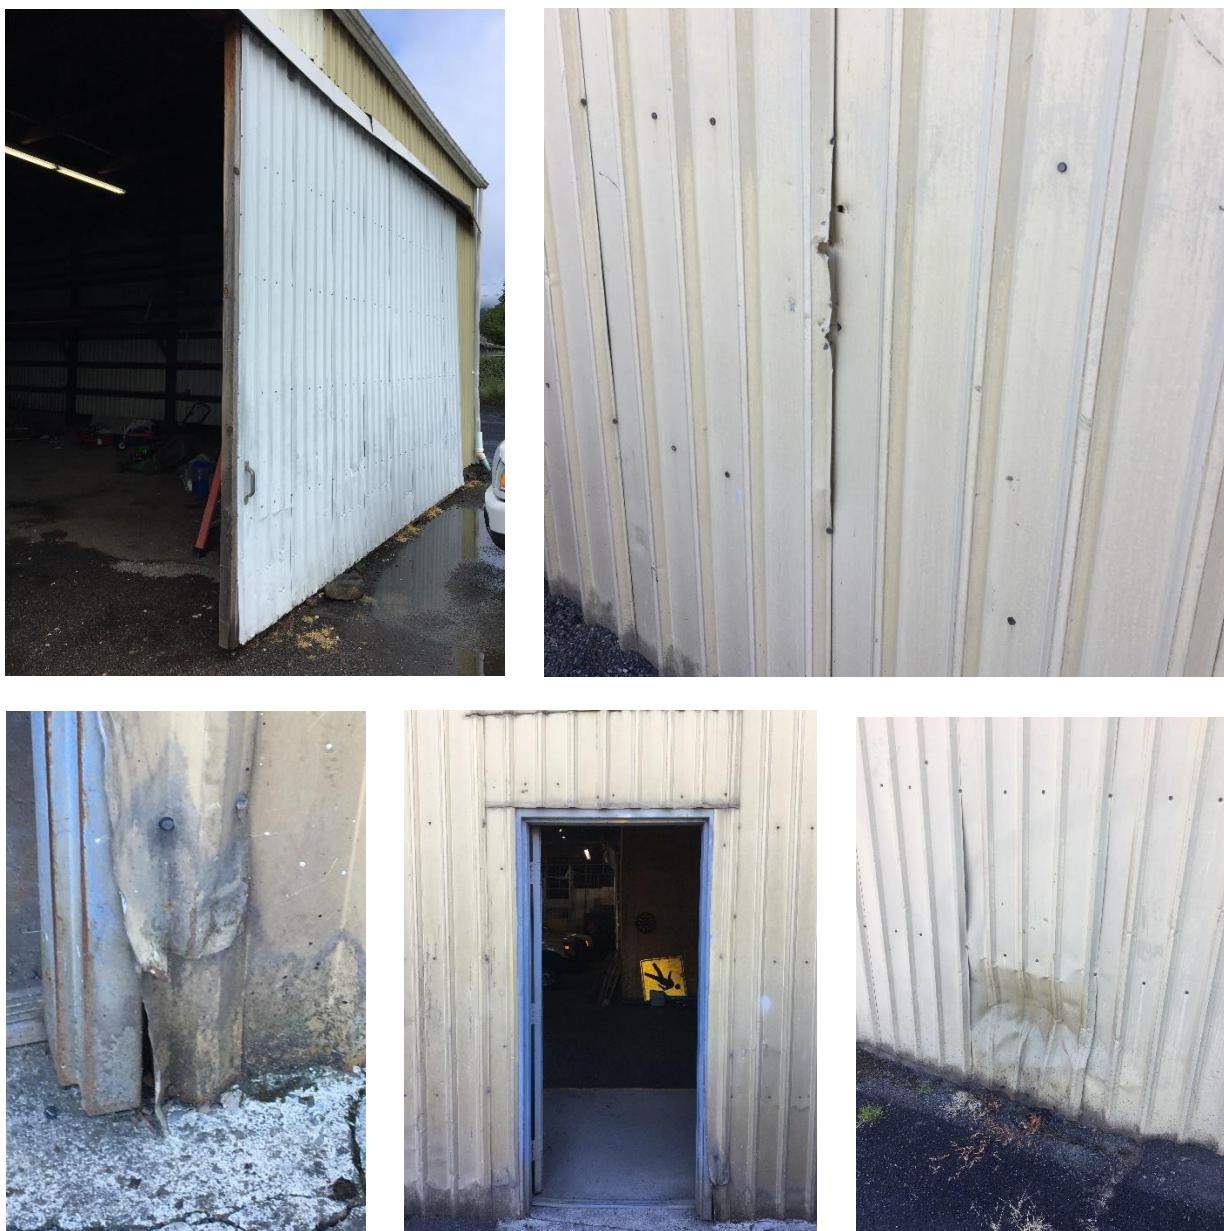
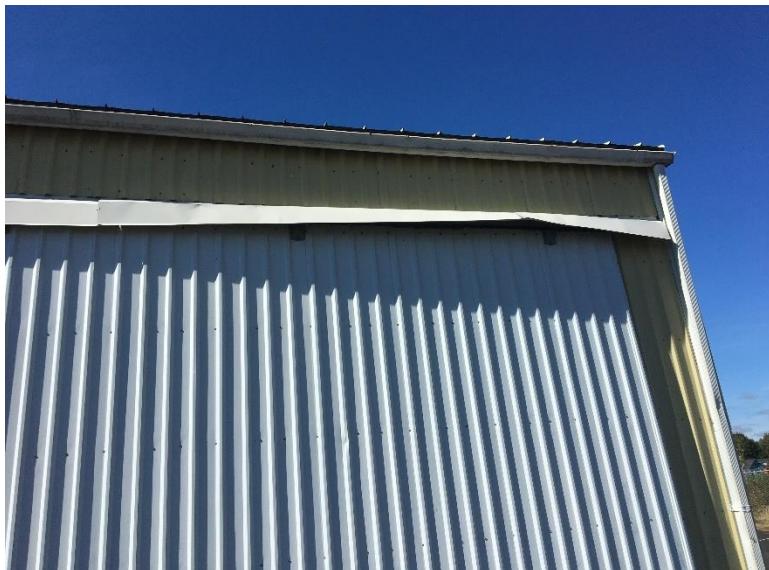
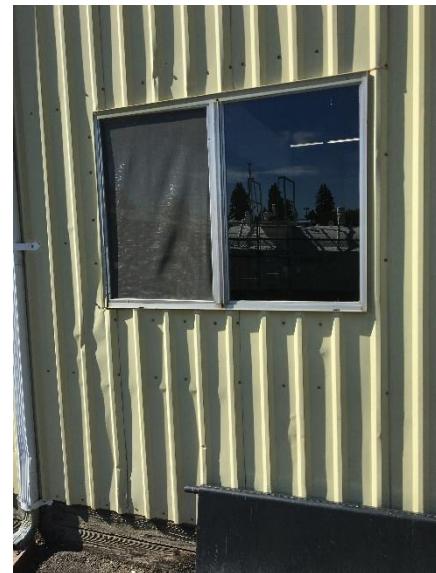
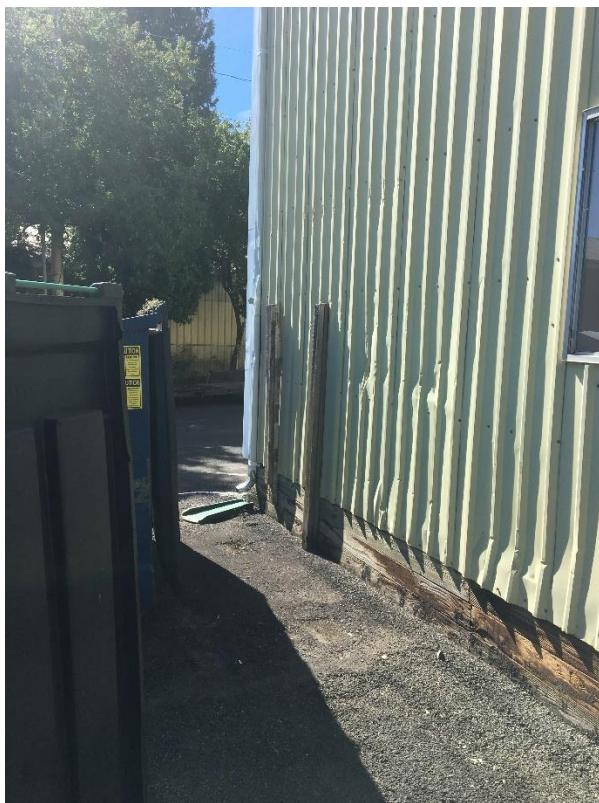
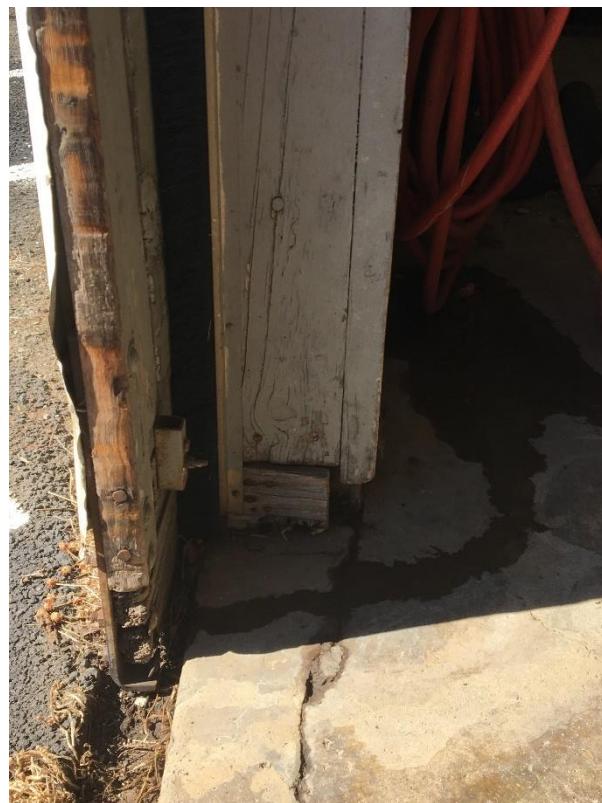
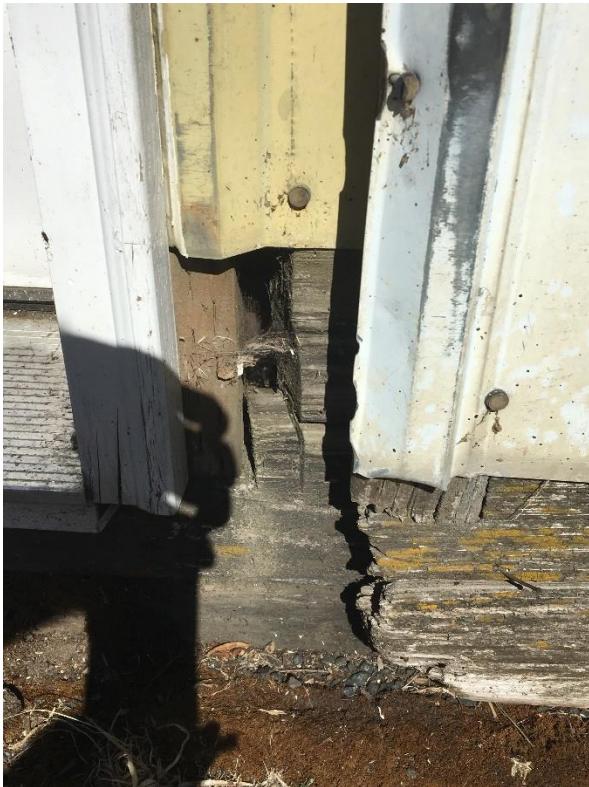
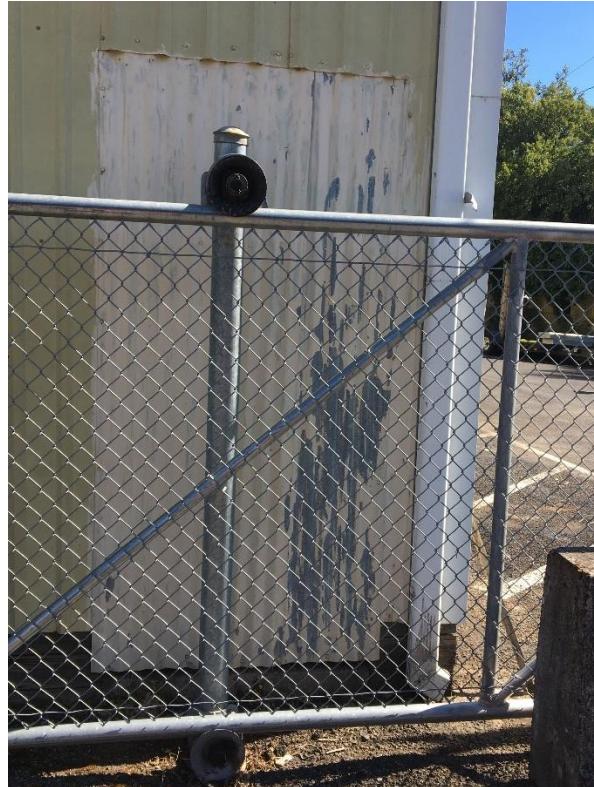
Figure 1.2. Building A Exterior Photos

- Uninsulated automatic overhead rolling door at shop is in fair condition.
- Manual uninsulated sliding barn door is in below average condition.
- Manual bi-parting uninsulated sliding door at the south façade is in below average condition. The wood framing of the door leaf is rotted.
- Security
 - Intrusion detection system is not found
 - Security Camera is not found at the site

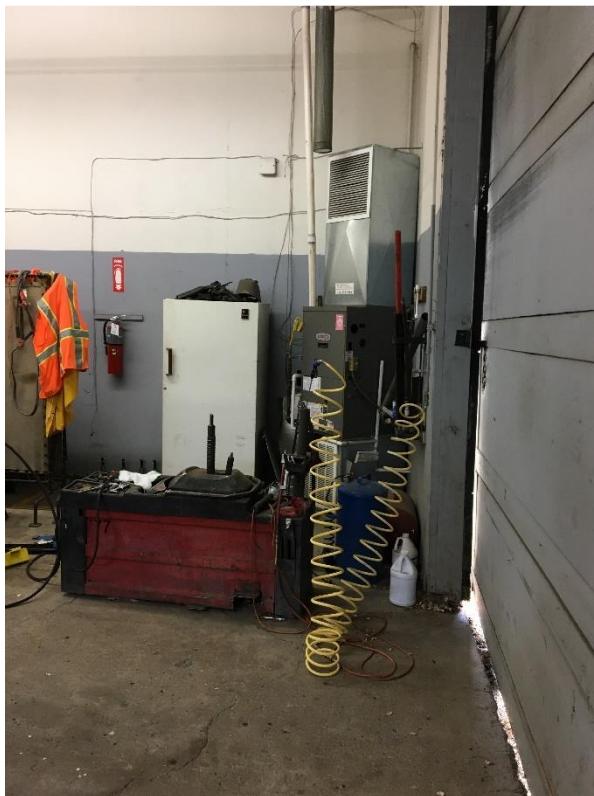
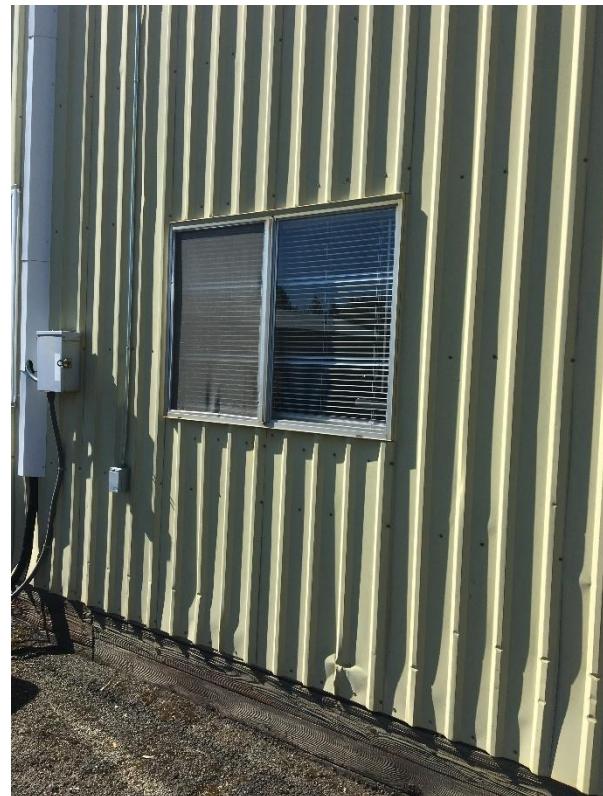
Figure 1.3. Building A Interior Photos

- Access control are through door locks

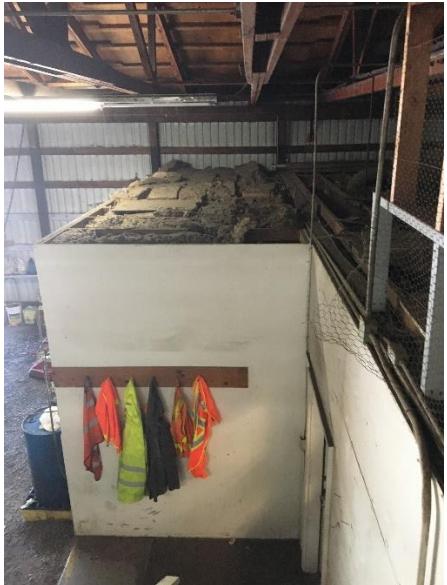
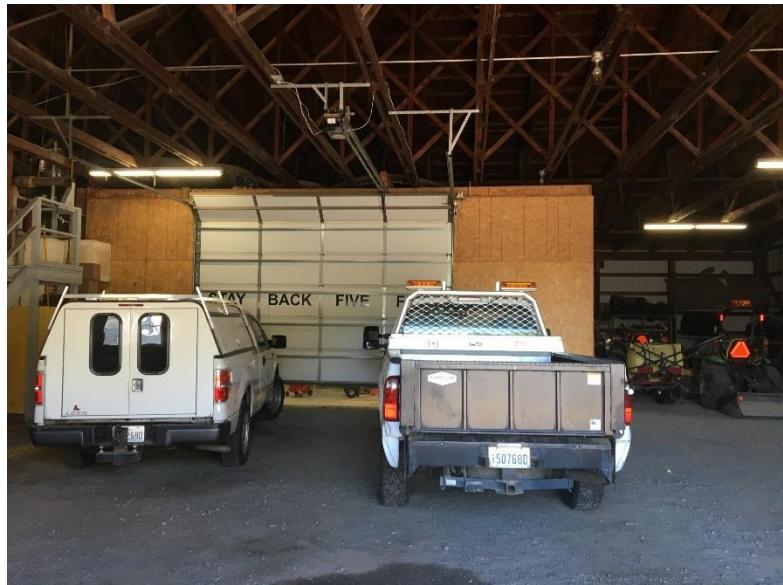
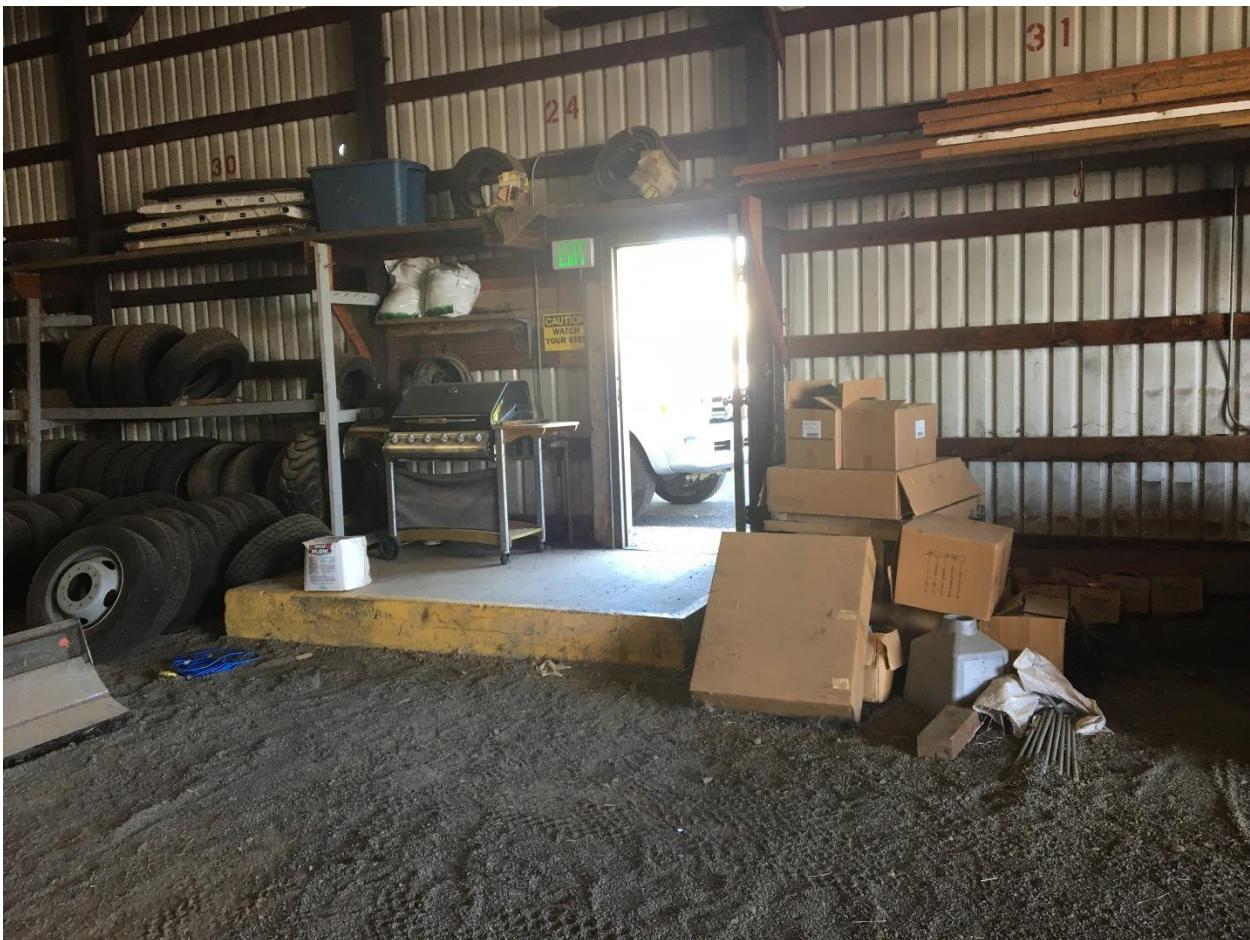
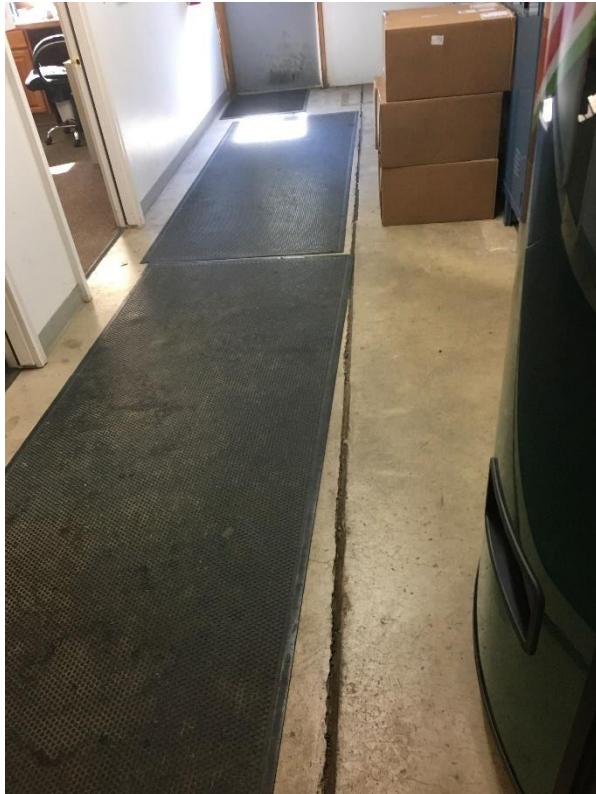
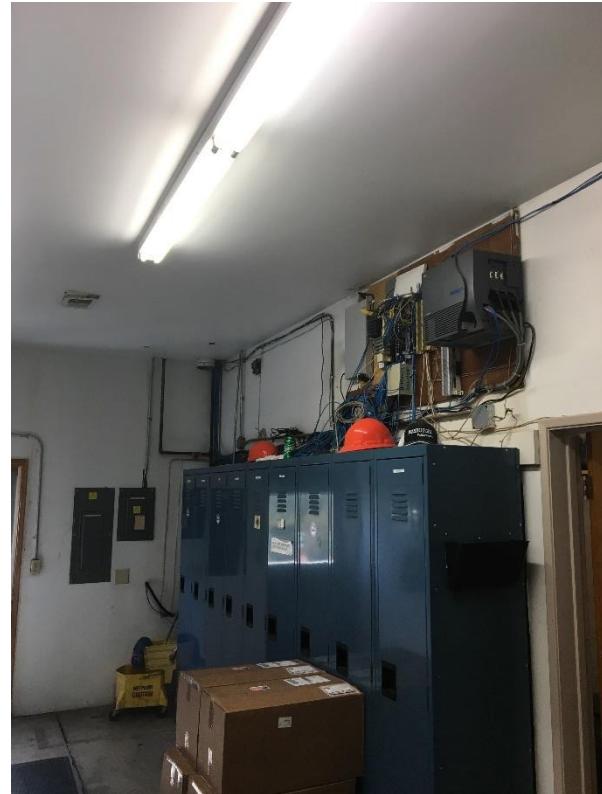
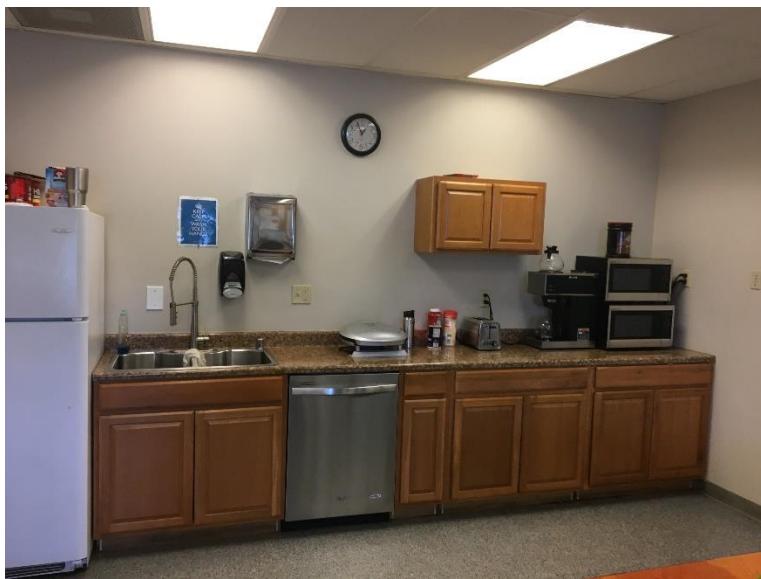
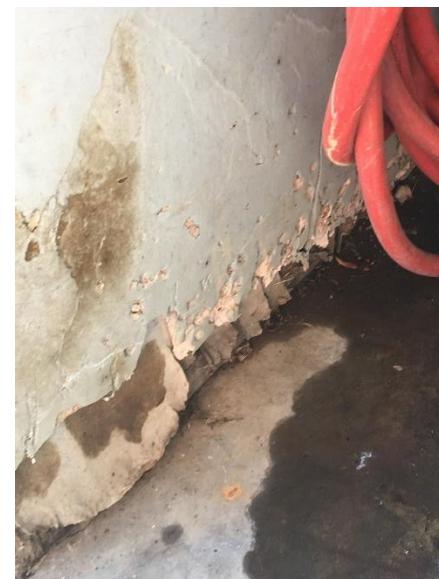
- Floor: Sealed concrete floor is in fair condition. Cracks around the perimeter of the slab are found.
- Observations at Street Shops and Tire Storage and Mezzanine:

Besides a potential hazard from the exposed electrical wire and the main hallway at the business area, the concrete floor with unpatched joints also presents a tripping hazard. The current setting of the offices does not provide any privacy for tenants when a meeting needs to be conducted.
