2022 FACILITIES MASTER PLAN

City of Washougal

FACILITY CONDITION ASSESSMENT

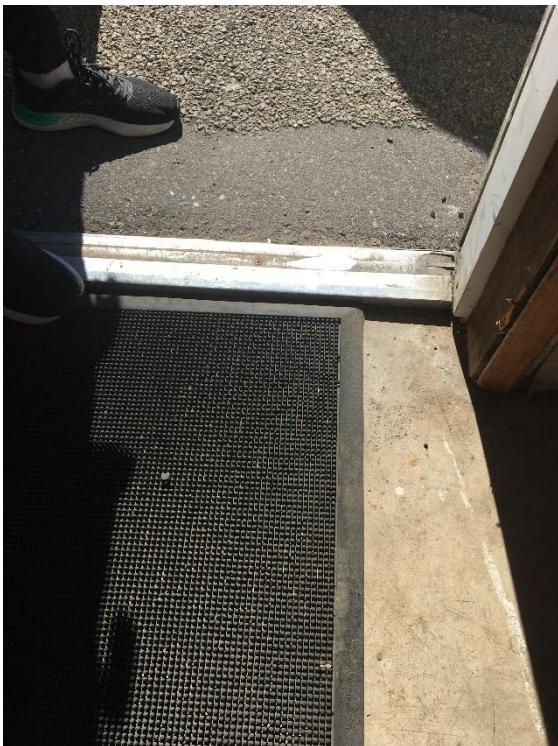
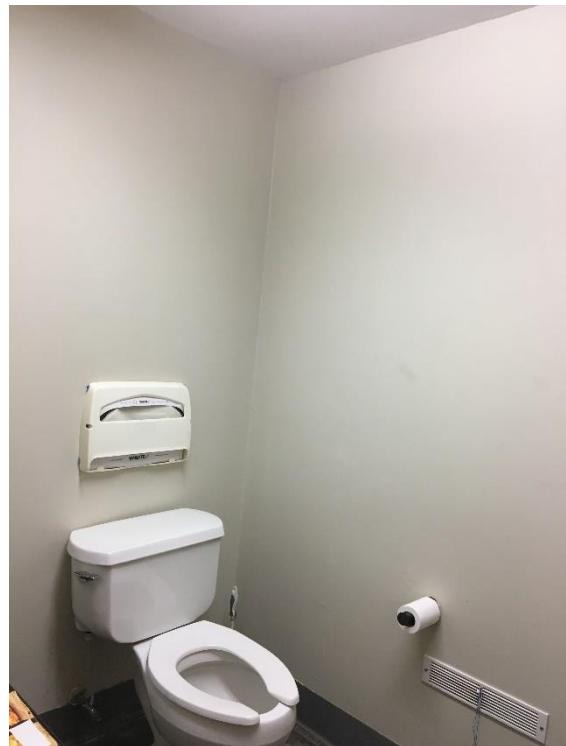
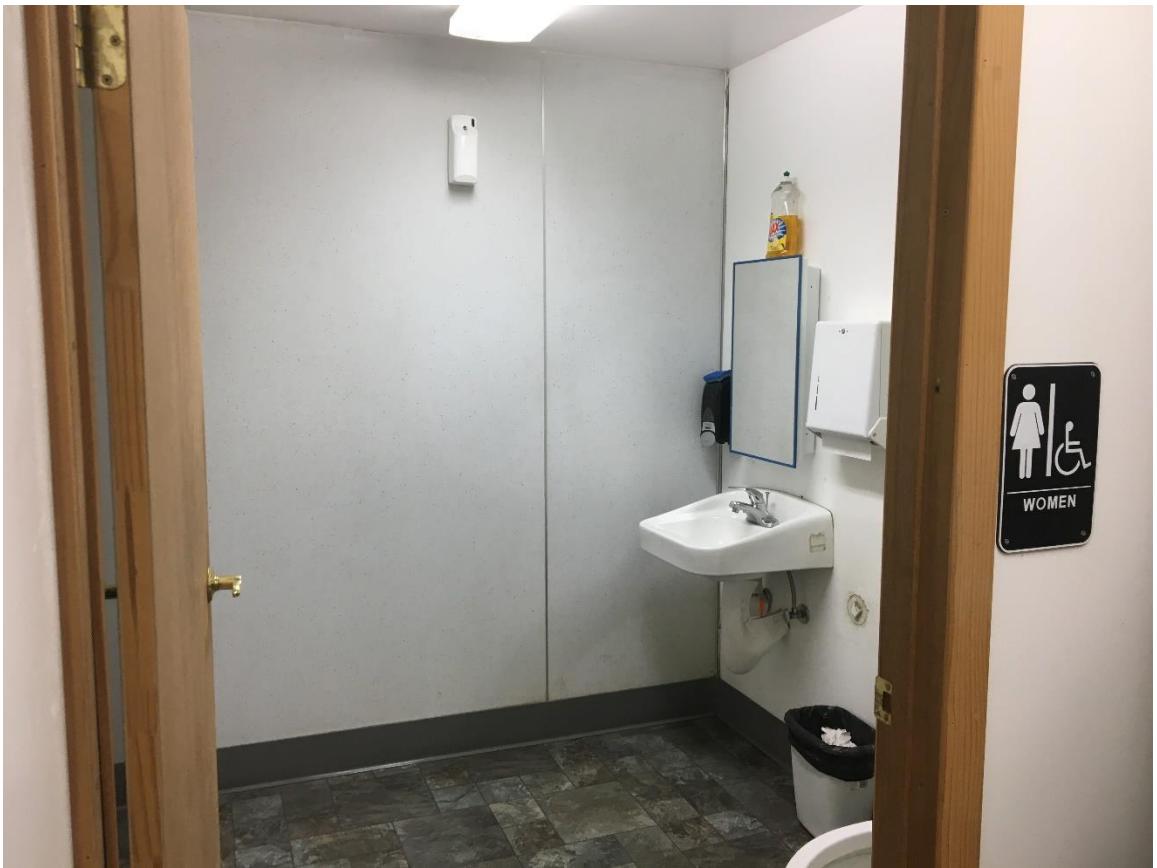
Figure 1.4. Building A Code Photos

- Fire extinguishers are located at various spaces
 - Exit Signs and Exit plans that indicate fire extinguishers' locations are provided
- Lighting level at office space and shops space meet minimal requirement of safety

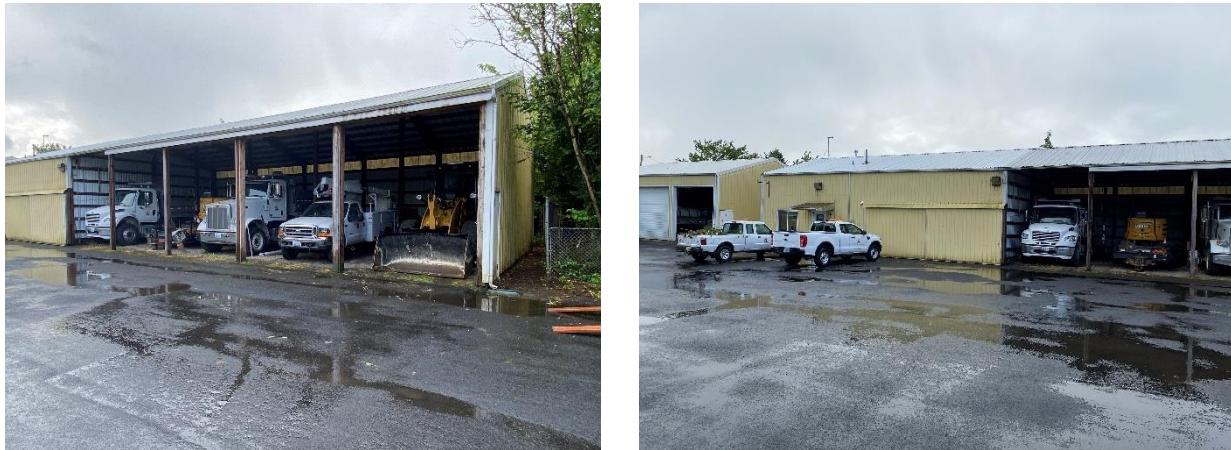
Figure 1.5. Building B General Photos

- Location: Building B is located at the south edge of the fully fenced campus. The building south façade is less than five feet to the fenced of Public Works campus, and its east is attached to Building C.
- Program:
 - It houses Fleet Vehicles
 - Fleet Storage
- Orientation: The building longitudinal direction is east and west
- Access: Open structure with vehicle access from the north of the building
- Levels: Building B is a single-story building
- Size: Approximately 30 by 50 feet. The longitudinal axis of the building is north-south direction.

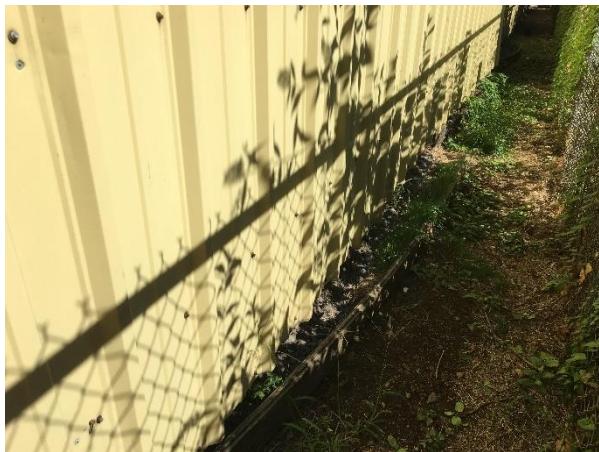
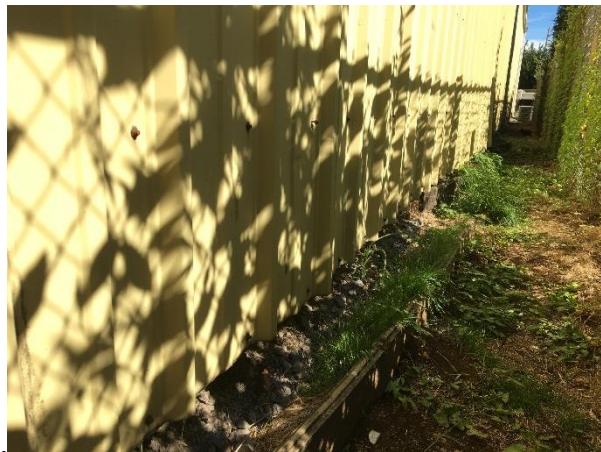
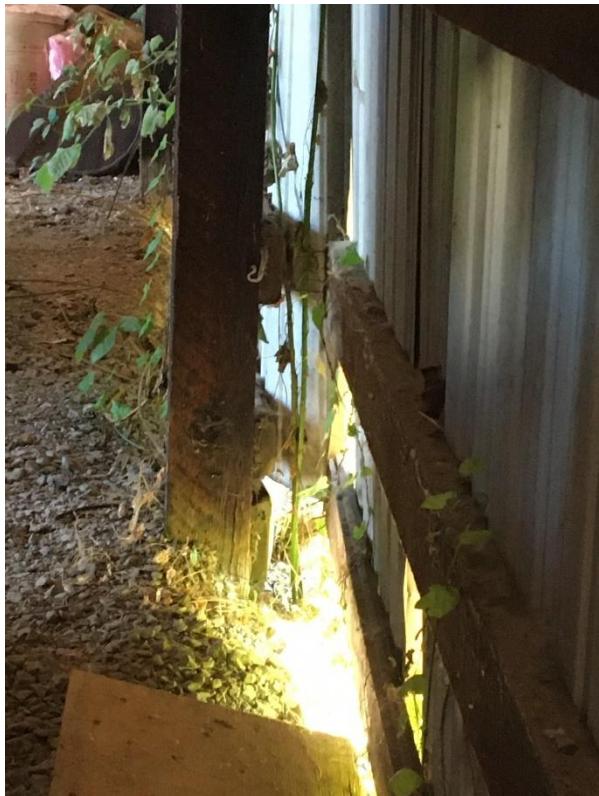
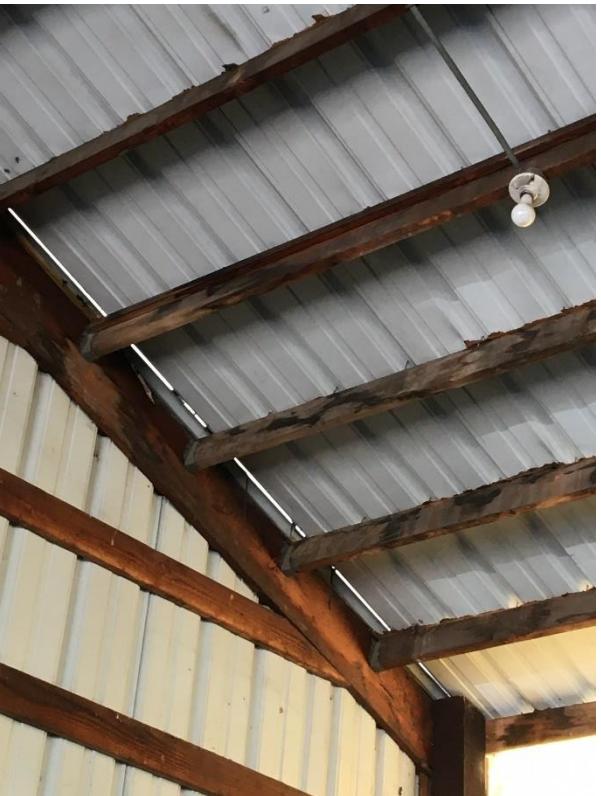
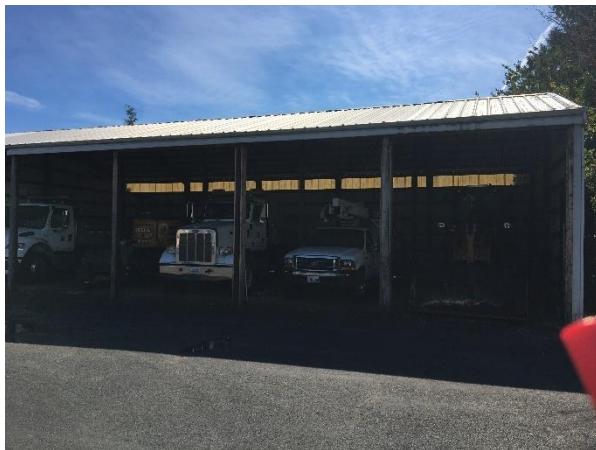
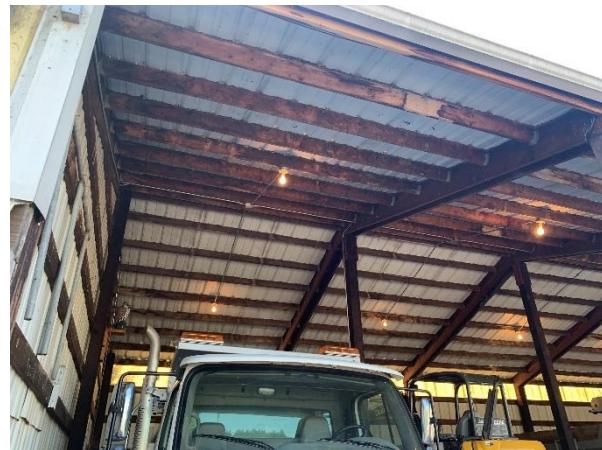
Figure 1.6. Building B Exterior Photos

- Metal roof and roof fascia system are in fair condition
 - No obvious wear and tear marks on the roof were found
 - Detached roof panels are noted near interface with Building C roof

- Leakage from the roof is expected
- Wall assembly is uninsulated box ribbed type metal wall panel. Observations on the exterior walls:
 - Wall exterior condition is below average

- Finish of the wall panels are generally intact
 - Multiple dents and locally deformed areas on metal panels are found
 - Back wall panels and horizontal wall girts are detached and left opening at the back of the building caused by impact from vehicle

- Aged, corrugated fiberglass wall panels are in fair condition
- Floor is paved by gravel
- Doors and Windows:
 - A single door is located at the south of the building. The condition is fair.

- Water may migrate from the back at the detached wall panels

HDR conducted a visual assessment of Building B. The overall condition of the building is below average. The roof and walls are in poor shape. Given it is an open structure to store fleets, the building walls and columns do not have any impact protections. Timber sill plates for exterior walls with direct ground contact are not recommended for industrial buildings.

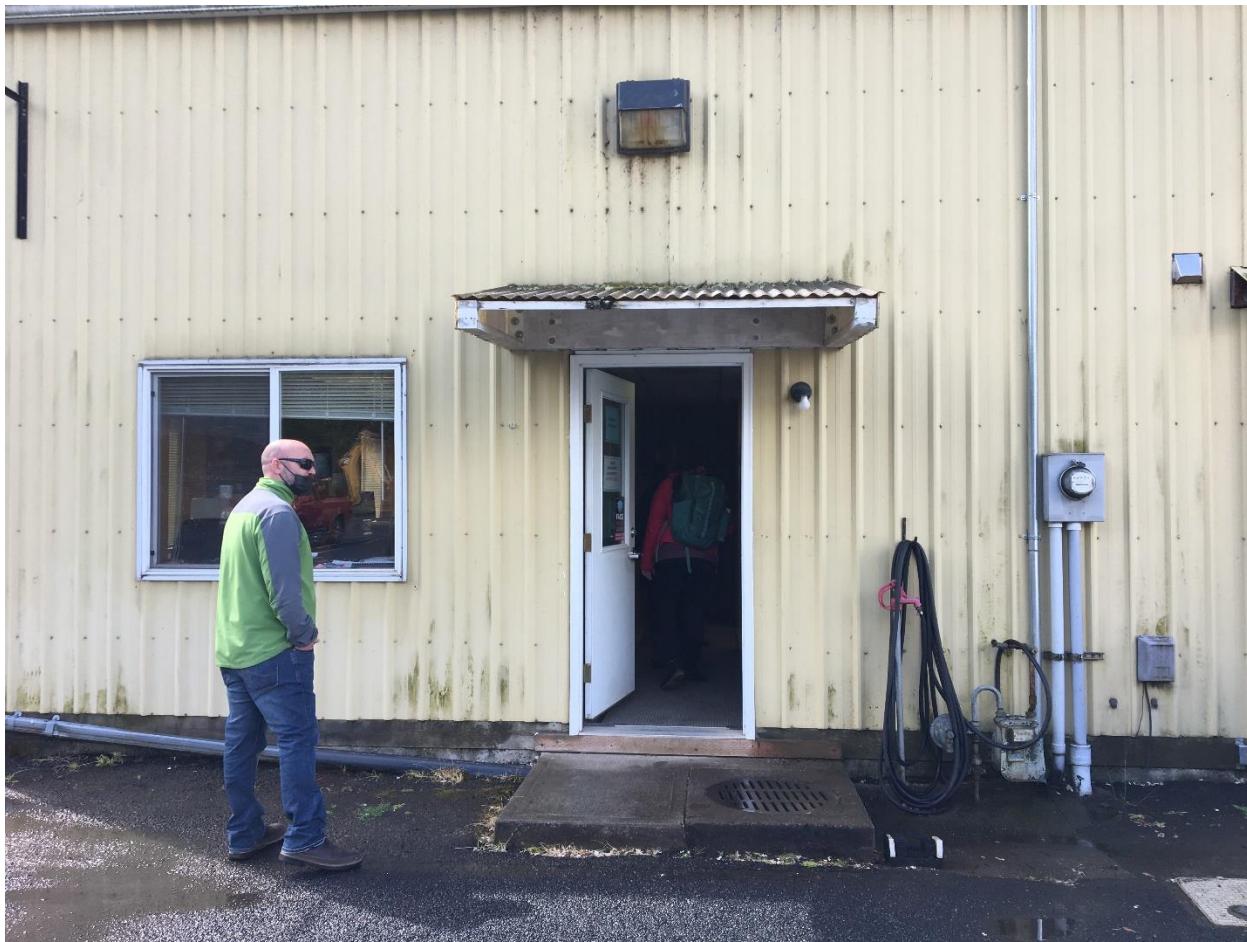
Figure 1.7. Building C General Photos

- Size: Approximately 45 by 50 feet. The longitudinal axis of the building is north-south direction.
- Style: Building C and Building B appear to be a single structure system and were subdivided into two buildings.

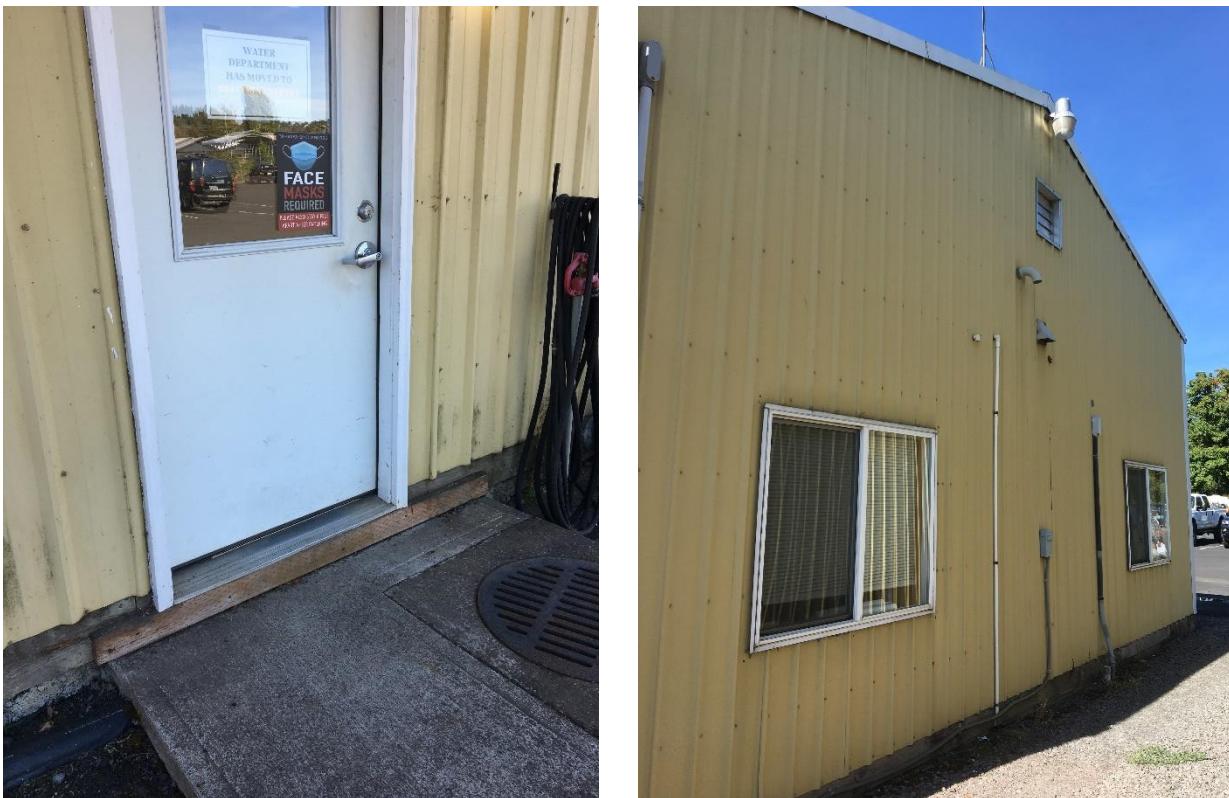
Figure 1.8. Building C Exterior Photos

The slab under the office space section is exposed at grade and does not have a turndown at the edges, which is required to ensure adequate frost depth (see [Figure 1.8. Building C Exterior Photos](#)). Frost depth at this location is 12 inches. It is likely that this slab was poured after the building was erected and does not work to provide structural support to the building. If frost damage to the slab were to occur, such as heaving, it could lead to damage to the floor finishes and partition walls.

- Wall exterior condition is aged and below average
 - Finish of the wall panels are generally intact
 - Dents and locally deformed areas on metal panels were found

- Downspouts are functioning
 - Downspouts are not tied to the storm drain system and most of them are without splash block
 - Oversize metal flashing and trim above vehicle access door to the shop is in fair condition. Metal flashings above windows function but are in poor condition.

- Doors and Windows
 - Double pane windows are provided at north and east walls and they are in fair condition
 - Water migration likely occurs at the windows due to poor flashing details. They function but are in bad condition.

- In-swing exterior egress door is not insulated
 - Manual uninsulated sliding rolling door at garage is deformed but functioning. It is in poor condition.

- Security
 - Intrusion detection system is not found
 - Security at the garage area is poor

The slab under the office space section is exposed at grade and does not have a turndown at the edges, which is required to ensure adequate frost depth (see Figure 1.8. Building C Exterior Photos). Frost depth at this location is 12 inches. It is likely that this slab was poured after the building was erected and does not work to provide structural support to the building. If frost damage to the slab were to occur, such as heaving, it could lead to damage to the floor finishes and partition walls.

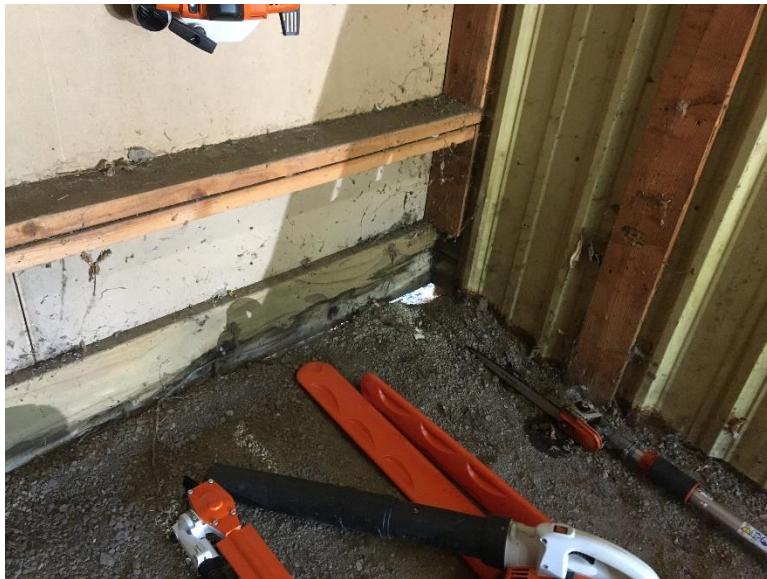
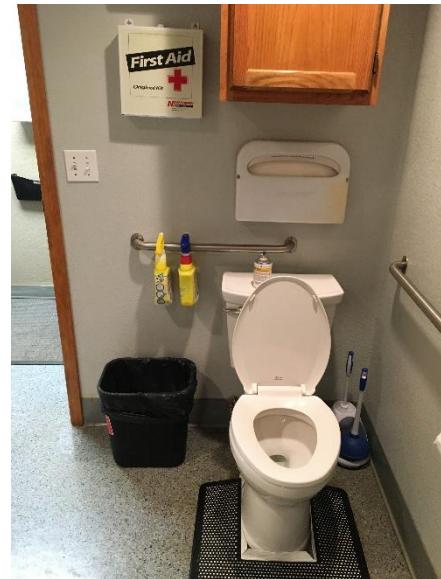
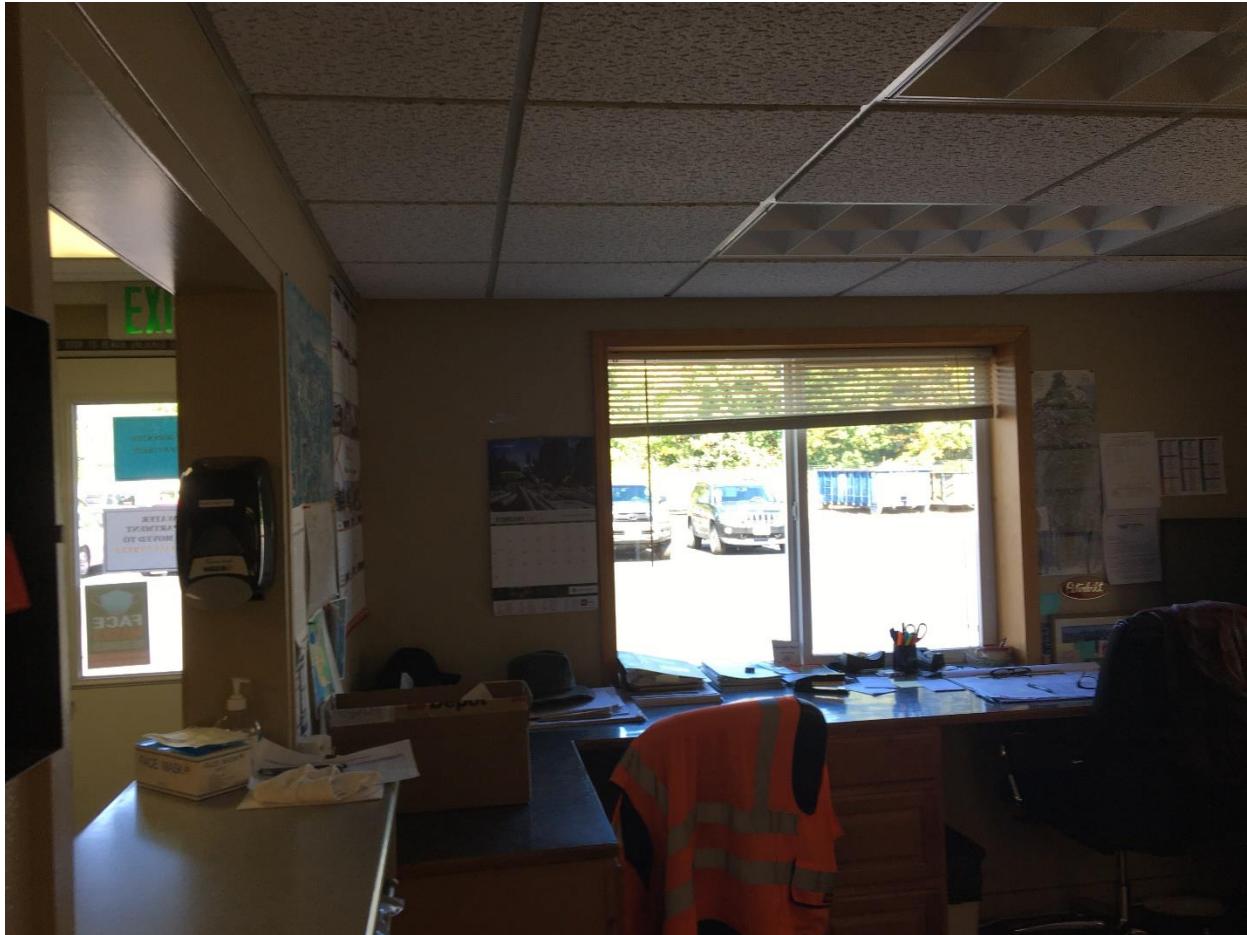
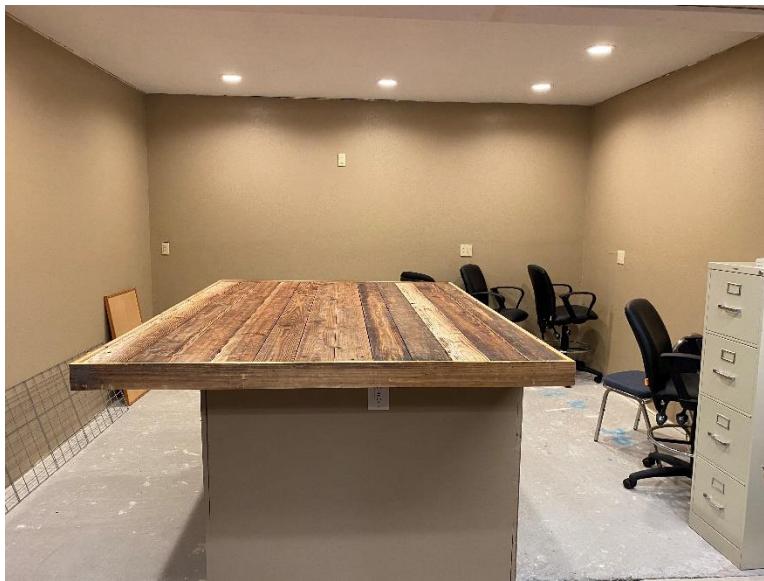
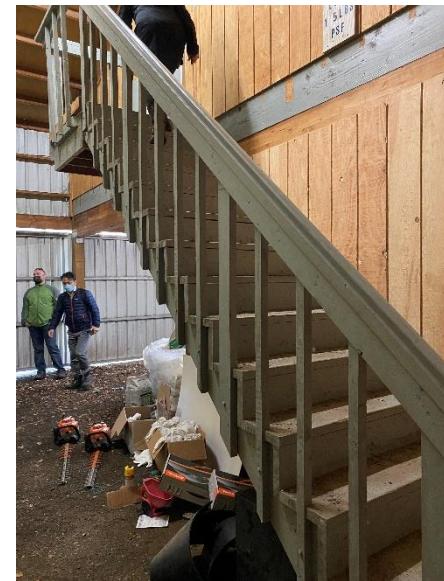
Figure 1.9. Building C Interior Photos

- Multiple water stains are found at the ceiling likely caused by condensation.
 - Partition finishes are painted gypsum walls. They are in fair condition. Insulation value at perimeter partitions cannot be confirmed. Partition insulation at business area stop at the ceiling height based on observation at attic above.

- Floor: Walk-off mat is provided at entry hallway. Vinyl floor is in fair condition at hallway and restroom. Carpet flooring is used at offices and they are aged and in fair condition.

- Observations at the Garage Area:
 - Ceiling is exposed structure with roof underlayment with liner. Approximately 13 to 14 feet at high point.
 - Vertical wood plank siding at business area partition is generally in good condition. The rest of the garage area is enclosed by uninsulated wall panel.
 - Floor is paved by gravel
- Observations at Attic Storage Space:
 - Ceiling is exposed structure with roof underlayment with liner. Low clearance at approximately 6 foot height with uninsulated perimeter walls.
 - Floor is constructed with painted plywood and is in fair condition.
 - Attic space has a maximum allowable load of 15 pounds per square foot.
 - Security is a concern for the space because of the poor condition of the sliding door to the garage.
- Access control is through door locks

- Due to missing vapor retarder, multiple moisture stain marks caused by condensation is present at acoustic ceiling tile. Mildew may occur in the business area at the ceilings and inside the exterior walls.

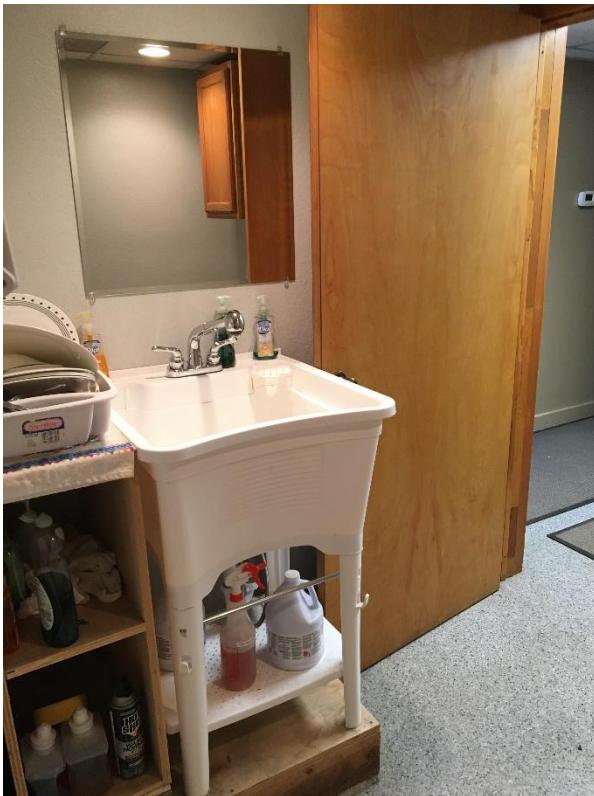
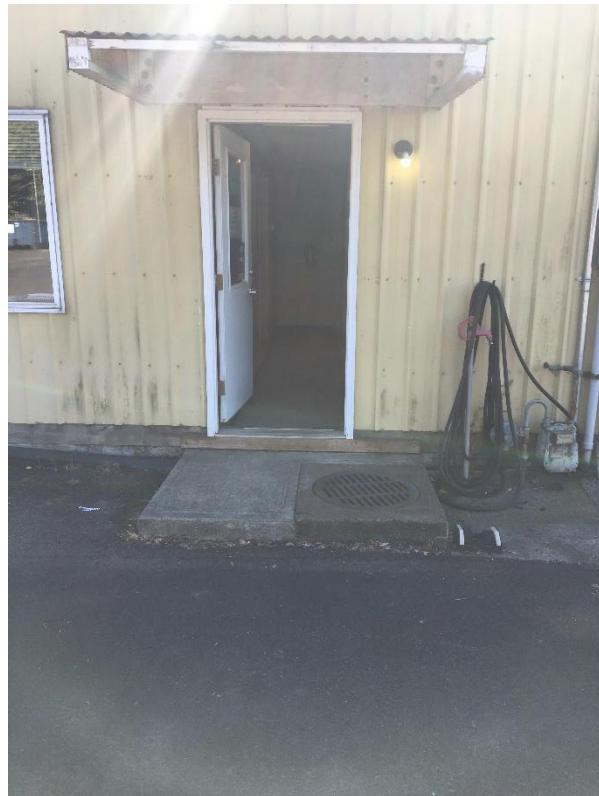
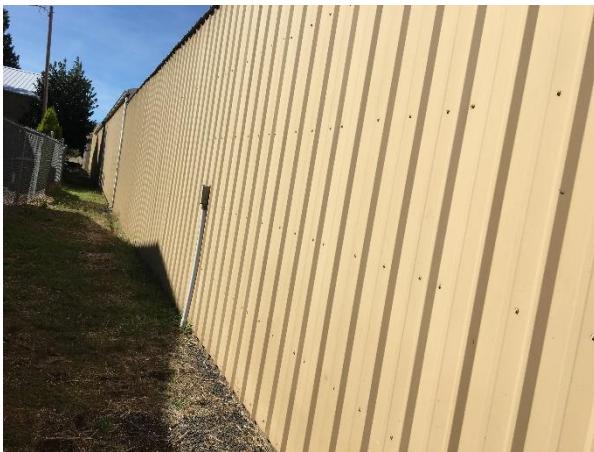
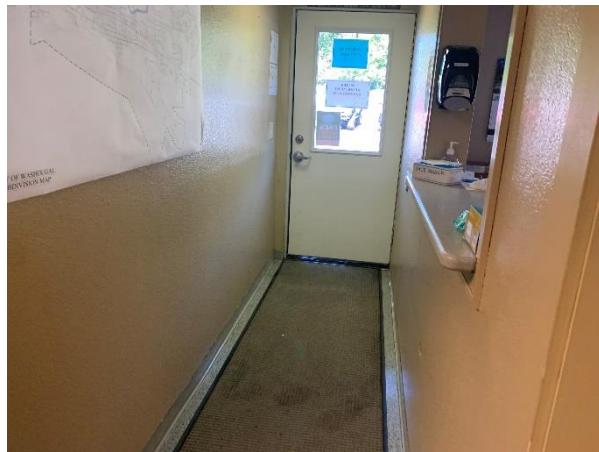
Figure 1.10. Building C Code Photos

- Fire extinguishers are located at various spaces
 - Exit Signs and Exit plans that indicate fire extinguishers' locations are provided

- ADA compliance is challenging at the current setting. The exterior door needs to be replaced to provide sufficient ADA clearance. The hallway is compliant to ADA minimal required 36 inches. It is narrow for practical functioning. Other building components that need to be upgraded to meet ADA requirement include, but are not limited to door thresholds, door hardware, and the finish grading, walking surface at main entry, casework upgrade, restroom upgrade, and signs, etc.

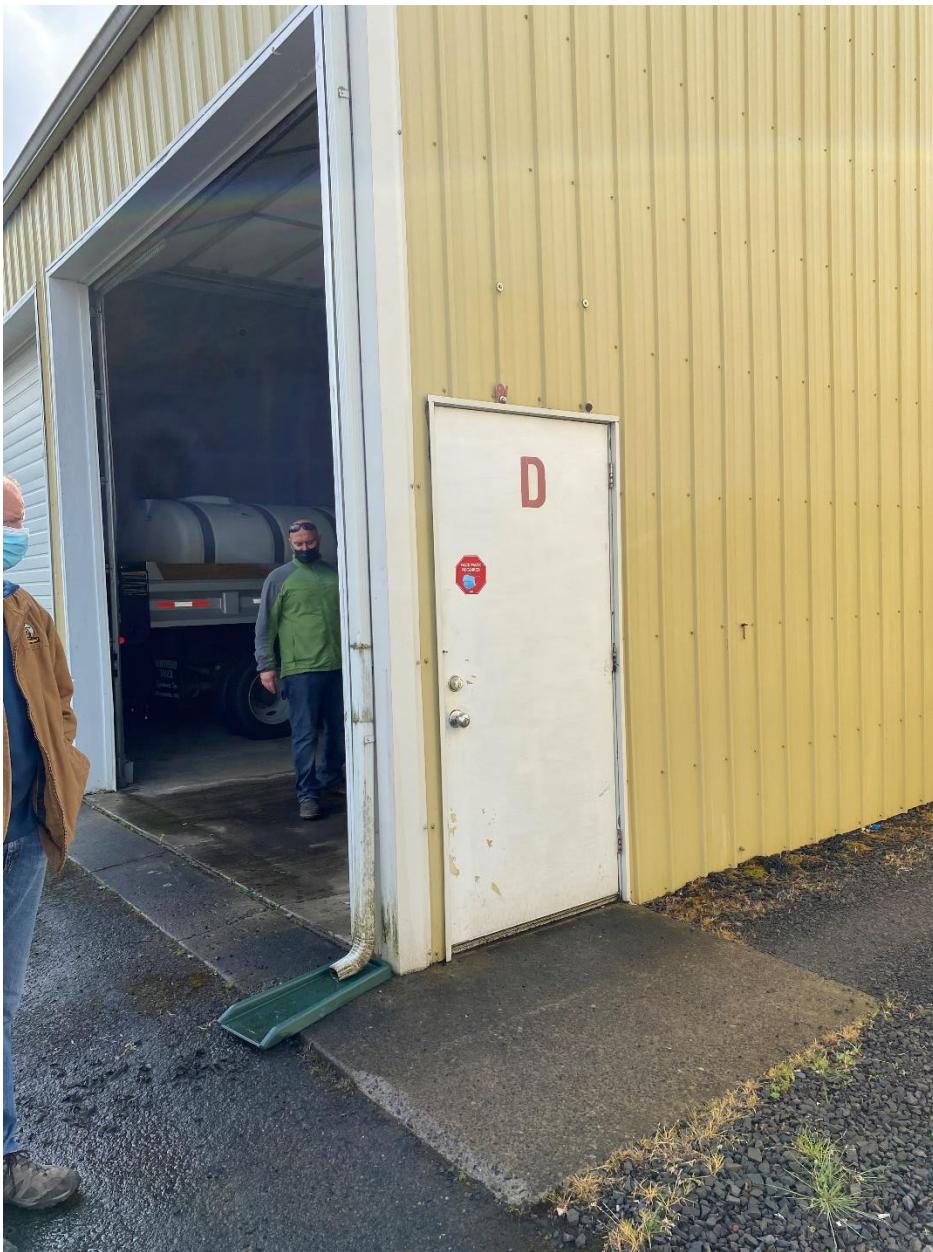
Figure 1.11. Building D General Photos

- Location: Building D is located at the center of the fully fenced T-shaped campus. The building's east façade shares a wall with Building E. Its west is a 12-foot wide alley that separates Buildings C and D.
- Program: It houses Storage, Snowplow equipment and vehicles
- Orientation: The building longitudinal direction is east and west
- Access:
 - An egress door to the alley is located at the west side of the building.
 - Vehicle access is located at the north façade of the building with three overhead rolling doors and a bi-parting barn door.
- Levels: Building D is a single-story building.
- Size: Approximately 25 by 40 feet. The longitudinal axis of the building is north-south direction.

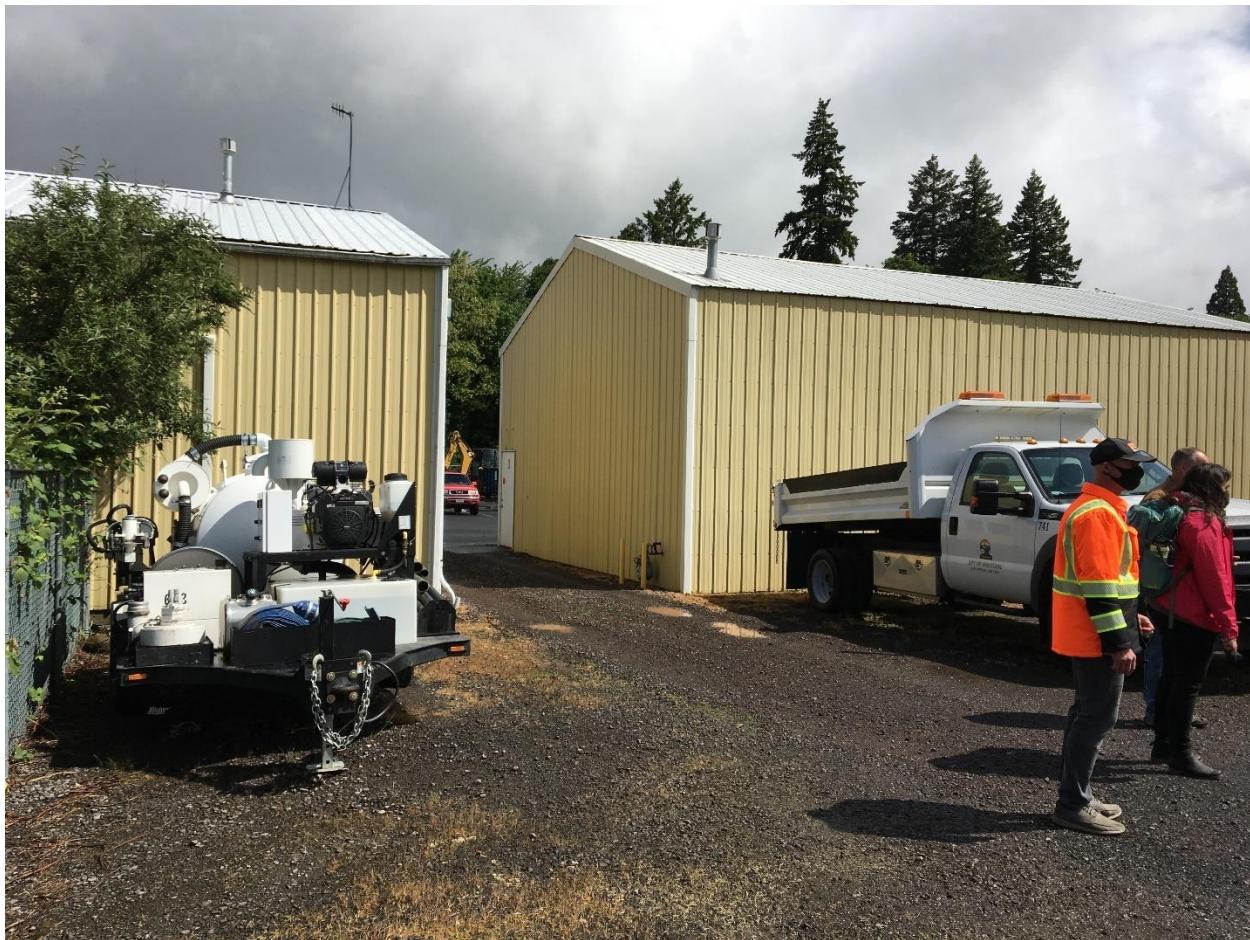
Figure 1.12. Building D Exterior Photos

- Wall exterior condition is aged and in fair condition
- Finish of the wall panels are generally intact
- Dents and locally deformed areas on metal panels are found
- Treated wood wall curbs are exposed without flashing transition or protection.
- Observations on weather protection details:
 - Rain gutter is overrun in horizontal distance
 - Wood fascia and wood blockings that support gutter systems are exposed and unprotected
 - Downspouts near Building E are not correctly detailed and installed
 - Oversized metal flashing and trim above vehicle access door to the storage is deformed
- Doors:
 - Manual overhead rolling door in fair condition. They appear to be non-insulated type.
 - Metal swing door for egress is in fair condition.

Timber sill plates for exterior walls with direct ground contact are not recommended for industrial buildings.

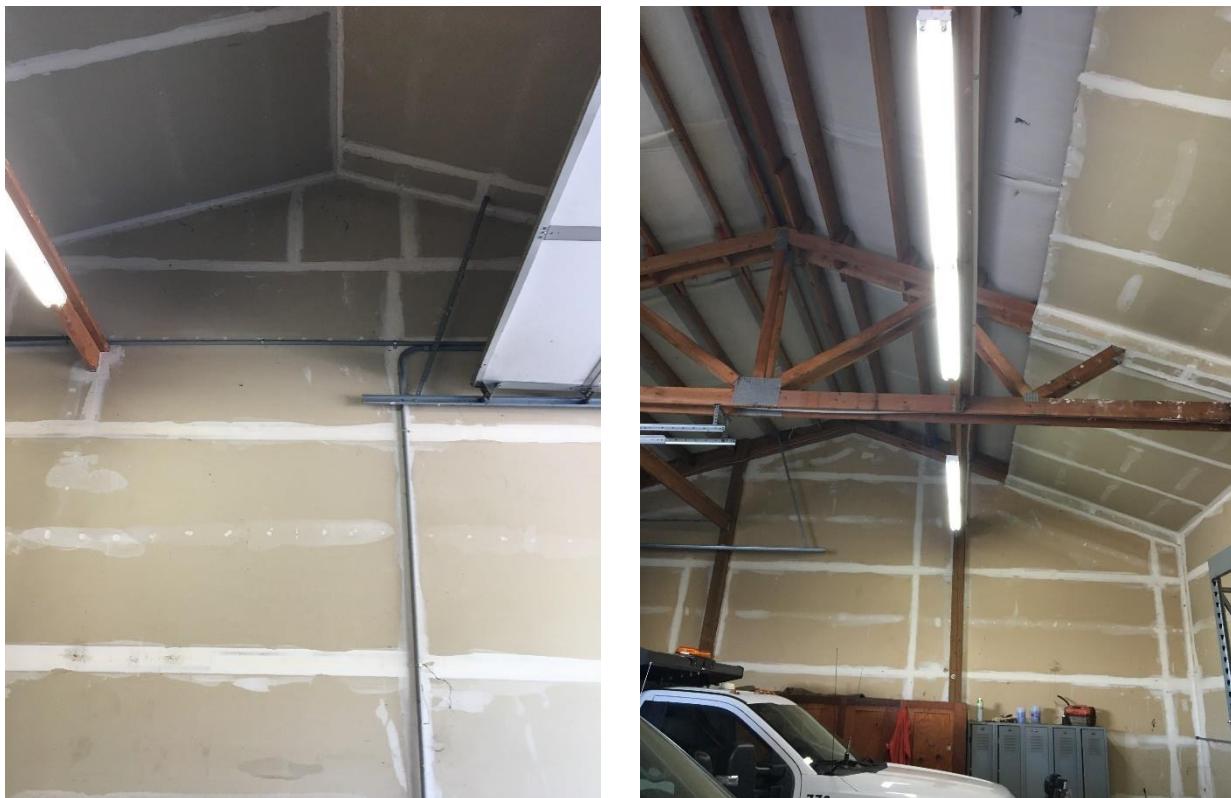
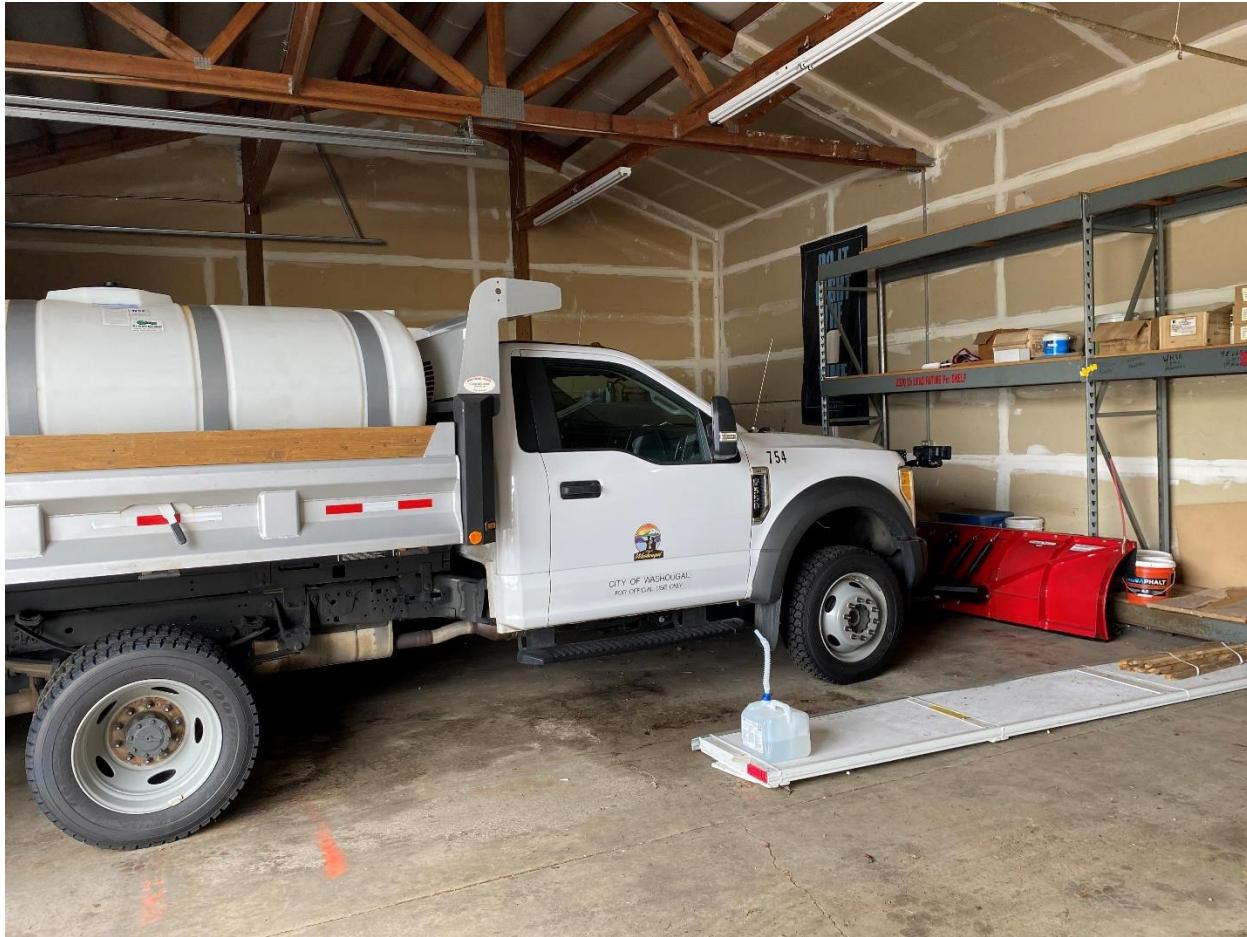
Figure 1.13. Building D Interior Photos

- Building E houses the Snow Plow Equipment and vehicles. An overhead heating unit is provided.
- Observations at Snow Plow Area:
 - Ceilings is half exposed structure and half gypsum vaulted ceiling. Roof underlayment with liner are exposed, but insulation is not noted. Approximately 13 to 14 feet at high point.
 - Walls are covered by gypsum wall boards
 - Floor is composed of concrete slab
 - Unprimed wall boards and gypsum ceilings are taped and mudded
 - Concrete floor slab is in fair condition
- Access control is through door locks

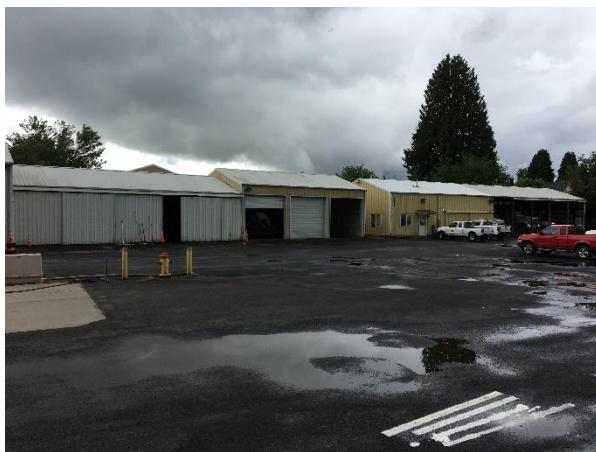
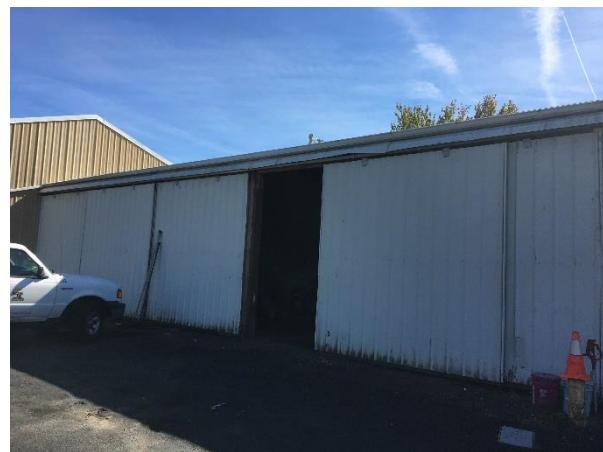
Figure 1.14. Building E General Photos

- Location:
 - Building E is located at the center of the fully fenced T-shape campus. The building shares walls with Building D and F at its east and west location.
- Program: Storage
- Orientation: The building longitudinal direction is east and west
- Access:
 - A man door connects to Building D at the east wall of the building for exiting
 - Vehicle access is located at the north façade of the building with bi-parting barn doors.
- Levels: Building E is a single-story building
- Size: Approximately 25 by 40 feet. The longitudinal axis of the building is north south direction.

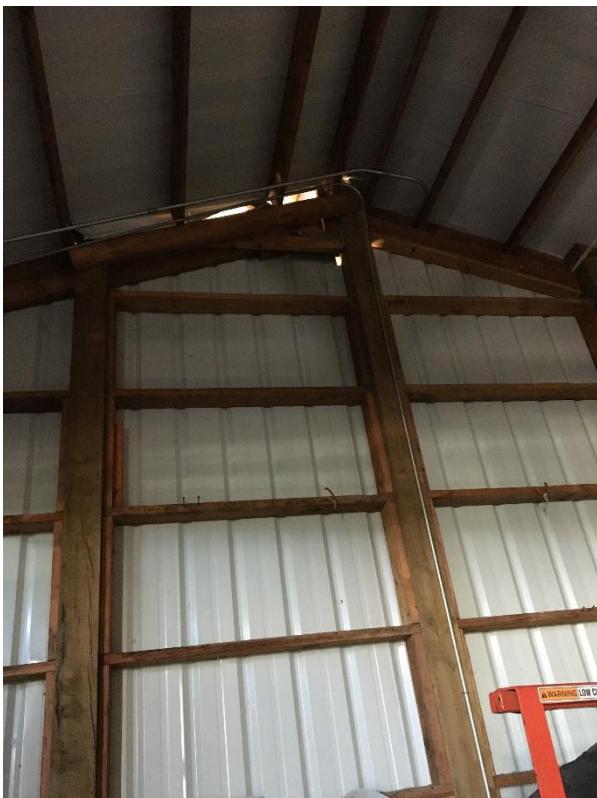
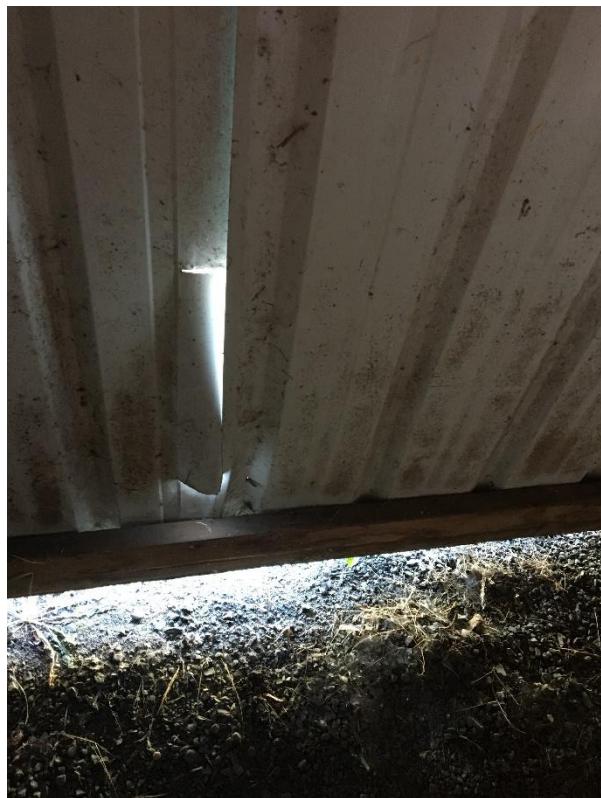
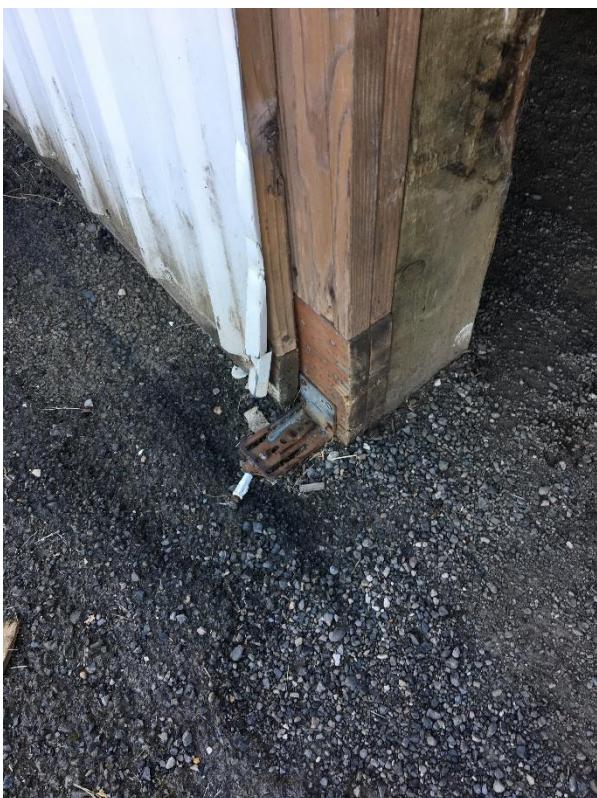
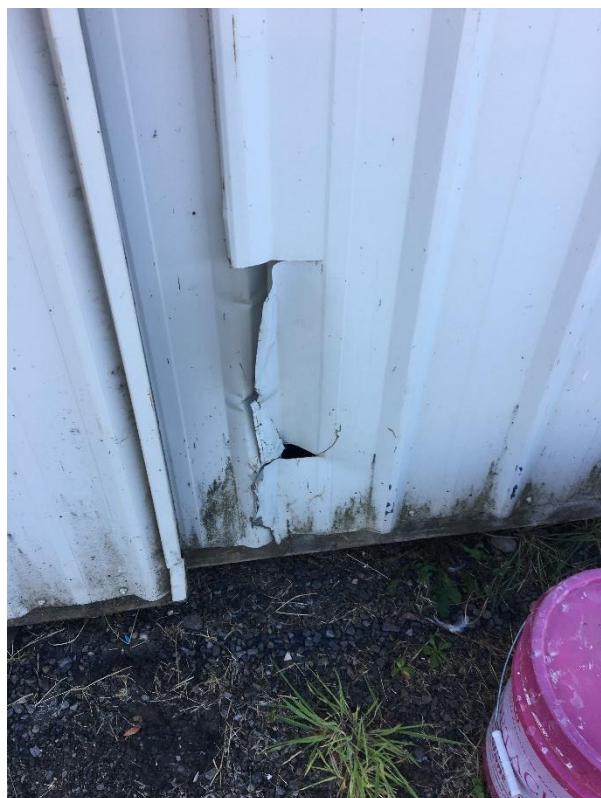
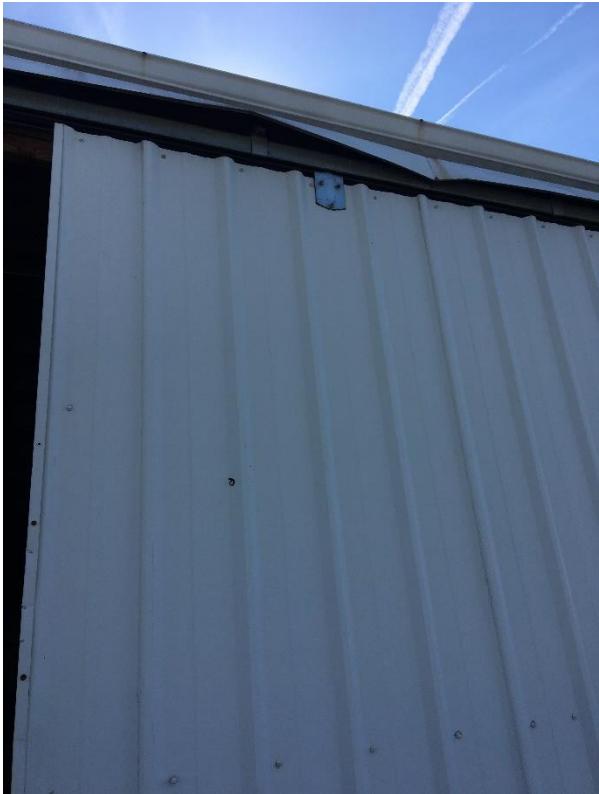
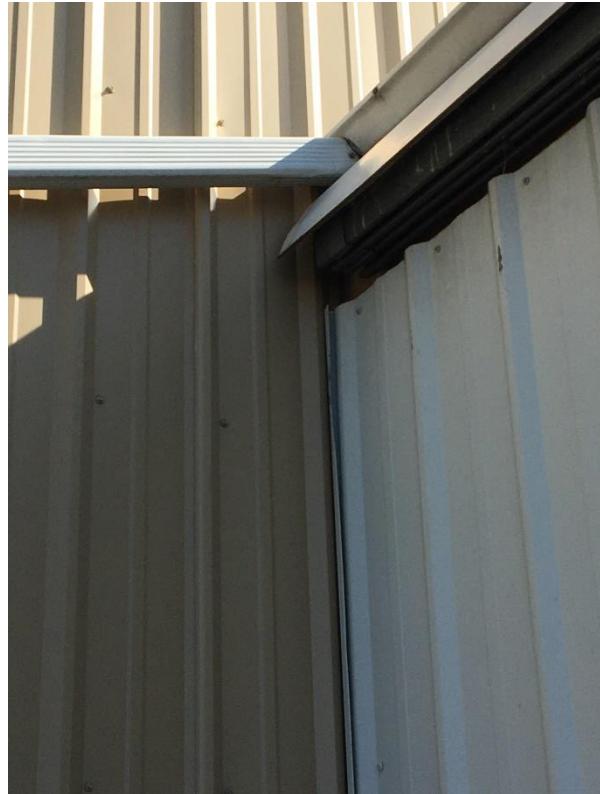
Figure 1.15. Building E Exterior Photos

- No obvious wear and tear marks on the roof panels were found
- Unsealed opening on the roof panels was found at the area near Building F
- Leakage likely occurs from the roof

- Wall exterior condition is aged and in fair condition
 - Finish of the wall panels are generally intact
 - Dents and locally deformed areas on metal panels wer found

- Oversized metal flashing and trim above vehicle access sliding doors to the storage is deformed
- Doors: Manual uninsulated sliding doors at Storage are deformed but functioning. They are in poor condition.

- Security: With poor condition of the vehicle sliding doors, security of the building is concerning.

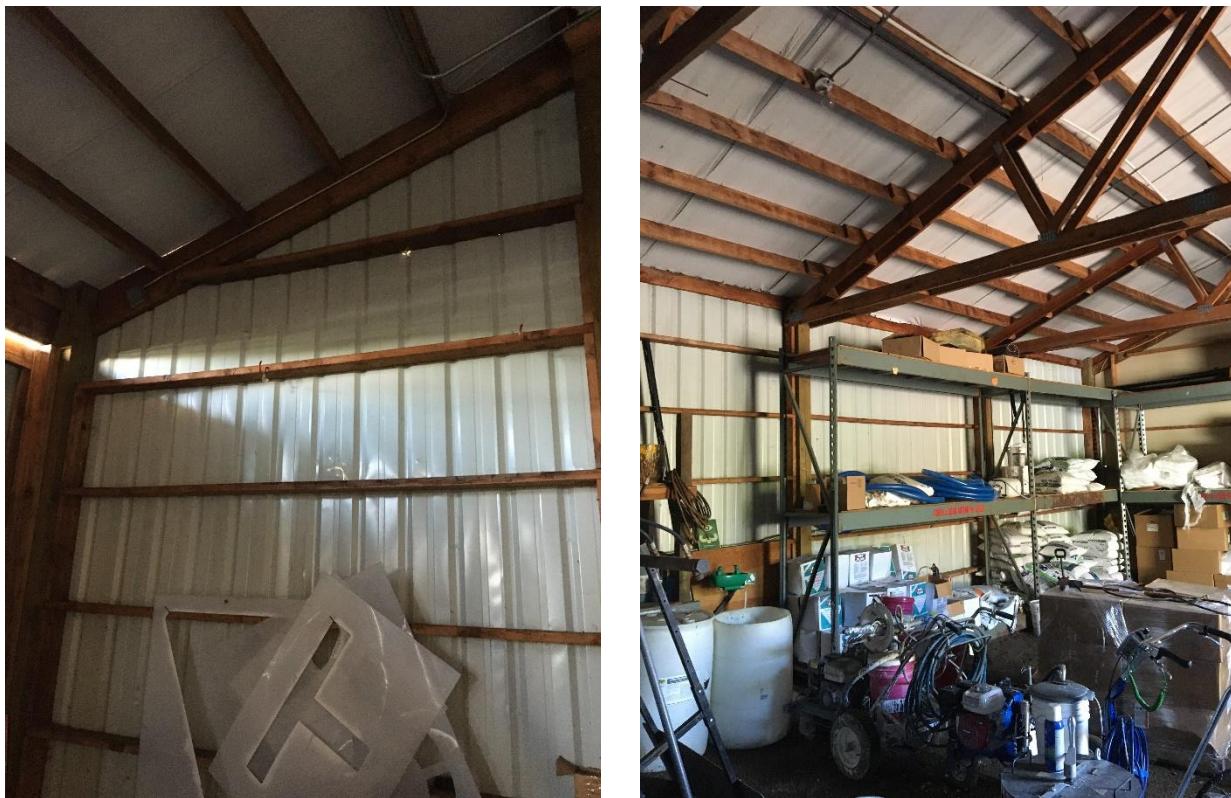
Figure 1.16. Building E Interior Photos

- Observations at Record Storage Space:
 - Ceiling is exposed structure. Roof underlayment with liner is exposed. Approximately 13 to 14 feet at high point.
 - Walls are uninsulated and exposed metal panels and wall girts
 - Floor is composed of gravel and soil

HDR conducted a visual assessment of Building E. The overall condition of the building is average. The roof and the walls are aged. Reasonable wear and tear is noted. Timber sill plates for exterior walls with direct ground contact are not recommended for industrial buildings.

Detached roof panels caused by poor workmanship or detail is noted near interface with Building E roof. Leakage from the roof is expected.

Deformed wall panels and sliding doors shall be repaired.
