2022 FACILITIES MASTER PLAN

City of Washougal

FACILITY CONDITION ASSESSMENT

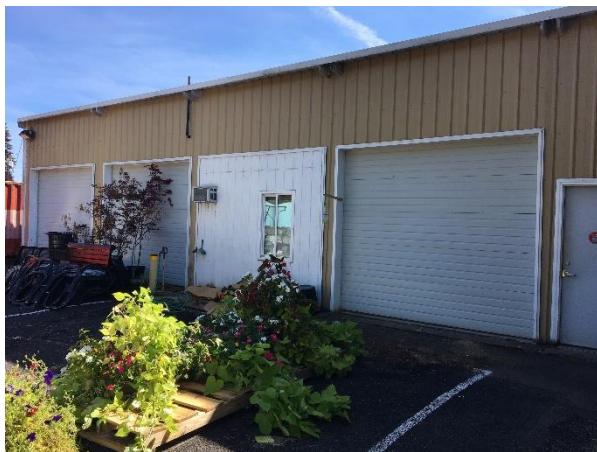
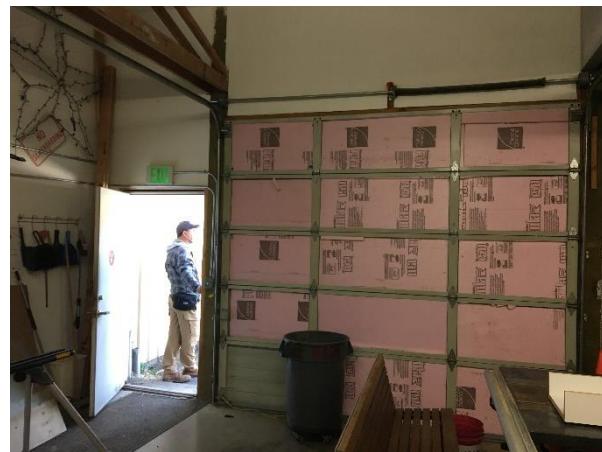
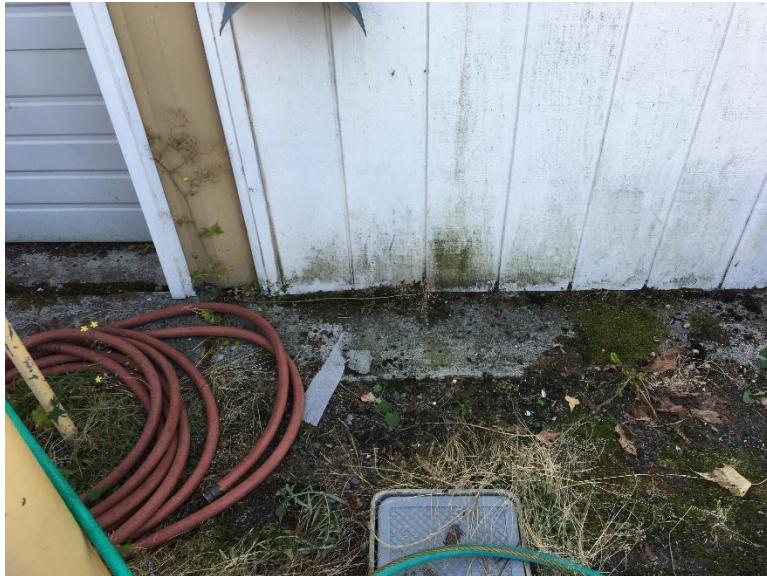
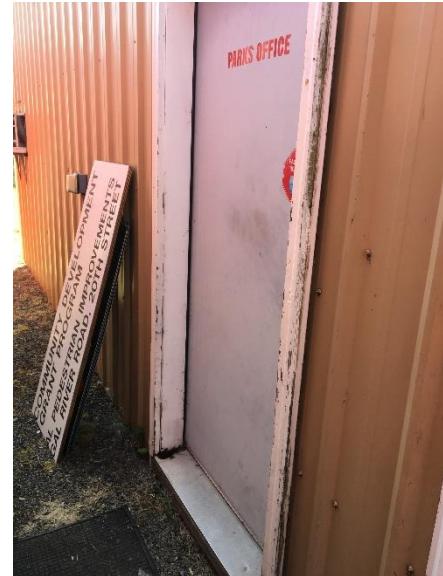
Figure 1.18. Building F Exterior Photos

- Wall exterior condition is aged but in fair condition
 - Finish of the wall panels are generally intact
 - Dents and locally deformed areas on metal panels were found

- Doors:
 - Manual overhead sectional doors are in good condition. They appear to be non-insulated type at the shop.
 - Manual overhead sectional doors are block off at the shop area. Rigid insulations are applied at the sectional doors, but it is partially completed.

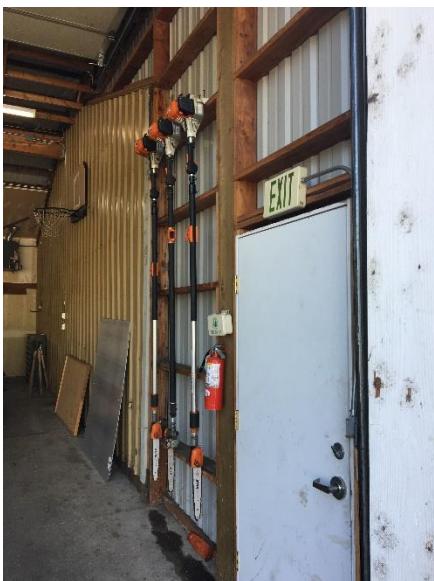
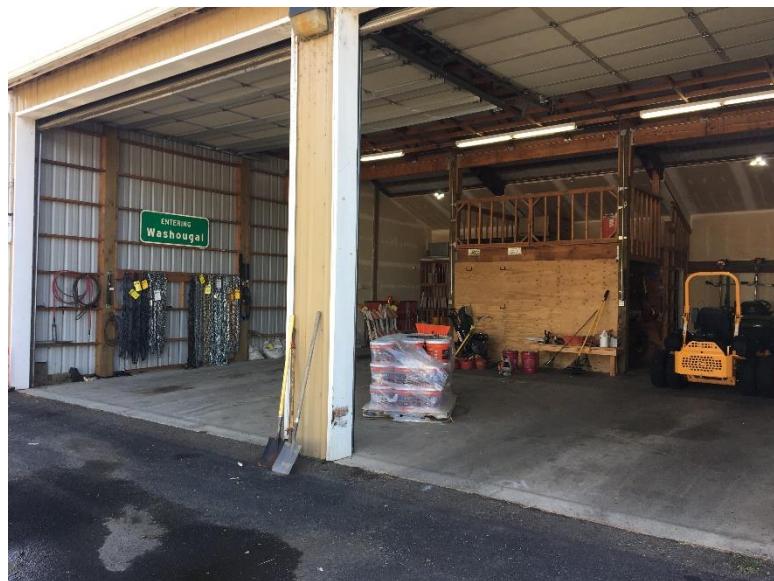
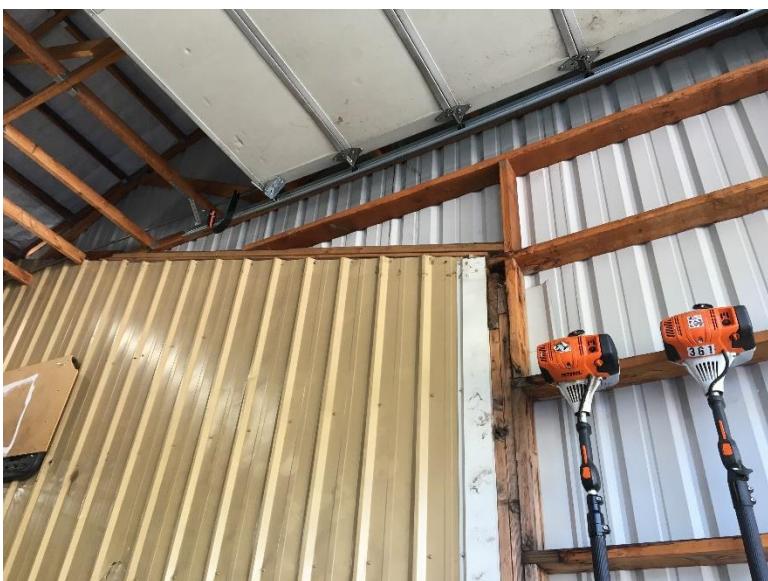
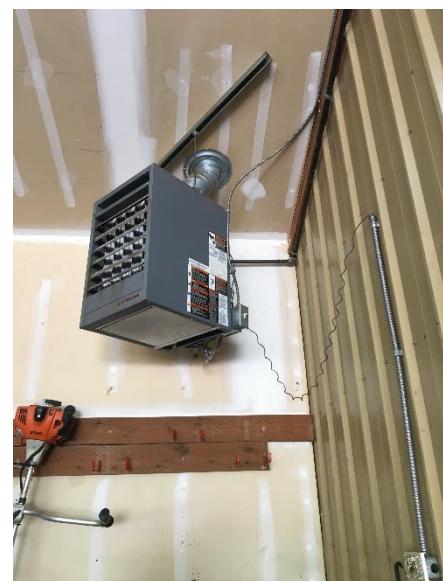
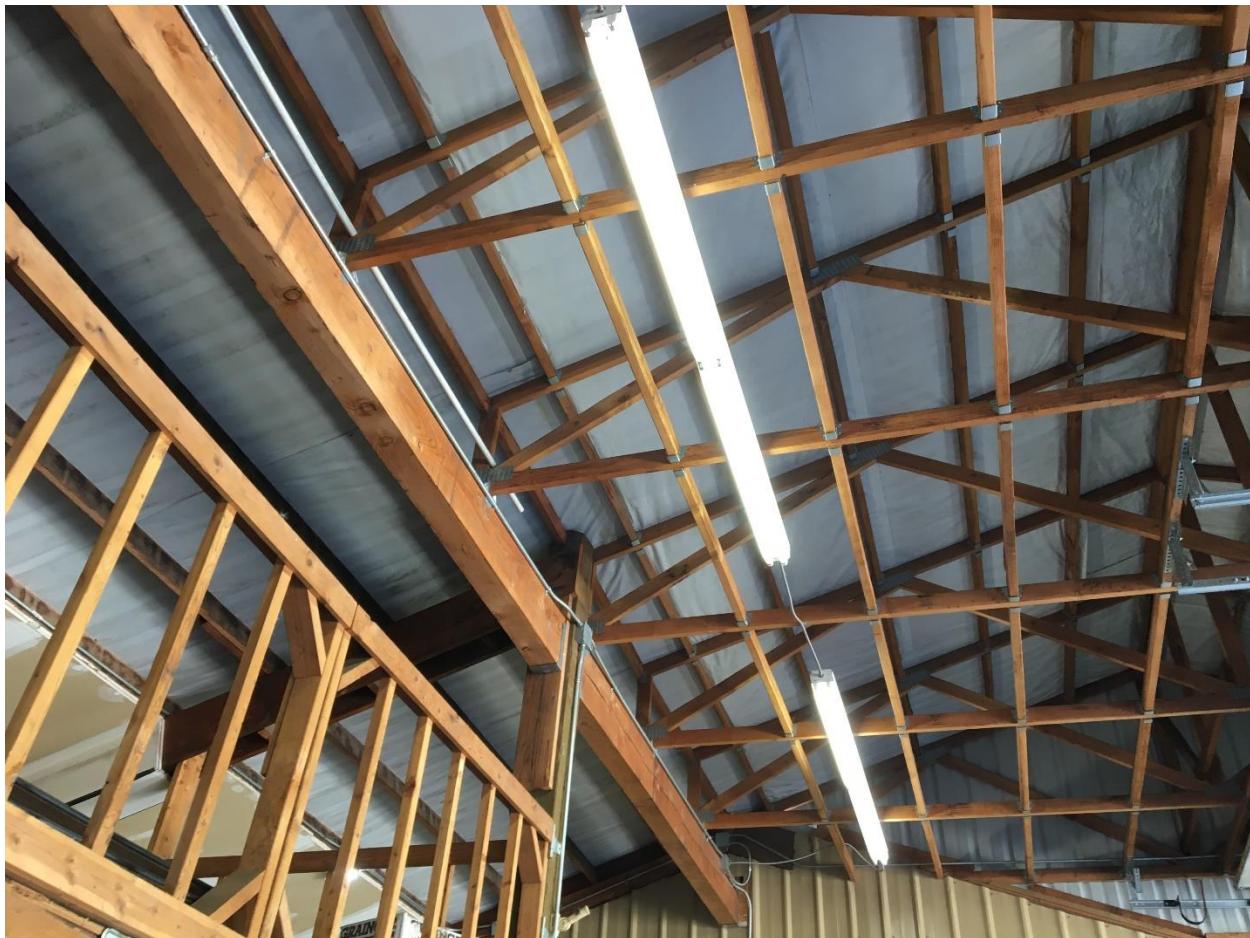
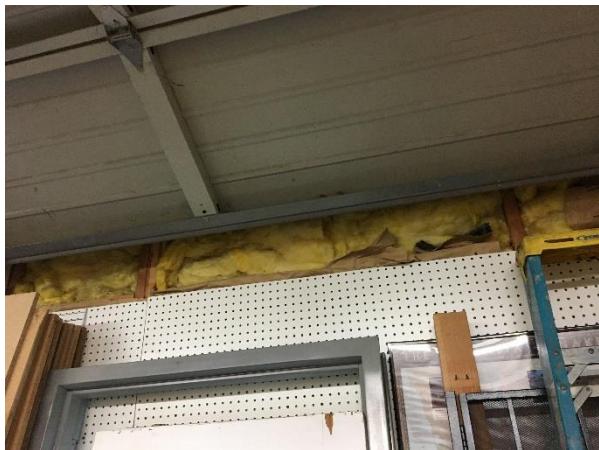
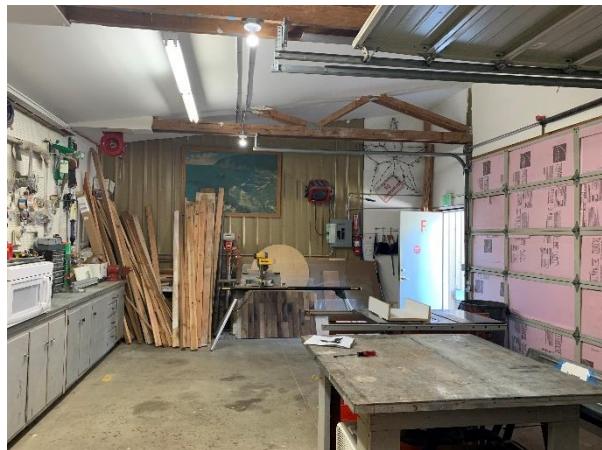
Figure 1.19. Building F Interior Photos

- Building F are divided into two zones, the Storage/Garage and the Shop. Overhead heating units are provided at both spaces.
- Observations at Storage/Garage:
 - Ceiling is half exposed structure and half gypsum vaulted ceiling. Roof underlayment with liner is exposed, but insulation is not noted. Approximately 16 to 18 feet at high point.
 - Walls are covered by unprimed gypsum wall boards
 - Floor is composed of concrete slab in good condition
- Observations at the Shop:
 - Ceiling is covered by finished gypsum boards at approximately 12 feet high
 - Walls are insulated and covered by gypsum wall board. Batt insulation in the wall is partially exposed above the overhead sectional doors.
 - Floor is composed of concrete slab
 - Two metal doors are provided for egress
- Access control is through door locks

HDR conducted a visual assessment of Building F. The roof and the walls are aged. Reasonable wear and tear are noted. The interior of the building is in fair condition. The overall condition of Building F is average.

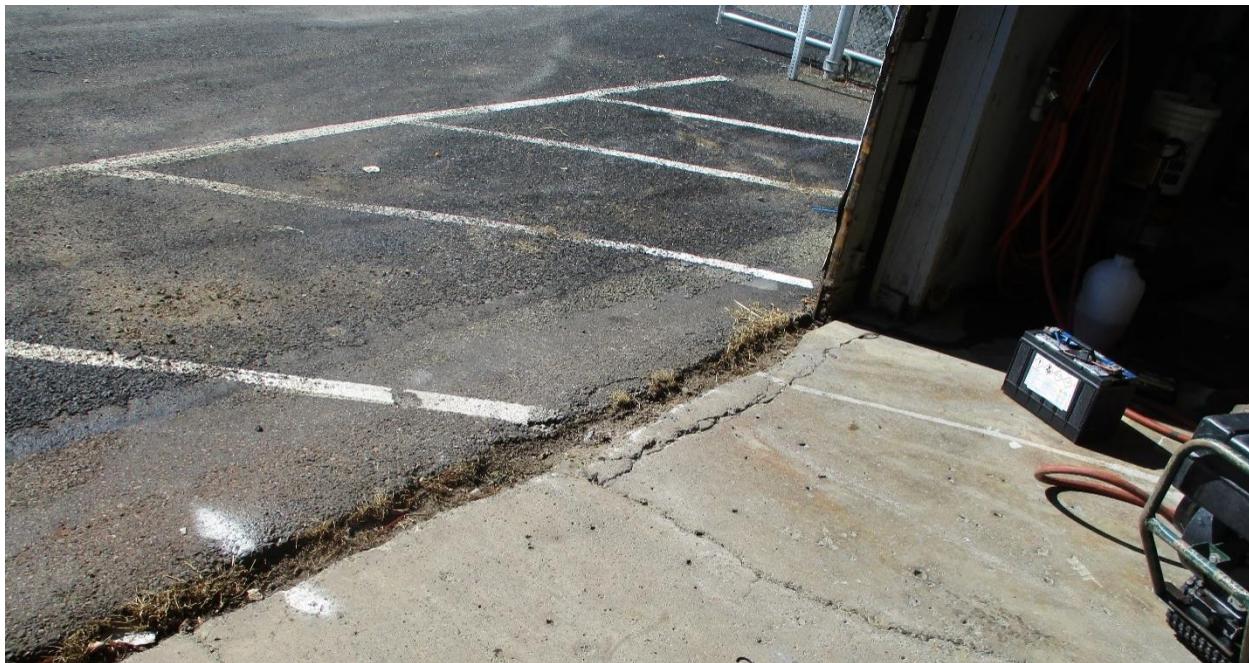
Figure 2.2. Example of Transition Between Asphalt and Concrete

Building A is an 8,500 square foot structure, constructed with wood post frame (pole barn) type construction. The roof is supported by wood trusses, as shown in Figure 2.1. The majority (approximately 2/3) of the building has had partition walls installed to create office and shop space. These areas have had concrete floors installed. In general, these concrete floors are in fair condition, however some cracking and damage is noted in the floor at the roll up door on the south side of the building. This is likely due to the rough transition between the asphalt and the concrete, as shown in Figure 2.2 and Figure 2.3.

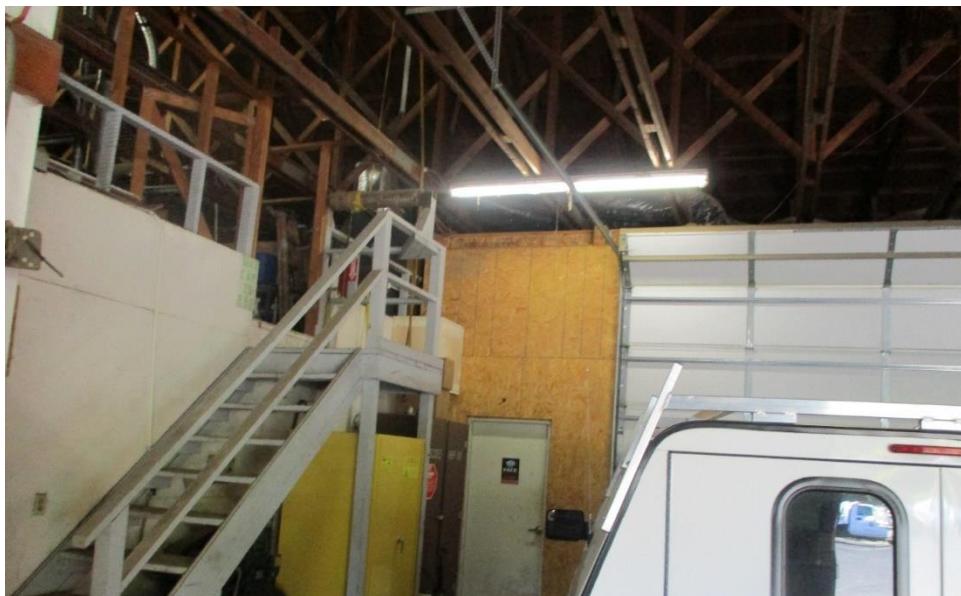
Figure 2.5. Area Used for Storage

The area above the main office space is accessible by a staircase in the gravel floor storage area. It appears this area is used for storage and mechanical equipment (see Figure 2.5 and Figure 2.6). A sign is posted at the top of the stairs indicating a 20 psf load limit (see Figure 2.7). This meets the current code requirement for uninhabitable attic spaces with storage. Code defines this as uninhabitable due to the low head clearance. The floor exhibits some softness when walking around. No signs of distress are obvious. The deflection felt in the floor is likely due to the ceiling structure of the attic space not being adequately designed to limit deflection. Care should be taken to limit what is placed in this storage area so as not to exceed the load limitation.

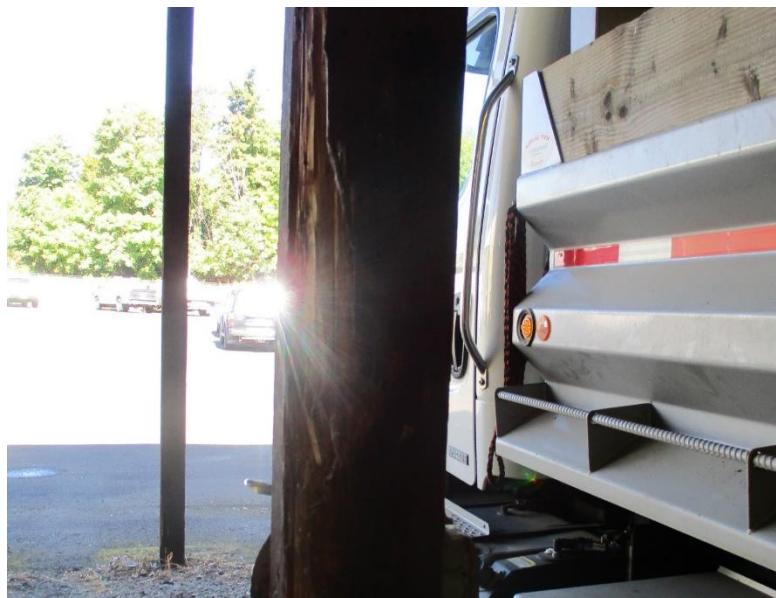
Figure 2.11. Column Damage

One column between the third and fourth bay shows damage due to vehicle impact, as shown in Figure 2.11. No decay was noted in this, or any other, of the columns. Other than the damaged purlins in the third bay, all other purlins appear to be in good condition. No signs of decay are noted in the roof system, however with only the metal roofing to protect the members, the roof system is at a greater risk of getting wet and decaying over time.

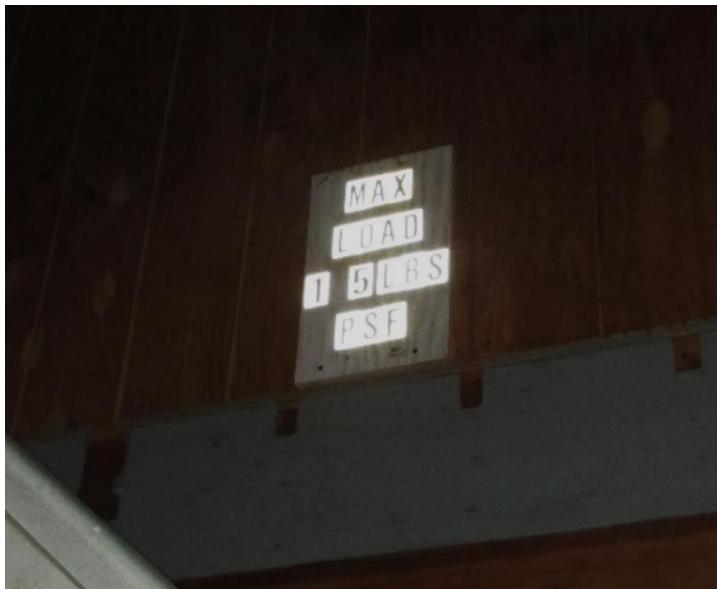
Figure 2.12. Sign at Top of Stairs

A sign at the top of the stairs indicates a maximum load limitation of 15 psf for the loft space (see Figure 2.12). The floor in this area does not exhibit unexpected deflections when walking around. However, the code minimum loading requirement for a habitable attic space such as this is 30 psf. As 15 psf is a value that is very easy to exceed, a thorough evaluation of the items stored in this space and its layout is required to ensure that the design load is not exceeded, particularly where the heavy-duty shelving is located (see Figure 2.13).

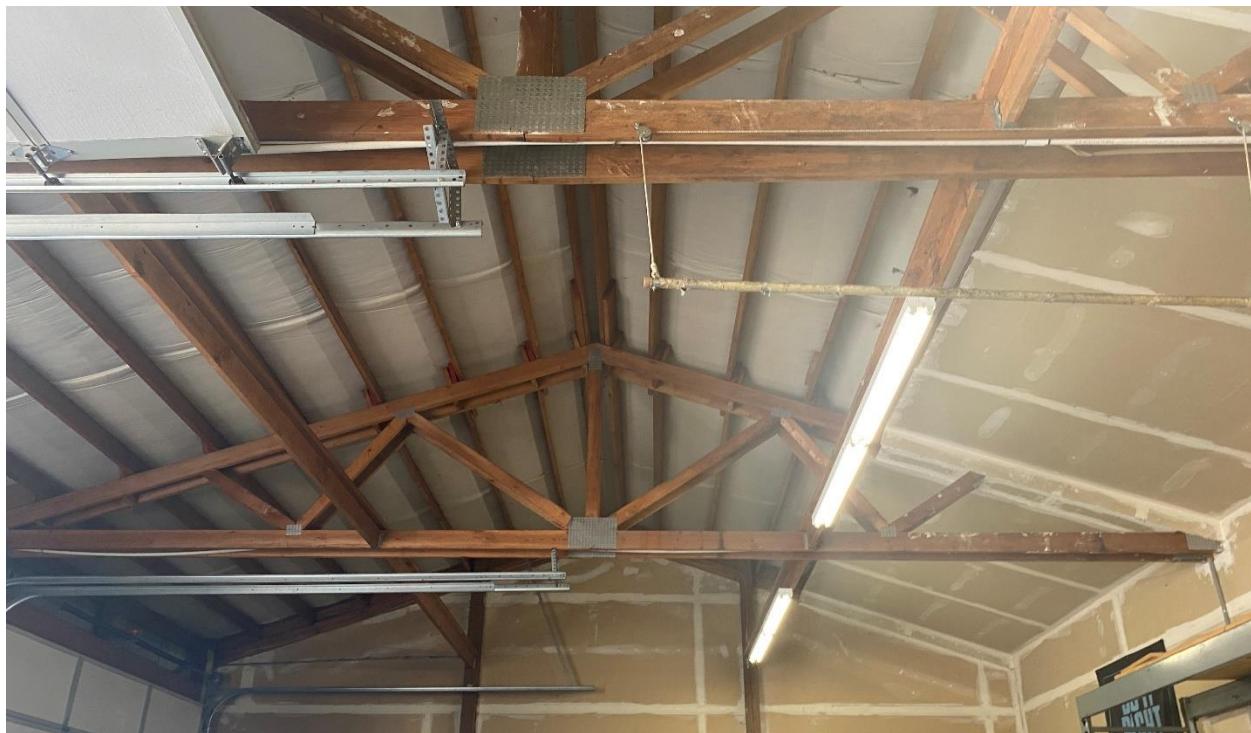
Figure 2.16. East Timber Trusses

Building D is a wood post frame building that is primarily used for vehicle storage on the west end and general purpose storage on the east half. The east and west halves have slightly different roof heights, and it appears that the two portions of the building were built at different times, as the truss designs are similar, but not identical. The east timber trusses are shown in Figure 2.16, with the west trusses are shown in Figure 2.17. It is likely that the west portion of the building is older. Both portions of the building appear to be in good condition. Building posts are constructed from treated timber. No evidence of decay or structural distress is evident. Some minor checking is noted in the columns of the west half.

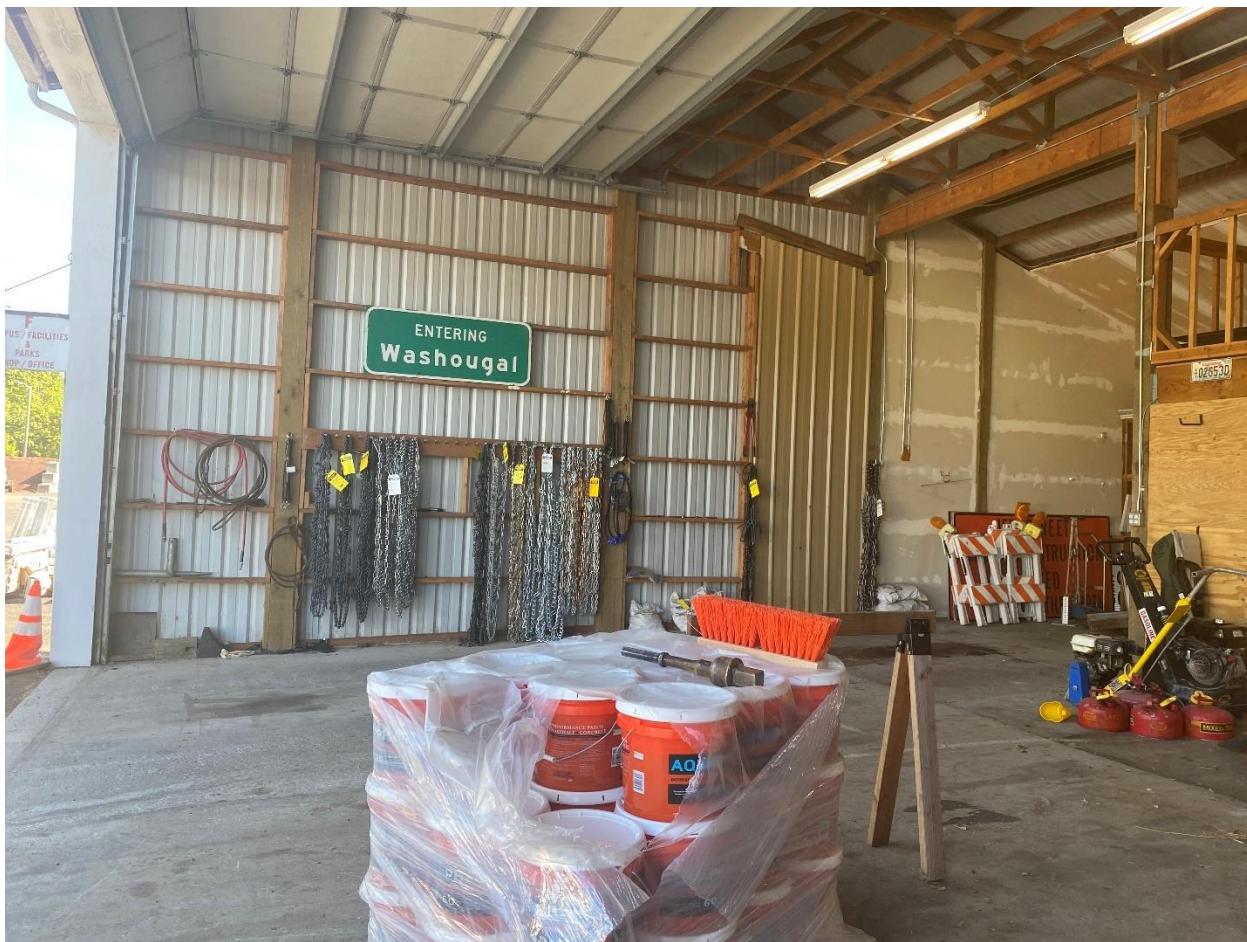
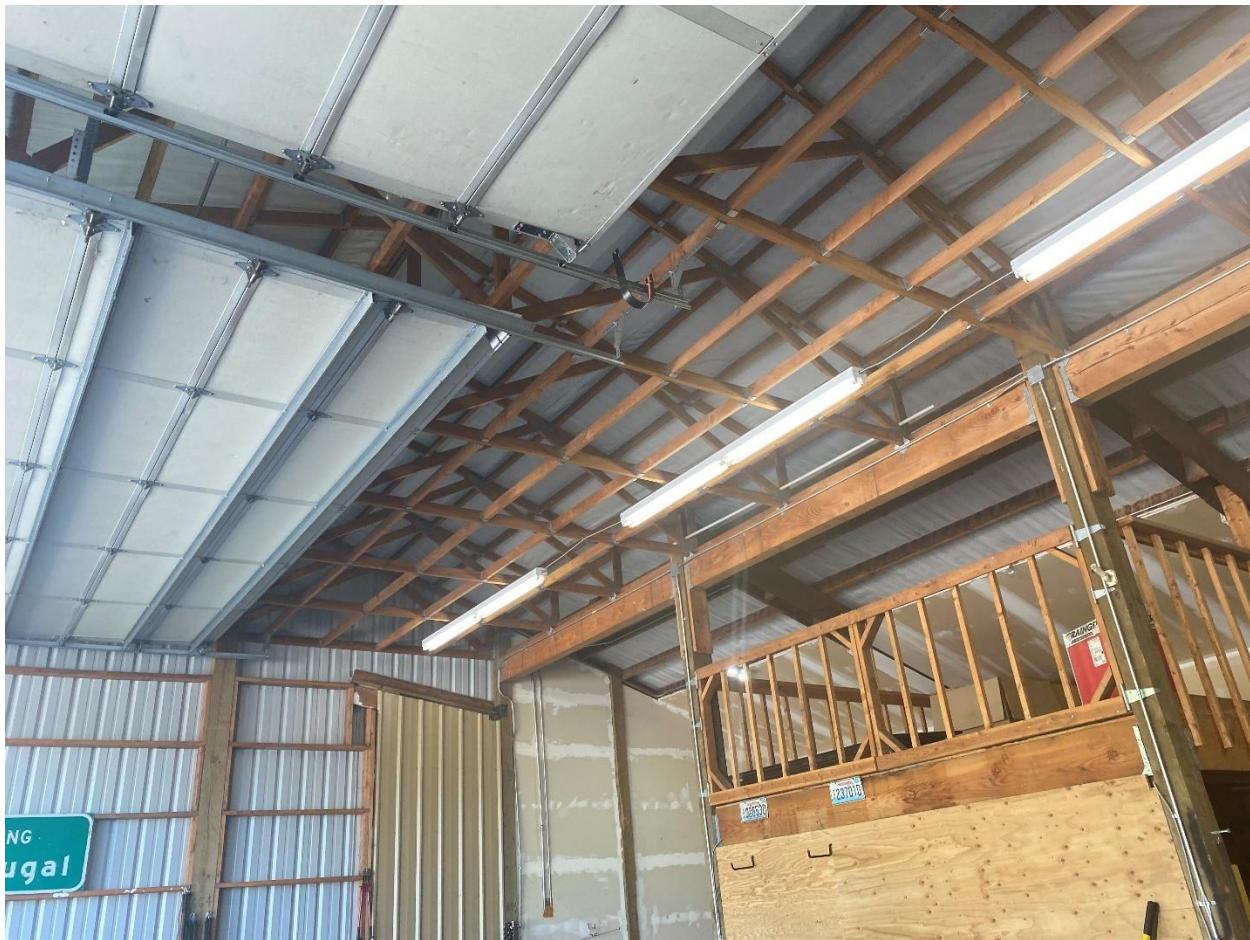
Building E is a wood post frame building that is primarily used for general purpose storage with a concrete floor. It is unknown if the slab meets frost depth requirements. The roof is supported by wood trusses. The west wall is shared with Building D and the east wall is partially shared with Building F. In general, the exposed structure appears to be in good condition. Based on the construction methods used and the coloration of the treated timber elements, it appears this structure is one of the newer structures on the site. Photos are shown in Figure 2.18 and Figure 2.19.

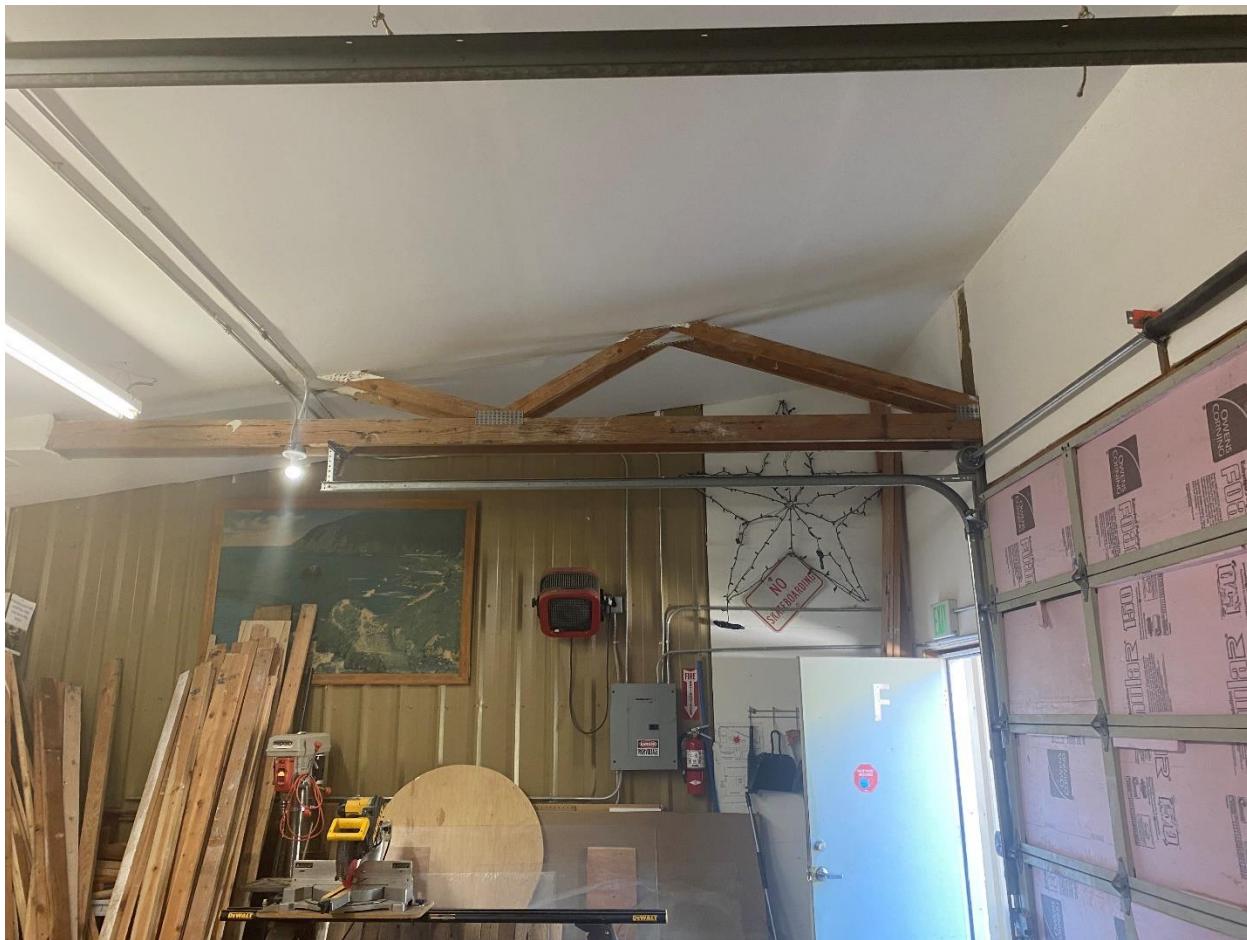
Figure 2.20. Roof Structure Hidden with Drywall

Building F is a building that is primarily used for storage and workshop space. It is assumed to be of wood post type construction, similar to all of the other buildings on site, however, the structure is hidden by drywall. The roof appears to be supported by timber trusses. The majority of the roof structure has been hidden with drywall, with only small portions of the trusses exposed (see Figure 2.20). This building has a concrete floor slab that is in good condition. It is unknown if this slab has turndowns to meet frost depth requirements. The condition of the structure cannot be evaluated as the structure is fully hidden, however, no obvious signs of distress, such as cracking in the drywall or out of squareness of doorways is noted.

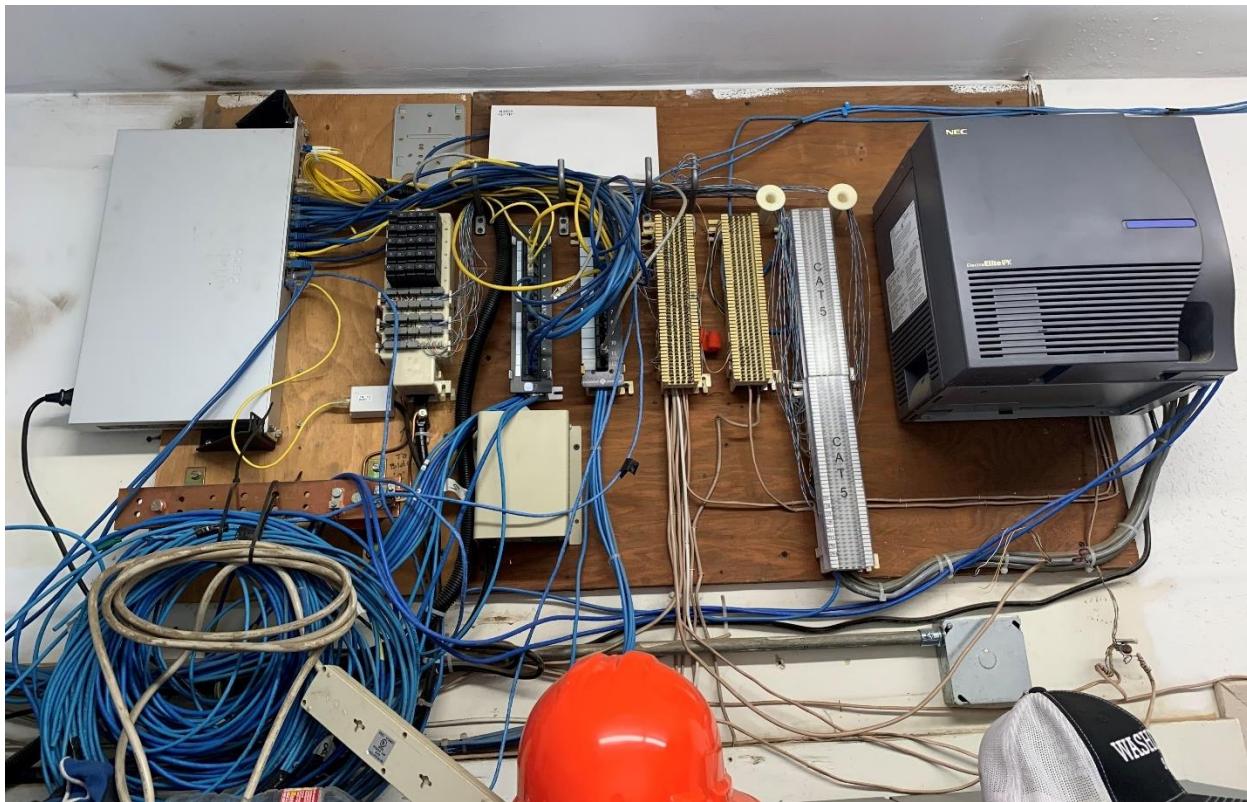
Figure 3.3. Exposed Communication Equipment

The building receives an overhead fiber optic communication line from Verizon Communication equipment. It is installed in the lobby above the lockers and is exposed as shown in Figure 3.2 and Figure 3.3. It is recommended that this equipment be installed in a dedicated space, such as a communication closet, or be installed in an enclosure for protection. The communication cables located in the attic space are loosely installed without adequate structural support as shown in Figure 3.4.

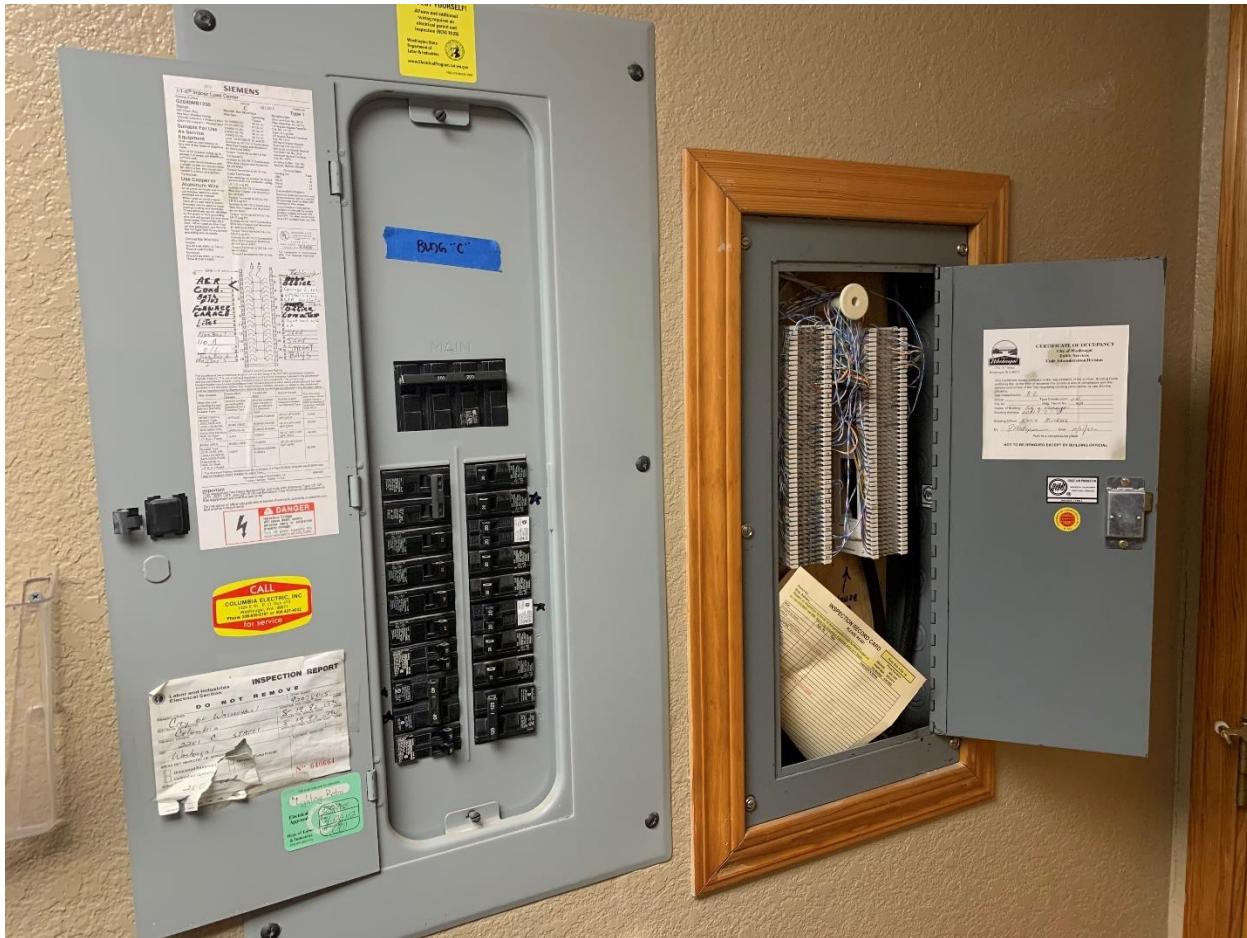
Figure 3.5. Building C Panelboard

Building C is provided with a 120/240-volt, 1-phase, 200-amp electrical service from Clark PUD. The building includes a 200-amp main panelboard with 20 spaces, as shown in Figure 3.5. Every circuit in these panels appears to be in use with no space for future

loads. The panel is a Siemens ITE load center and appears to be in good condition. There is no standby power provided to the building.

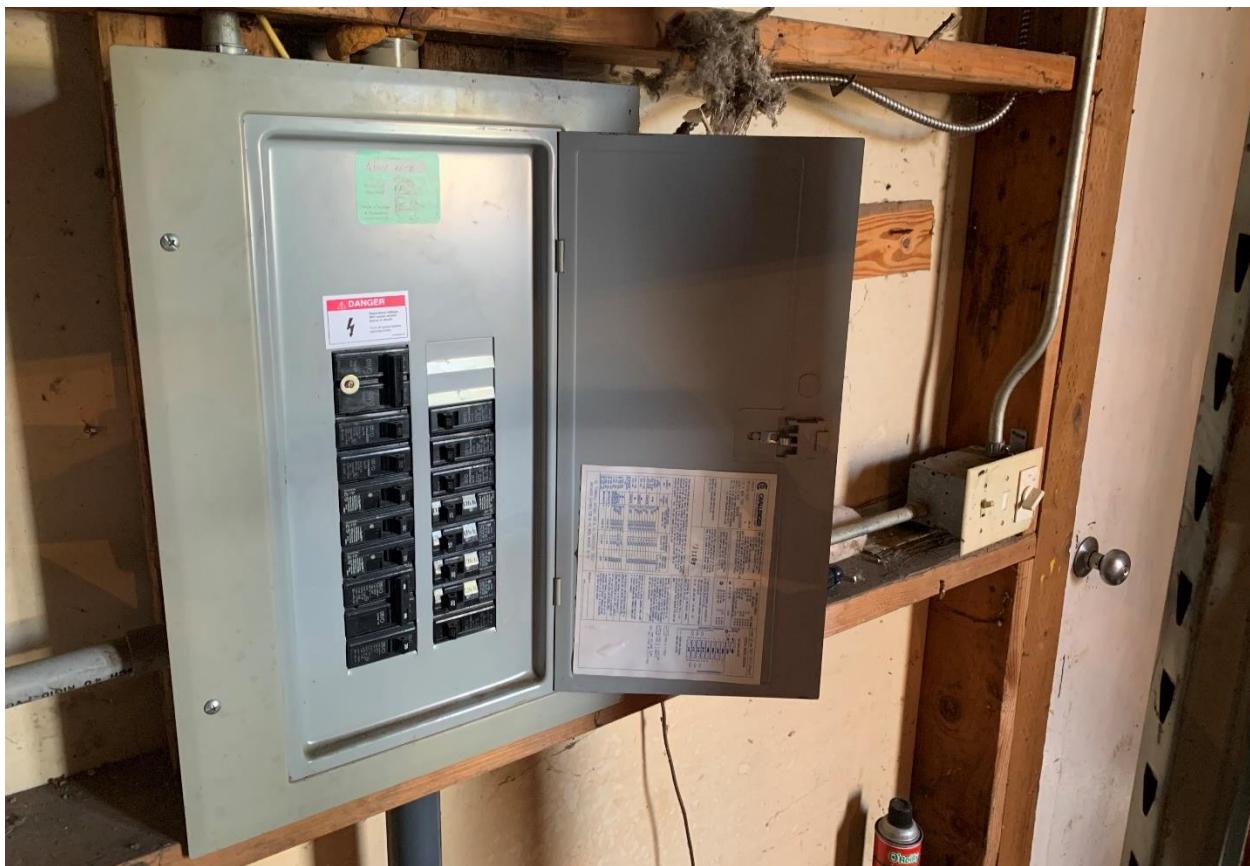
Figure 3.9. Building D Panel

Building D is provided with a 120/240-volt, 1-phase, 125-amp electrical sub panel that is fed from a circuit from Building C. The panel is a Challenger load center with 20 spaces, as shown in Figure 3.9, and appears to be in good condition. A large metal shelf is installed in front of the panel, as shown in Figure 3.10, which is in violation of NEC requirements for clear working space in front of electrical equipment. The panelboard circuit directory is missing, which is a violation of NEC requirements.

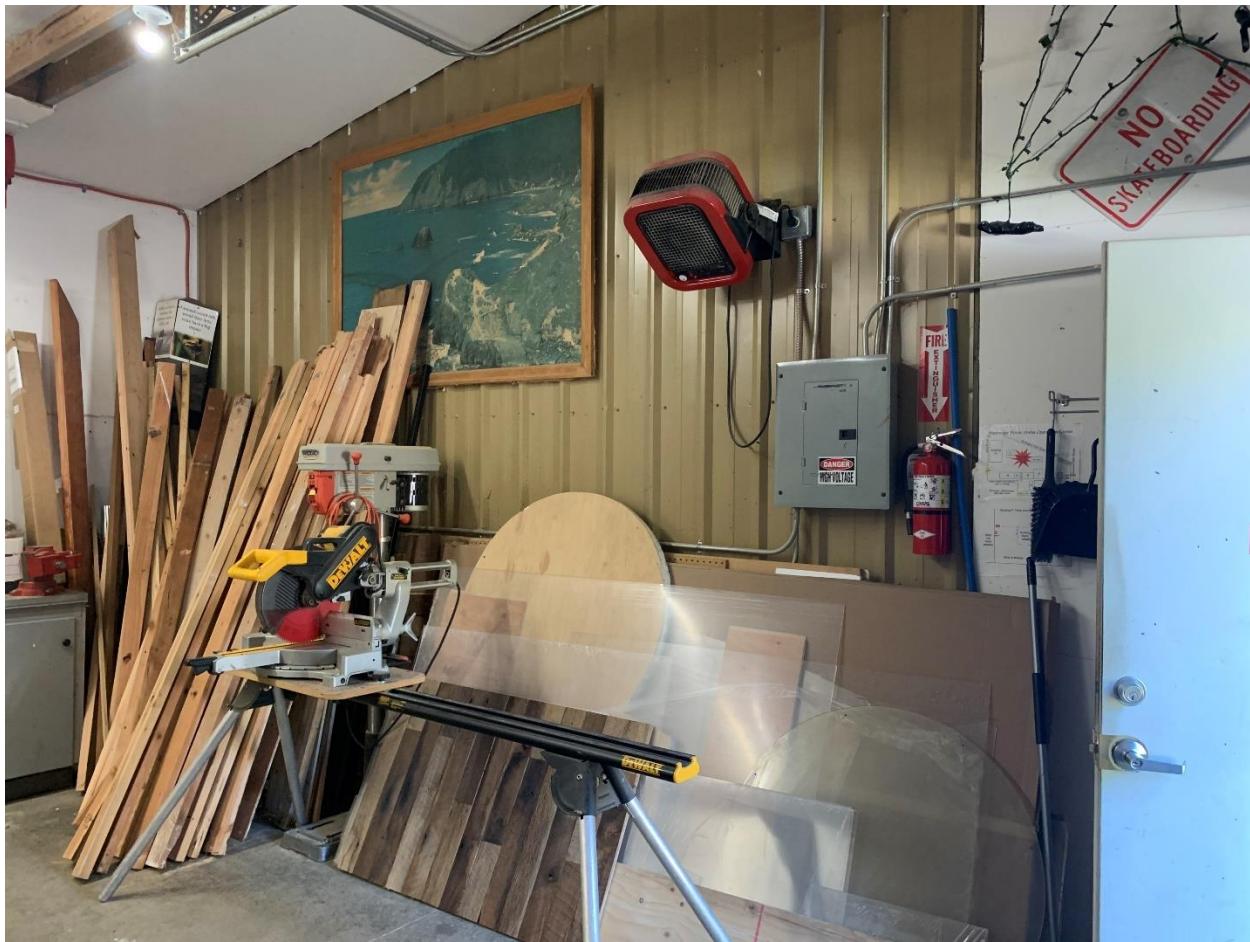
Figure 3.12. Scrap Materials Stored in Front of Panel

Building F is provided with a 120/240-volt, 1-phase, 100-amp electrical sub panel. This building does not include a separate electrical service from Clark PUD. During the site visit it was undetermined where this panel is being fed from. The panel is a Siemens load center with 12 spaces, as shown in Figure 3.11, and appears to be in good condition. A large amount of scrap materials is being stored in front of the panel, as shown in Figure 3.12, which is in violation of NEC requirements for clear working space in front of electrical equipment.

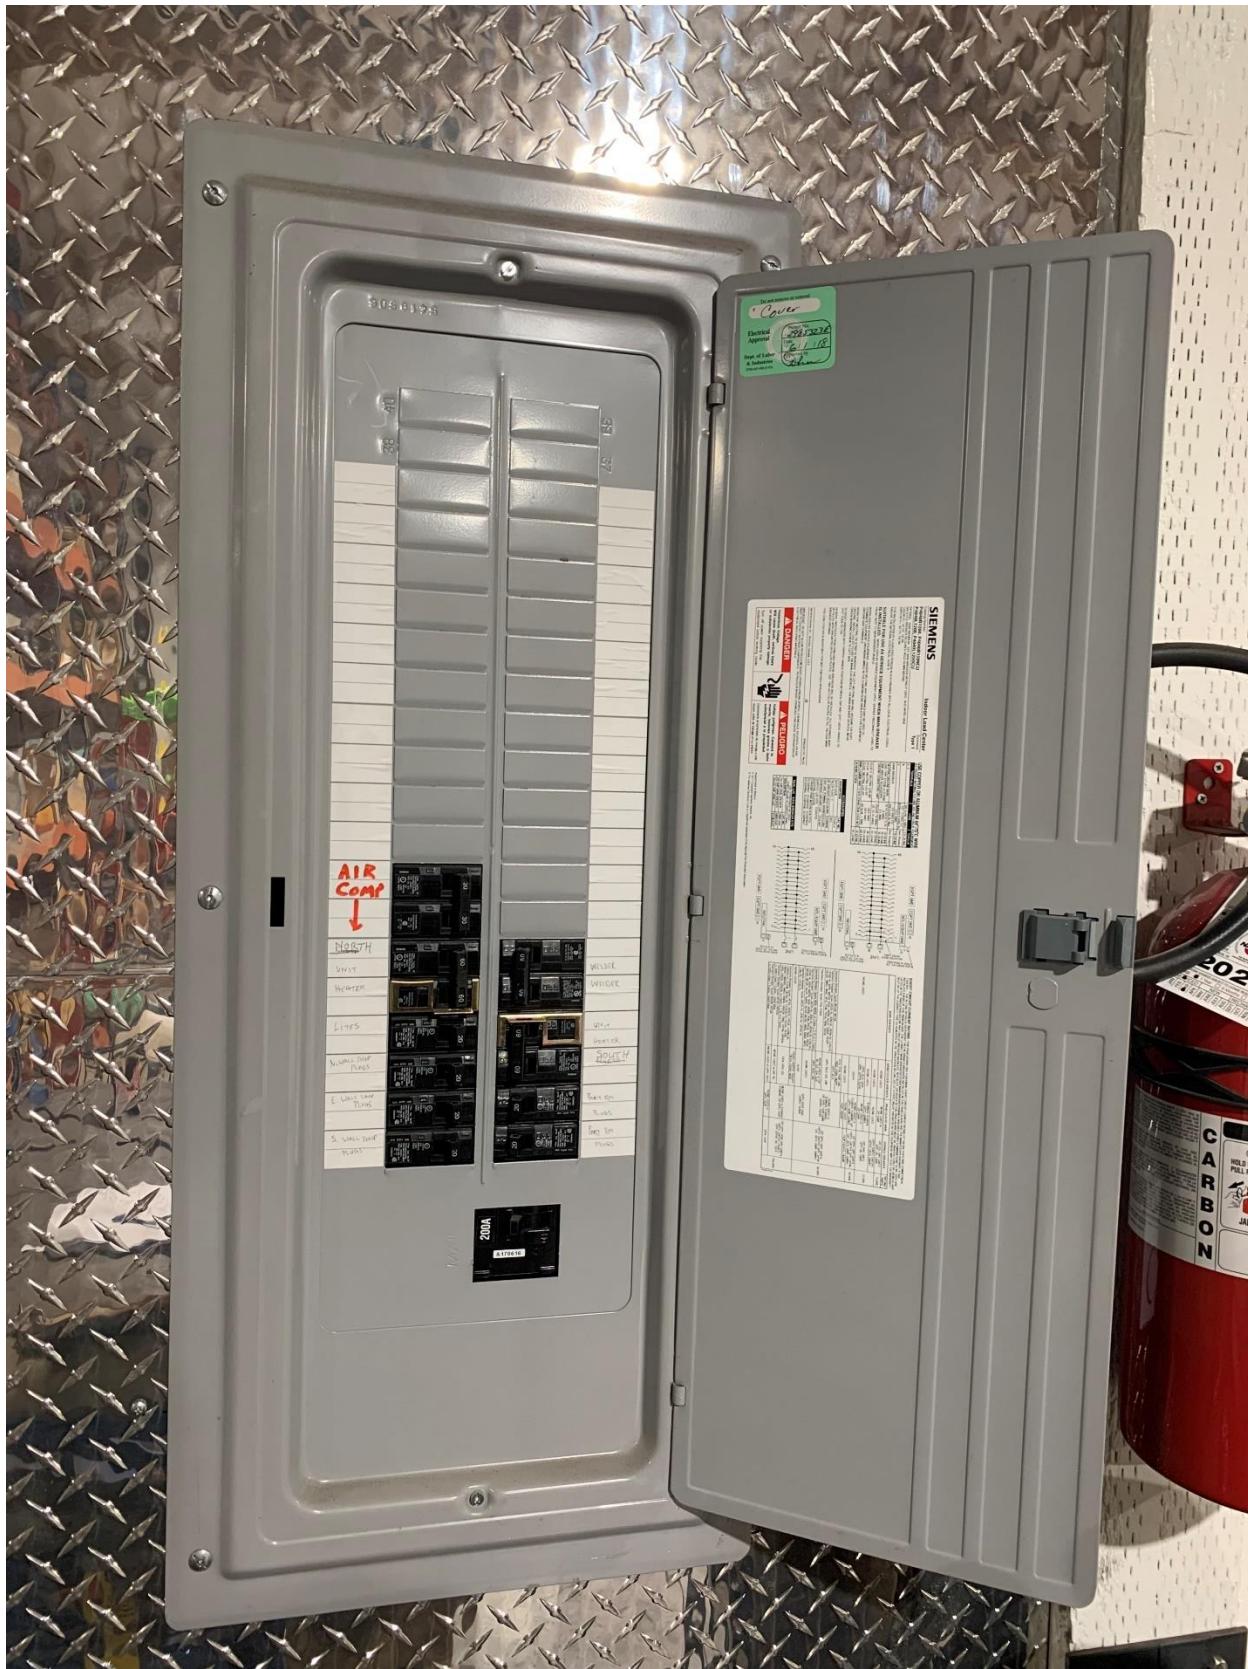
Figure 3.13. Building G Panel

Building A is provided with a 120/240-volt, 1-phase, 200-amp, electrical service via an overhead line from Clark PUD. The building includes a 200-amp main panelboard with 40 spaces, as shown in Figure 3.13. The panelboard is in new condition and has many spaces available for expansion. There is no standby power provided to the building.

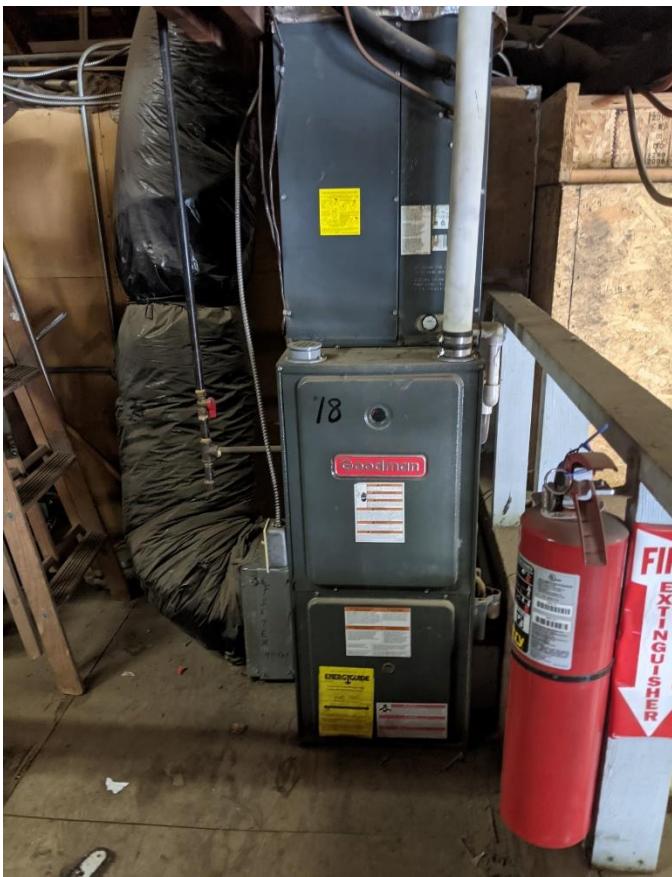
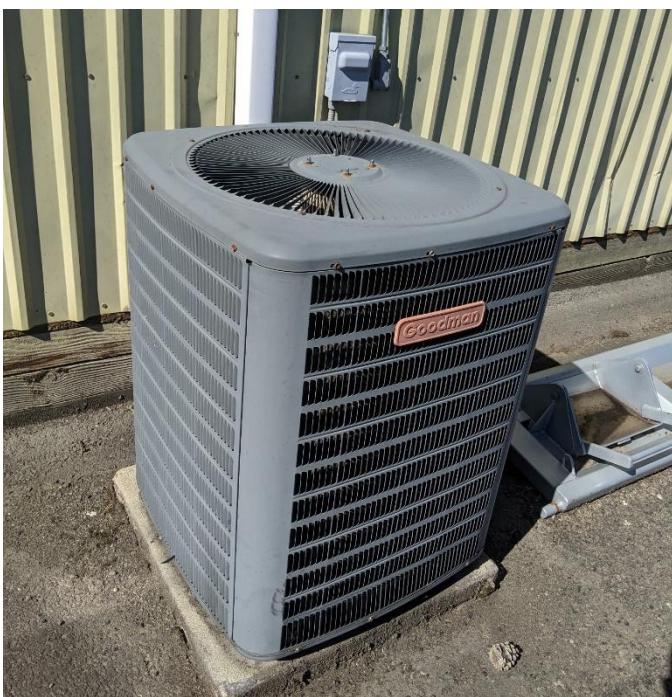
The west side of the building has a mechanic's shop that is served by a second Goodman furnace that has a 3-ton Goodman heat pump from 2007 (see Figure 4.4 and Figure 4.5). This heat pump is an R-22 unit and while not visibly failing is near the end of its expected service life (15-20 years per ASHRAE) and planning should include replacing this unit in the near future.

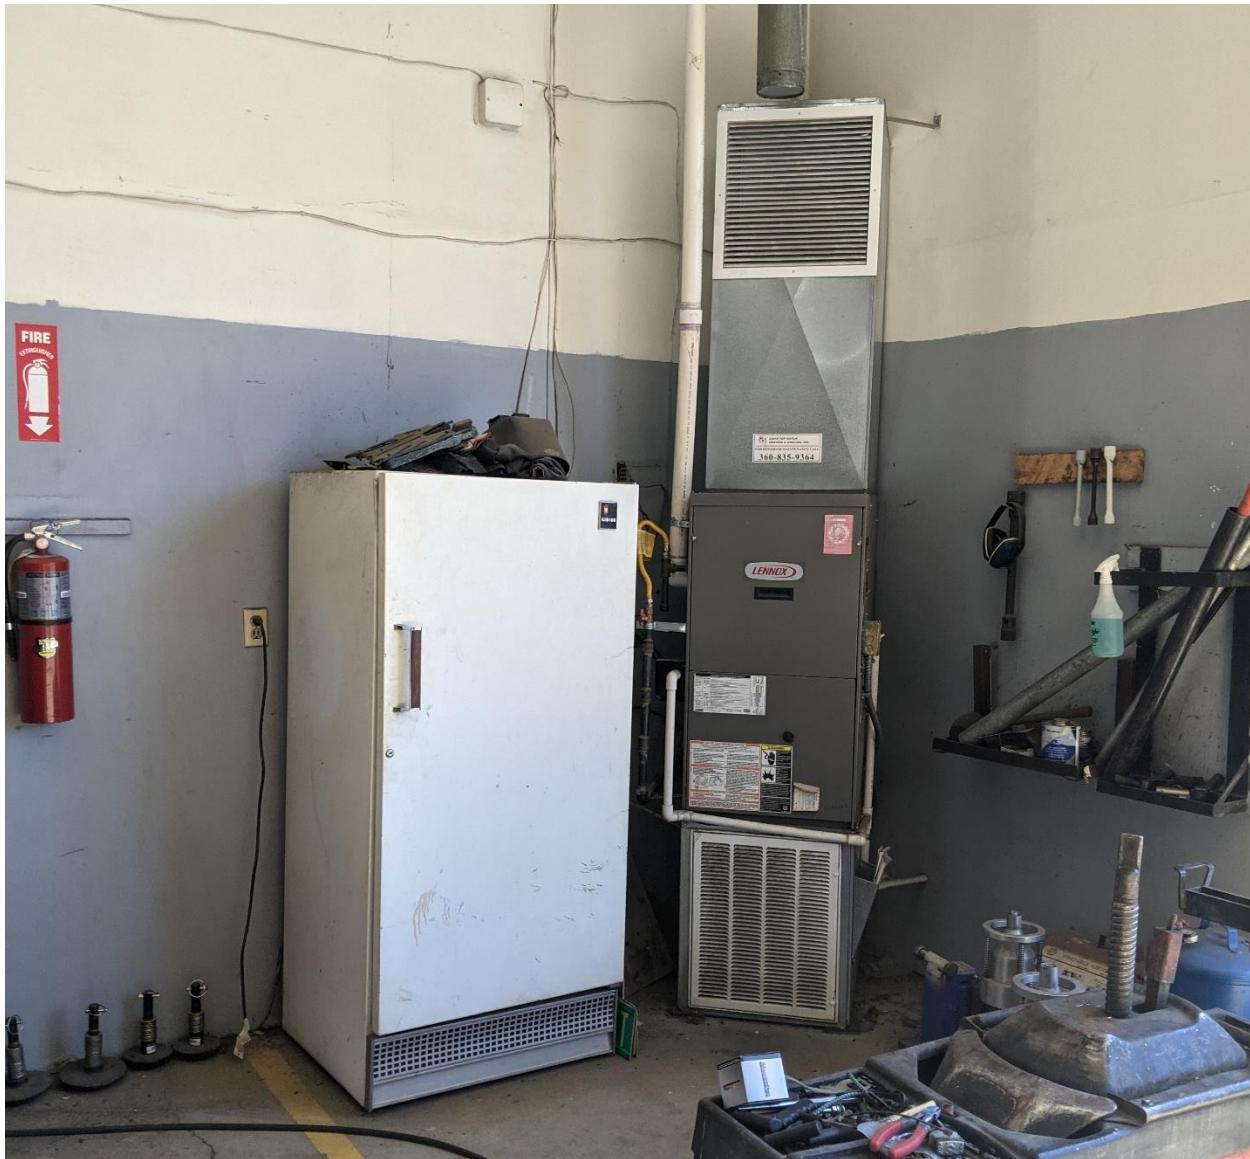
Figure 4.6. Building A Shop Furnace

The southwest corner of the building is another shop that also has a small, elevated office and a couple parts storage areas. This shop has a Lennox furnace in the southeast corner. It does not have any cooling capacity (see Figure 4.6).
