2022 FACILITIES MASTER PLAN

City of Washougal

FACILITY CONDITION ASSESSMENT

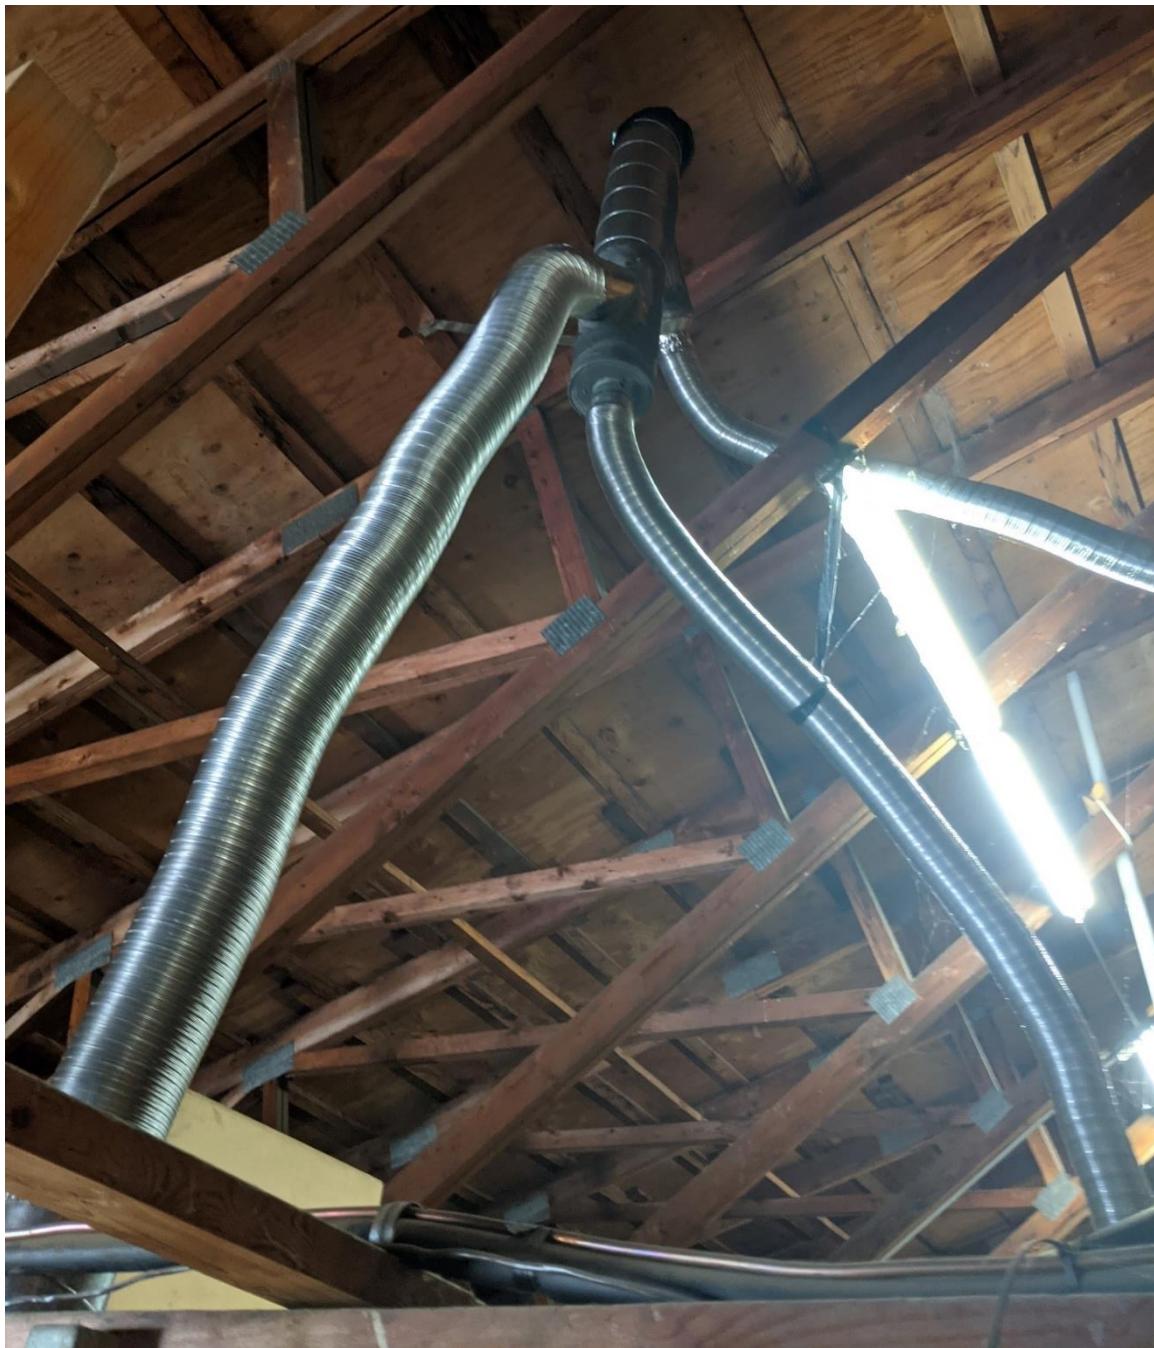
Figure 4.7. Building A Exhaust Connections

There are several exhaust systems connected into a single roof penetration (see Figure 4.7). None of these ducts are insulated and may have condensation issues since they are located in the unheated portion of the building.

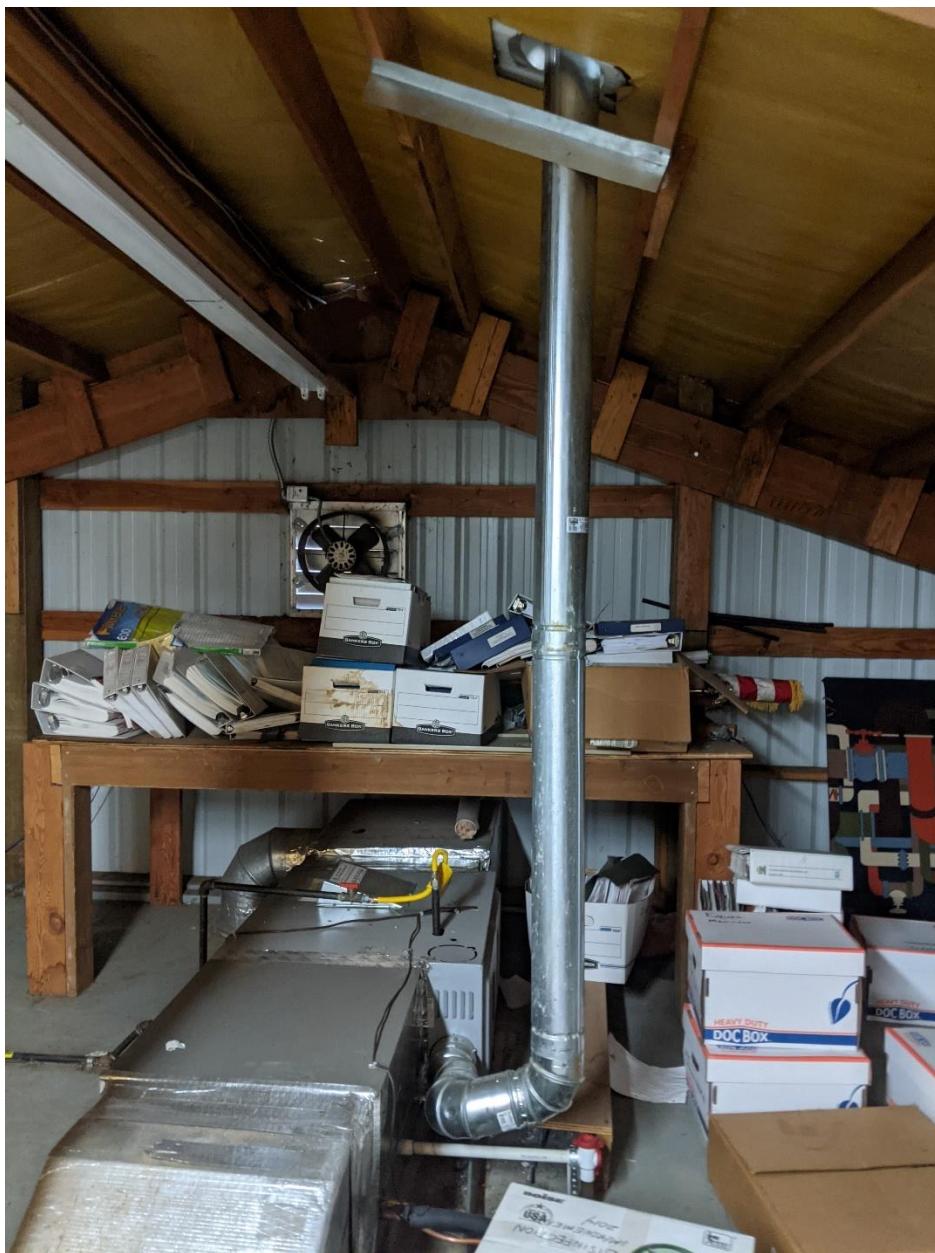
Figure 4.9. Building C Furnace

Building C has an HVAC and plumbing system serving the main level with equipment located in the attic (see Figure 4.9). A horizontal Lennox furnace is installed on the floor of the attic and an Aire-Flo (Lennox subsidiary) air conditioner is installed at the rear of the building (see Figure 4.10).

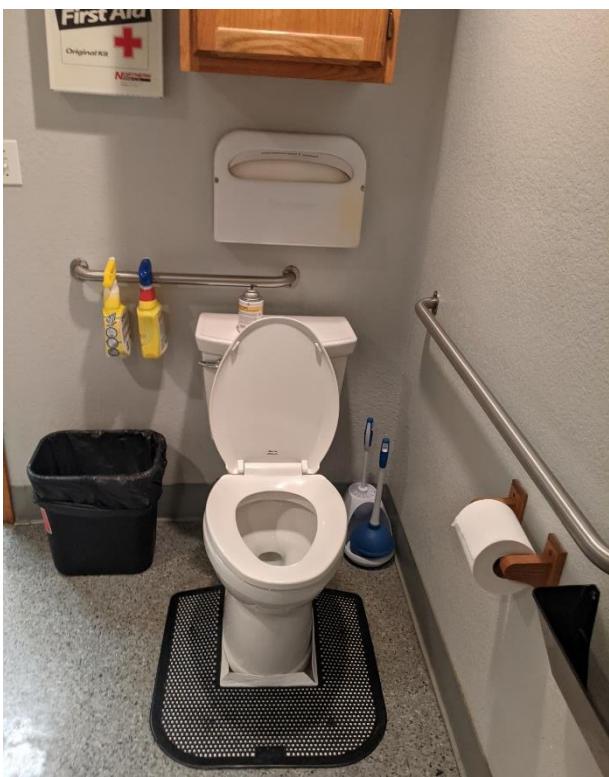
Figure 4.11. Building C Water Closet

The restroom has a shower, water closet, and service sink which is not ADA accessible, (see Figure 4.11, Figure 4.12, and Figure 4.13). A Bradford White natural gas water heater is in the attic (see Figure 4.14). This unit is dated 1993 per the Washington LNI Certificate of Inspection. There are signs of previous leaks in the drain pan below the unit and the unit is well beyond the expected life of 10 to 15 years. The plumbing piping was recently modified to serve a partially constructed new room in the back of the building using PEX piping; this new room is not complete and is not in compliance with the current codes. The natural gas meter is in fair condition showing some surface rust.

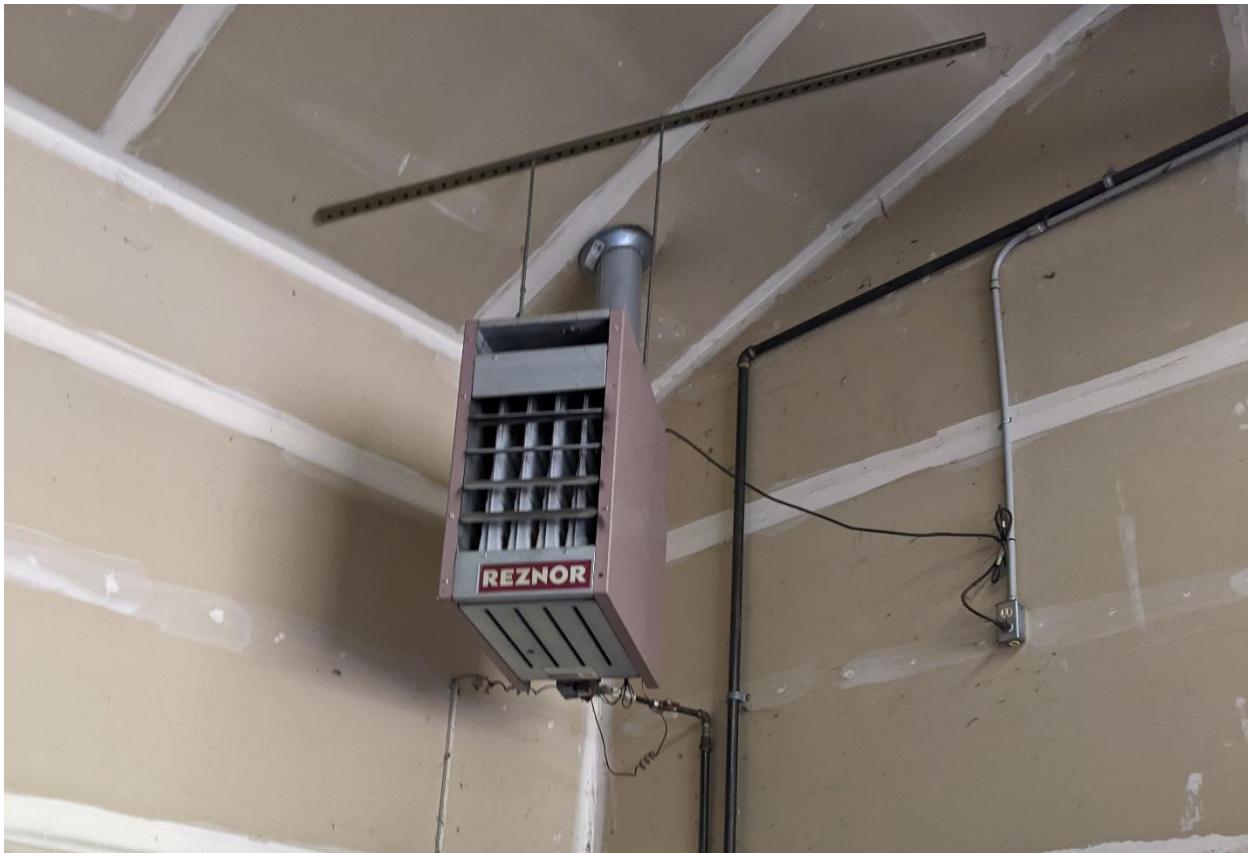
Figure 4.15. Building D Gas Unit Heater

The west half of Building D has a single natural gas unit heater located in the southwest corner (see Figure 4.15). There is no other heating, air conditioning, or ventilation in this building. The natural gas line in this building is extended to the east to serve Building E.

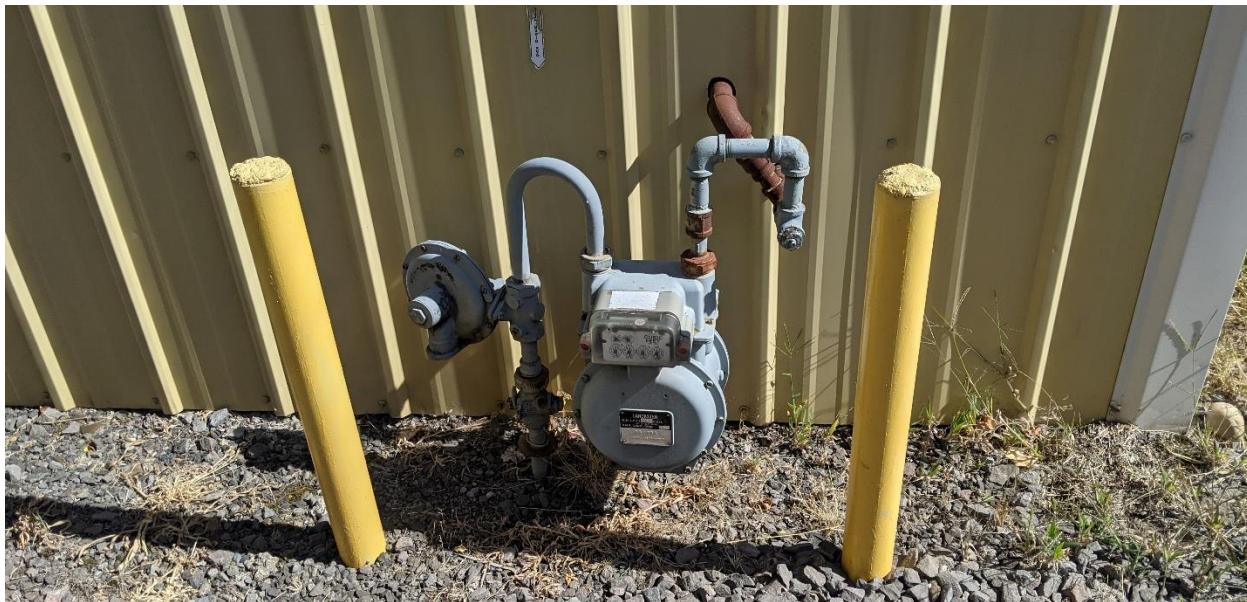
Figure 4.16. Building D Natural Gas Meter

The natural gas service is located in the narrow access road between buildings C and D but protected by bollards (see Figure 4.16).

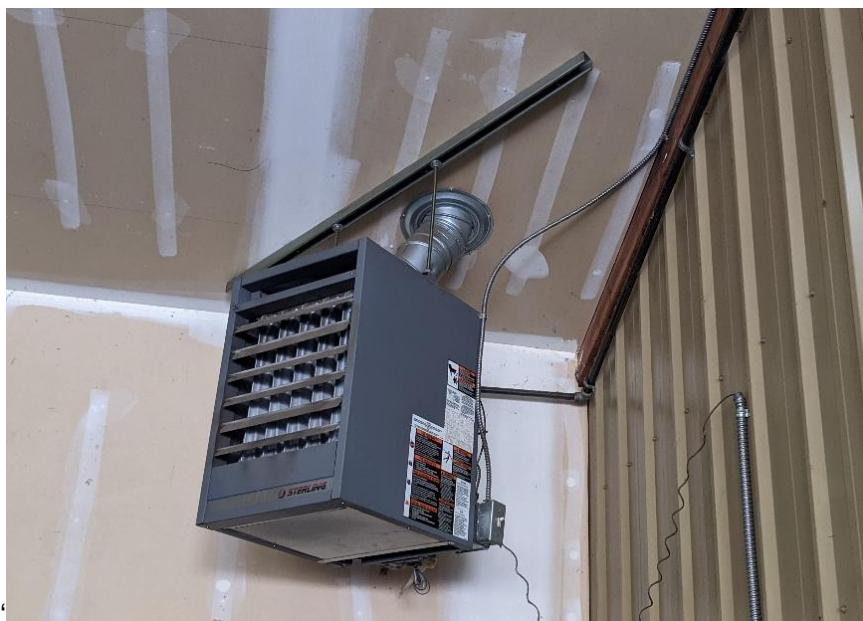
Figure 4.17. Building E Unit Heater

Building E has a single unit heater in the southwest corner, fed by natural gas from Building D (see Figure 4.17). The thermostat for this unit has been disassembled and may not be functioning (see Figure 4.18). There are visible gaps around the perimeter of this space, most noticeably at the joint between Building D and Building E that allow air and water to infiltrate the building. These gaps should be repaired to maximize heating system efficiency.

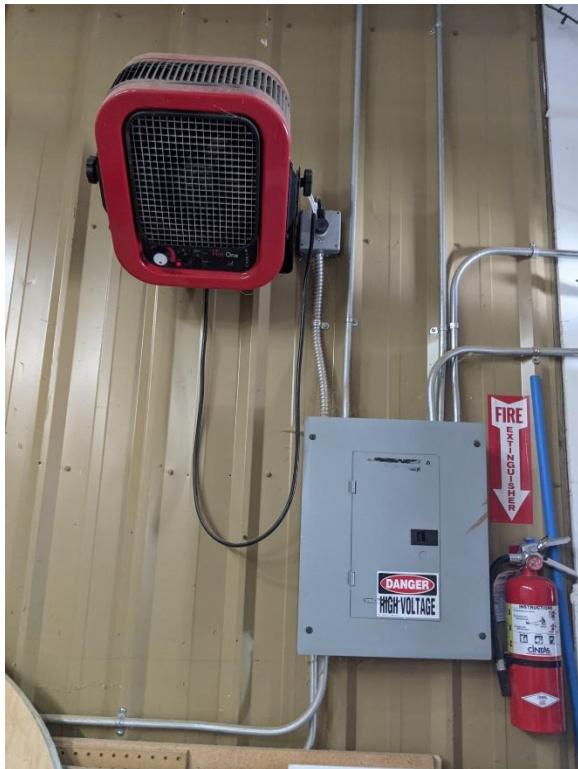
Figure 4.19. Building F Electric Unit Heater in Entry Area Shop

Building F, at the far east end of the row of buildings, has several different systems serving it. In the entry, there is an electric unit heater in the entry area shop (see Figure 4.19), and another in the shop and storage area (see Figure 4.20).

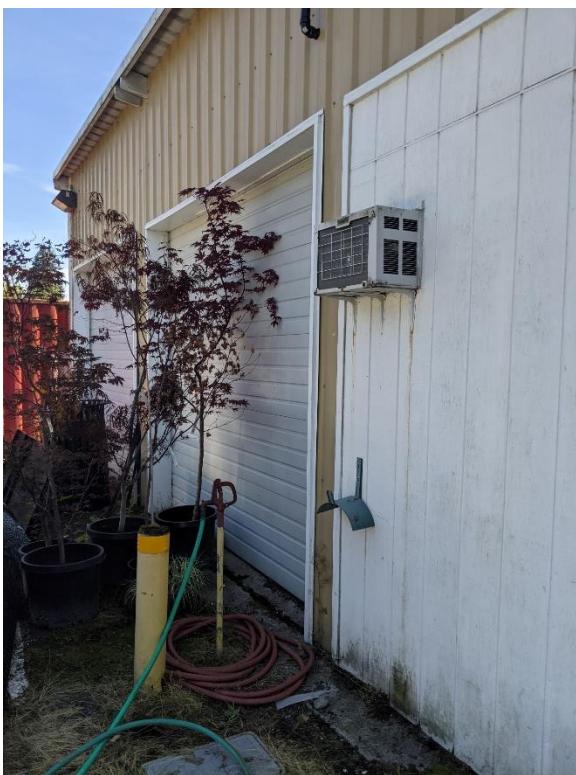
Figure 4.21. Building F A/C in Entry Area Shop

Two wall-mounted air conditioners serve the entry area shop (see Figure 4.21), and the parks office in the southeast corner (see Figure 4.22). Neither unit is in use and they are both blocked by stored items on the inside.

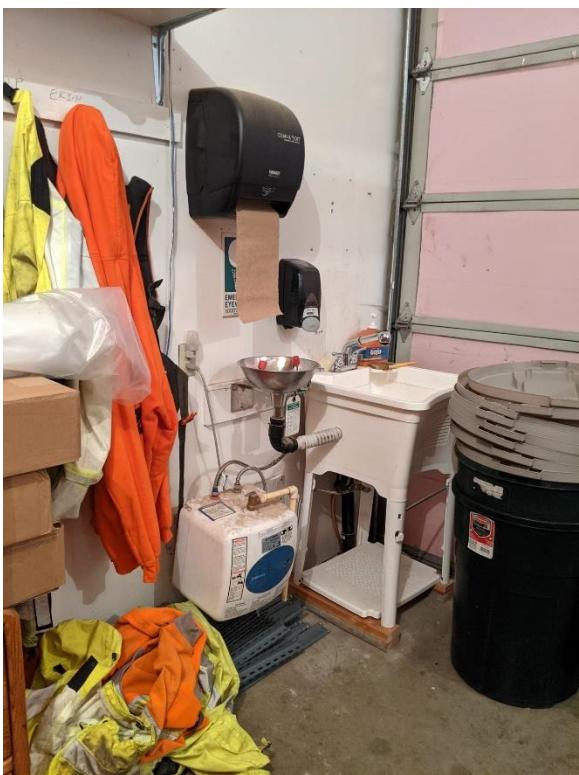
Figure 4.23. Building F Sink

A service sink in the shop and storage area has a small electric water heater serving a service sink (see Figure 4.23).

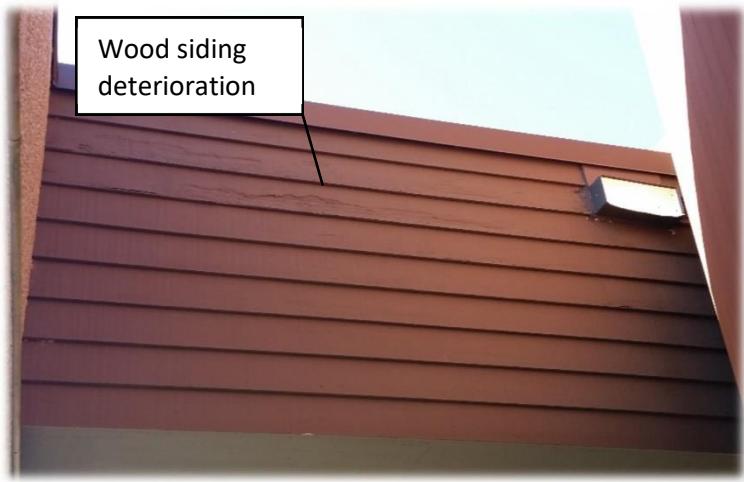
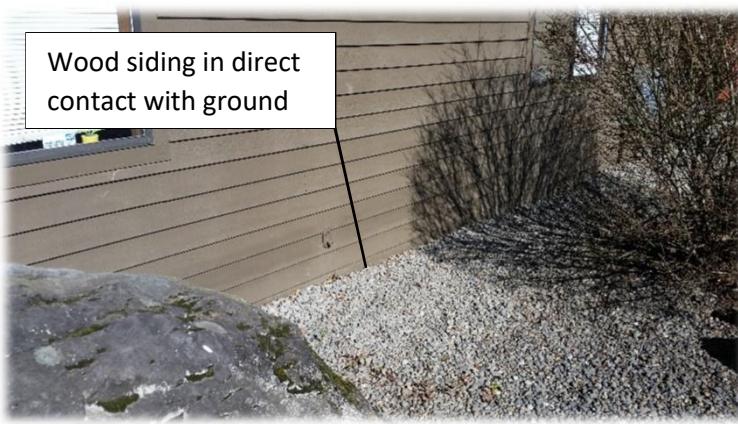
Horizontal cedar lap siding in poor condition where exposed to weather. Vertical cedar siding at Council Chambers in good condition. Stone-embedded stucco at facade in poor condition with many areas showing cracks and decay.

Wood siding in direct contact with ground

- Repair the cracking and spalling of embedded stucco and decayed wood structure.
- Repair lap siding at damaged, exposed or ground contact locations.
- Contract with a commercial HVAC contractor to install outside air ducting to air handlers and provide balance dampers on air distribution ducts to balance air flow and improve indoor air quality. Install additional thermostats or temperature sensors to improve temperature control throughout office spaces.

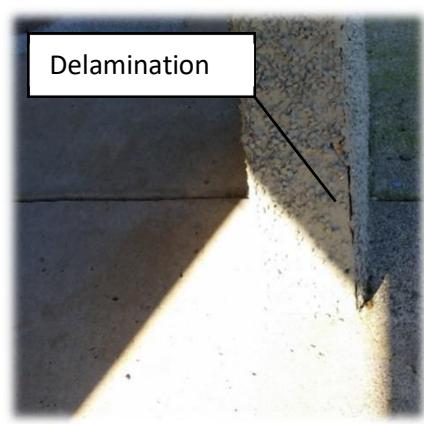
Delamination

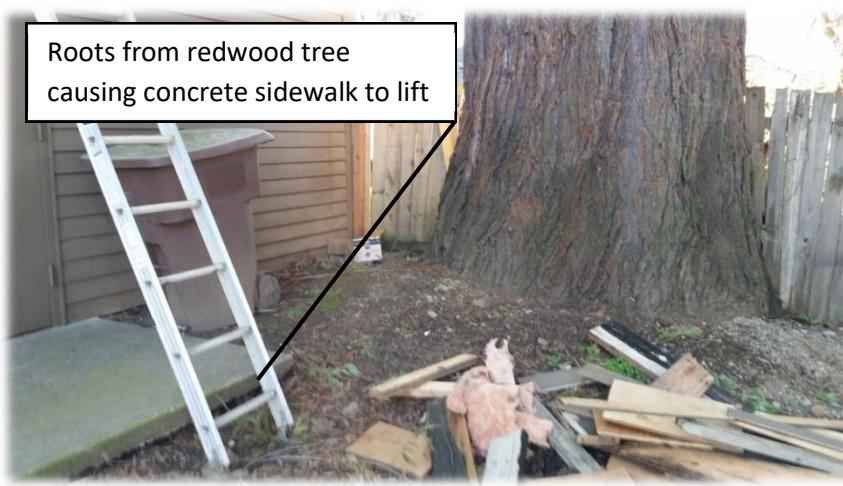
Asphalt Paving Fair condition
Concrete Surfaces Good condition
Parking Shared parking lot with City Hall
Stormwater None
Lighting Recessed soffit lighting
Landscape Very large redwood tree in close proximity to NW building corner. Roots from tree have lifted concrete sidewalk and may damage concrete foundation over time. Large limbs falling from this tree will damage roof and create a life safety hazard.

- Repair the cracking of embedded stucco and decayed wood structure.
- Repair lap siding at damaged, exposed or ground contact locations.
- Replace all doors, currently they have $\frac{1}{4}$ " gap around all outer doors
- Contract with a qualified arborist to explore options regarding the large redwood tree growing near the building. The tree roots are lifting the concrete sidewalk and could damage the concrete foundation and electrical service. Falling limbs would damage the new roof membrane and air handlers and present a life safety hazard.

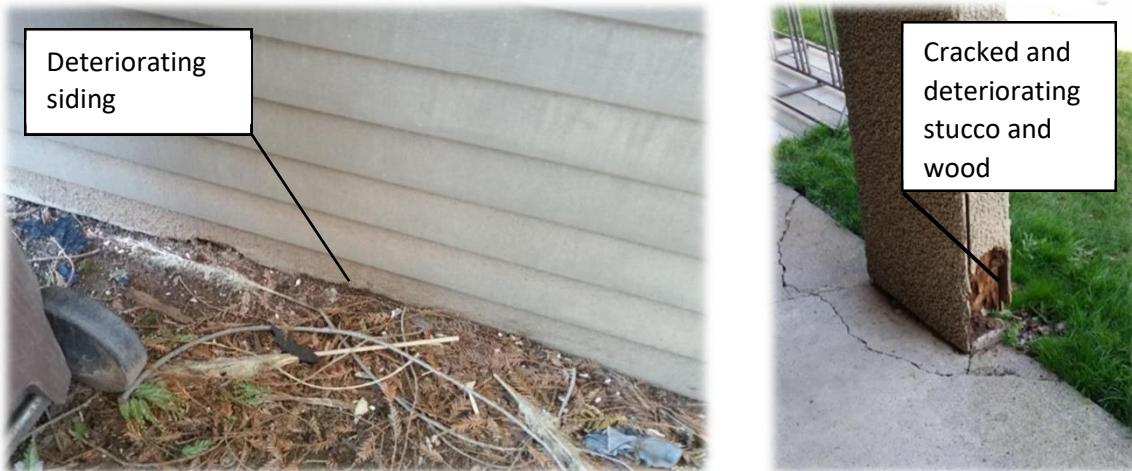
Horizontal cedar lap siding at North, South, and East elevations. CMU at West elevation. Cedar siding has areas of decay where exposed to weather. The stone embedded stucco façade is in poor condition with evidence of cracking and decay of the wood substrate.

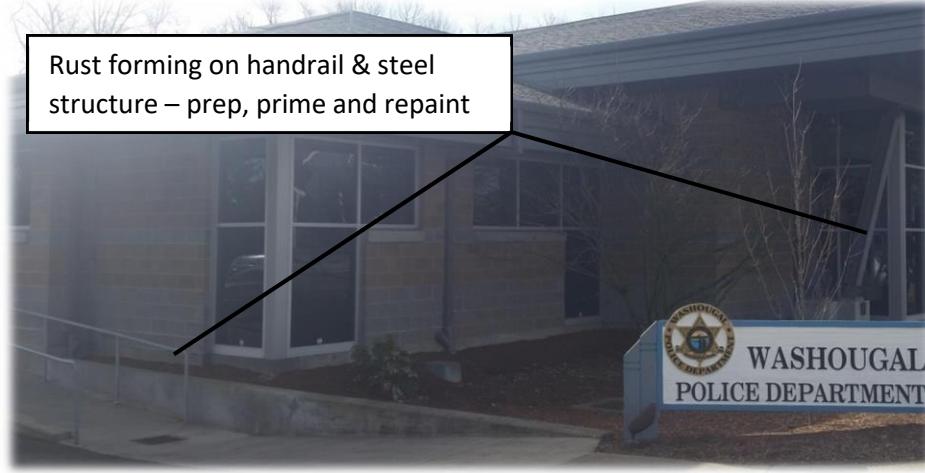
Rust forming on handrail & steel structure – prep, prime and repaint

- Small areas of rust are beginning to form on west exterior hand rail and at steel support structure at NE corner of building. Suggest that rust be removed, primed and repainted.

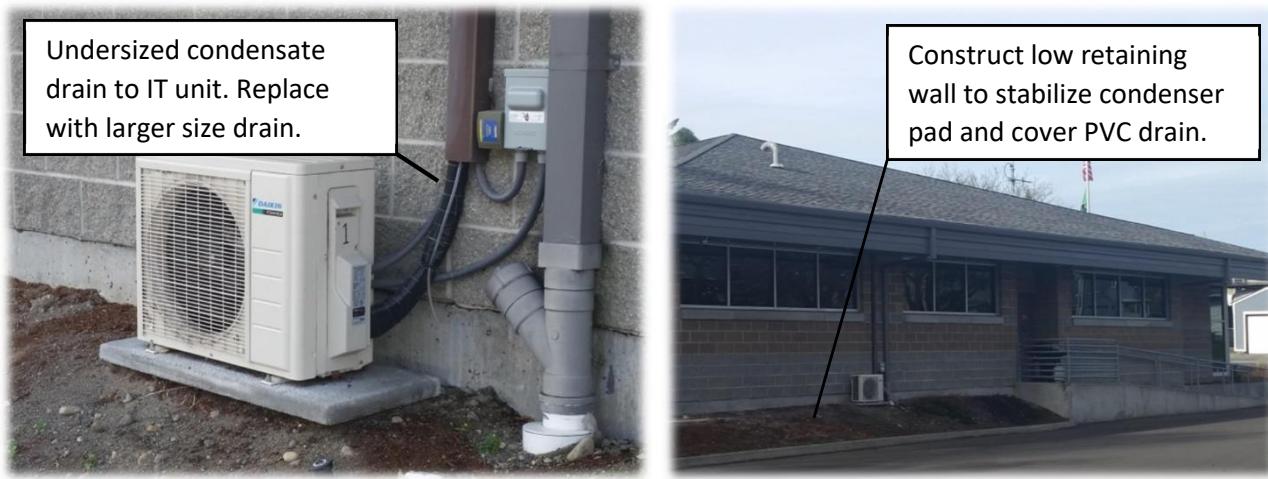
HVAC System 4-each gas furnaces with DX cooling and OSA – all in good condition. Test, adjust and balancing needed to resolve air distribution and temperature control issues. Condensate leaking down wall in IT room.

Energy Controls Single Honeywell programmable thermostat for each air handler. Thermostats are inappropriately located resulting in poor temperature control of occupied spaces. Electrical consumption is 15.5 kWh/sf/year.

The most significant facilities deficiency noted was comfort issues related to temperature control and air distribution. Recommend that the City have a competent commercial HVAC technician, rebalance the system; relocate and upgrade programmable thermostats; and revise zoning to better accommodate current room use.

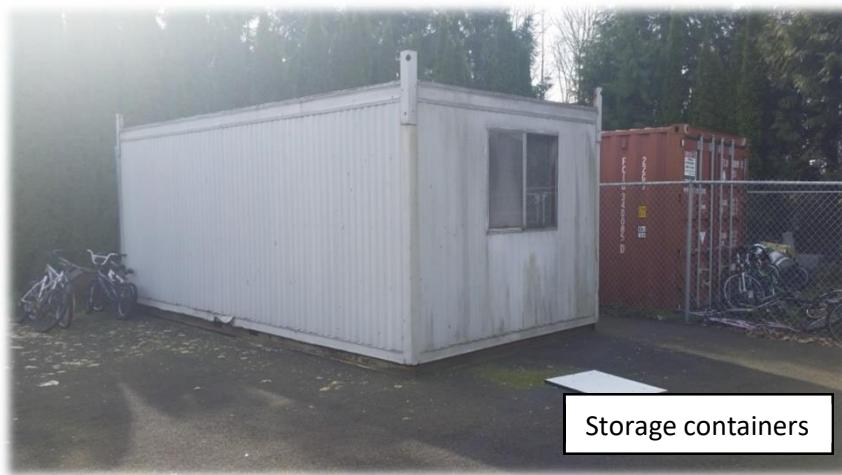
- Suggest retaining wall at east elevation to stabilize mini split condensing unit and cover exposed PVC drain piping.
- The easterly Conex box used for storage is in poor condition.

Recommendation is to replace the Connex boxes with a secure building.

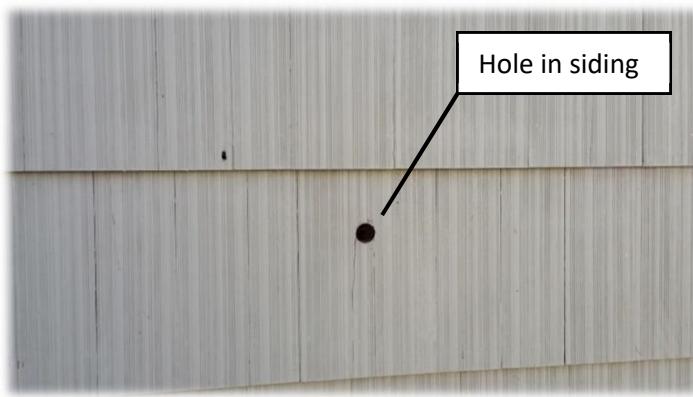
Roof	8:12 pitch, wood frame with asphalt shingles – in good condition
Gutter & Downspouts	Seamless metal gutters and downspouts – in good condition
Windows	Wood frame, single pane
Exterior Cladding	Cedar shingle siding – fair condition with some repair needed. Due for paint.
Chimney	Fireplace with masonry chimney

- Repair and repaint cedar shingle siding.
- Repair hole in concrete foundation wall on east side of garage.
- Repaint the inside and outside
- Replace all windows, doors, and lighting
- Suggest sealing fireplace chimney to reduce energy loss.
- Replace HVAC System
- Convert the Engineering Tech garage into Engineering office space, bathroom, and conference room.
(This conversion will need to be ADA Compliant)

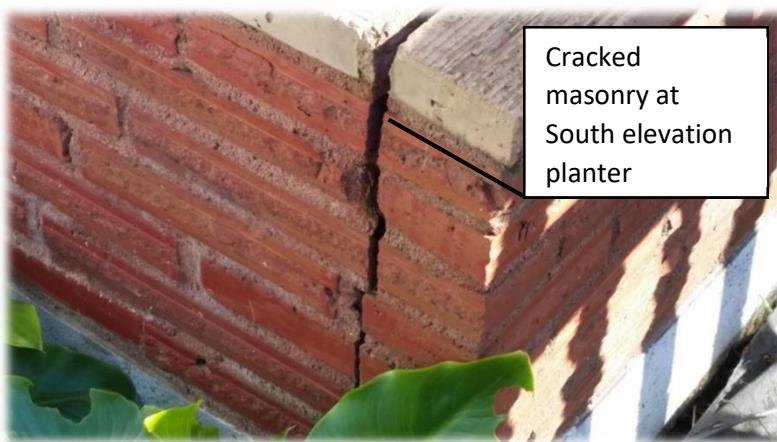
Roof	Asphalt shingles showing curling and cupping – need replaced
Gutter & Downspouts	Continuous metal gutters and downspouts – in fair condition
Windows	Aluminum frames, double pane
Exterior Cladding	Stucco in poor condition, showing numerous cracks
Chimney	Fireplace with chimney – in fair condition but needs chimney tuck pointed due to failing mortar joints

- Wood trim at crawl space access and around window is decaying.
- Soffit at South elevation is sagging; could be a structural issue and needs further investigation.
- Chimney about roof line shows deteriorating mortar joints and should be tuck pointed.
- Stucco exterior cladding is cracked in numerous locations.
- Masonry planter at South elevation is cracked.
- Suggest sealing fireplace chimney to reduce energy loss.
- Add insulation
- Replace roof
- Make it ADA compliant
- Repaint the inside and outside
- Replace HVAC System
- Replace all windows, doors, and lighting

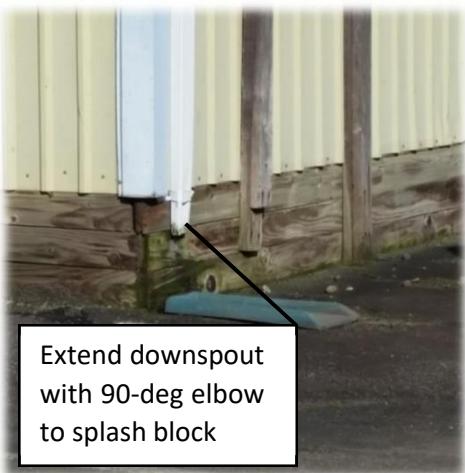
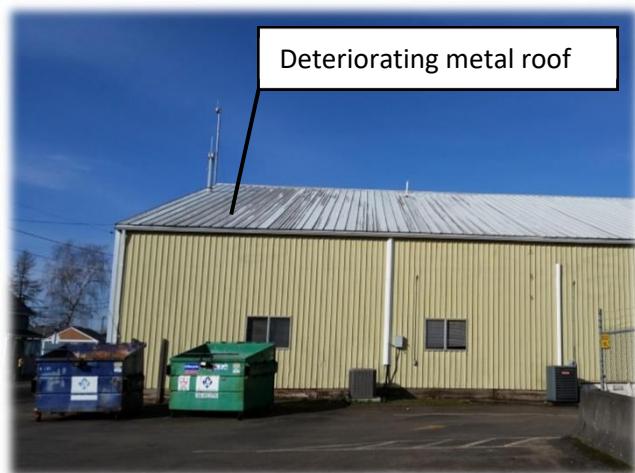
Roof	Metal roofing panels in fair condition except for East section that is showing deterioration
Gutter & Downspouts	Continuous metal gutters and downspouts – in good condition
Windows	Aluminum frames, thermal pane
Exterior Cladding	Sheet metal

- Remove or seal old unused vent/exhaust stacks.
- Rebuild office mezzanine for storage.
- Suggest extending OSA grille from attic space to above roof line.
- Suggest adding insulation and door weather-stripping to reduce energy costs.
- Replace carpeting in office and update lunch room
- Replace metal roof and downspouts
- Repaint the inside and outside
- Replace all windows, doors, bay doors and lighting
- Bathroom Expansion-Building A, Operations Center
- Public Works has outgrown the yard area and needs another 2-3 acres of property for storage, wash rack, and equipment.

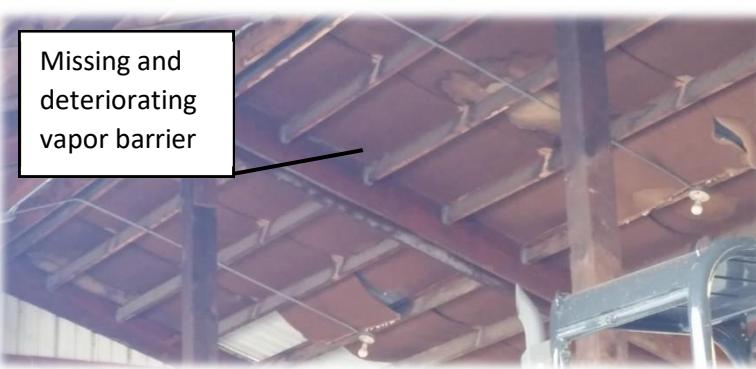
Roof	Metal roof in good condition. Vapor barrier under metal roof is in poor condition.
Gutter & Downspouts	Continuous metal gutters and downspouts – in good condition
Windows	None
Exterior Cladding	Metal siding

- Replace RT post at NW corner for possible decay.
- Remove deteriorating vapor barrier below metal roof panels and replace if condensation becomes a problem.
- Repaint the inside and outside
- Replace metal roof and downspouts
- Replace all windows, doors, bay doors and lighting
- Public Works has outgrown the yard area and needs another 2-3 acres of property for storage, wash rack, and equipment.

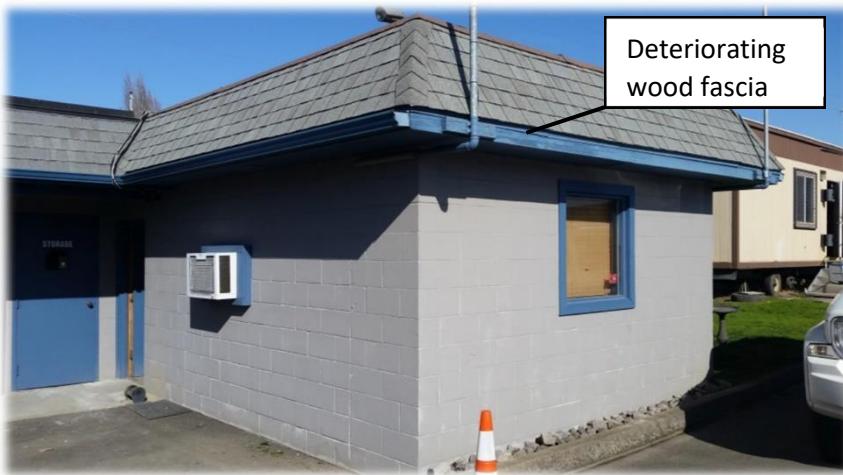
Roof	Single ply membrane roof with asphalt shingle on mansard roof – in good condition
Gutter & Downspouts	Continuous metal gutters and downspouts – in fair condition
Windows	Thermopane windows
Exterior Cladding	CMU single wall construction. Wood fascia at South elevation is deteriorating and needs replacement.

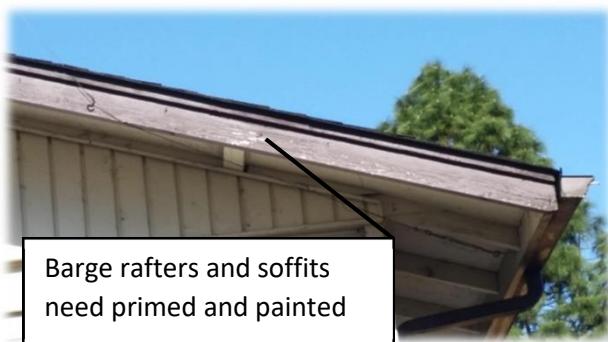
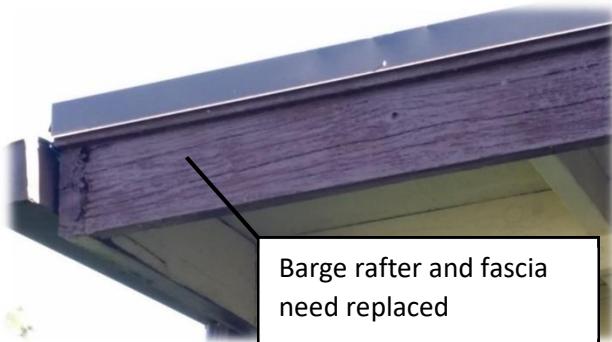
Roof	Asphalt shingles in deteriorating condition – needs replacement within 5 years
Gutter & Downspouts	Continuous metal gutters and downspouts – in fair condition; missing downspout at SW corner
Windows	Aluminum frame, dual pane
Exterior Cladding	Vinyl siding in poor condition due to age and UV

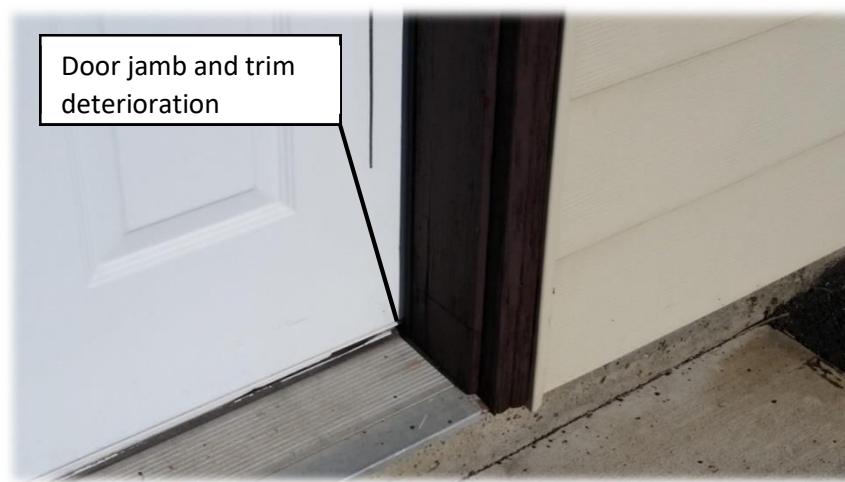
Floors condition	Vinyl floor in commons area, concrete in shop – in poor
Walls	Painted gypsum board – in poor condition
Ceilings	Painted gypsum board – in poor condition
Doors/Hardware	Steel man doors in wood frames – rot in wood frame and trim at South elevation. Three large overhead doors in shop area – in poor condition. One large overhead door to shop area at South elevation – in poor condition.
Casework	Kitchen in commons area

- Replace outside faucet at north elevation with frost proof hydrant.
- Replace rotting wood door frame at South elevation.
- Replace exterior wood including soffits, fascia, and barge.
- Remove electrical wire protruding from South wall at South elevation, seal opening in wall.
- Replace gutters, siding, windows, doors, and new bay doors
- Make ADA compliant
- Replace HVAC and electrical
- Replace roofing
- Remodel kitchen/new appliances
- Replace flooring and paint interior and exterior
- Repave and stripe parking lot
- Remove antenna tower
- Repaint the inside and outside
- Replace metal roof and downspouts
- Replace all windows, doors, bay doors, and lighting
- Add insulation
- Combine police yard and silver star yard with new secure fencing

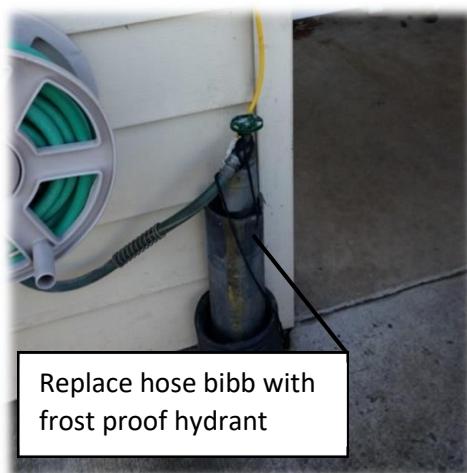
Water Supply	City of Washougal
Sewer	City of Washougal
Plumbing	Likely original plumbing
Fire Sprinkler	None
HVAC System	Forced air furnace with electric heat. No air conditioning. Did not have access to shop area.
Energy Controls	Single thermostat. Electrical energy consumption is 2.7 kWh/sf/year

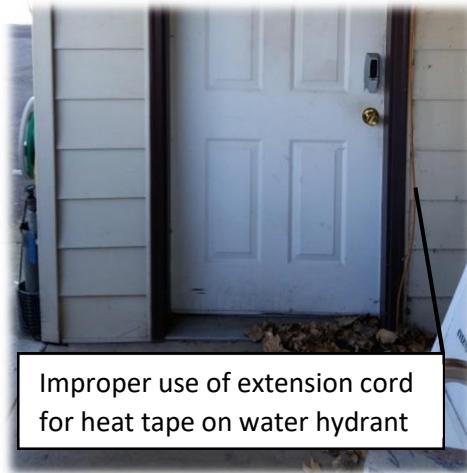
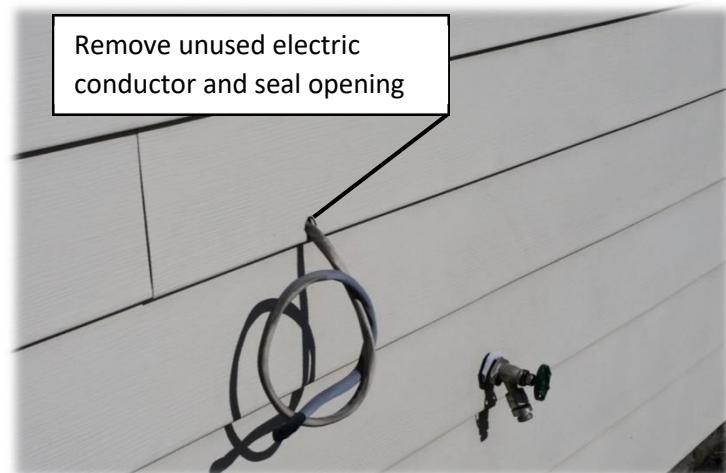
Switchgear/	Original 200-amp panel board
Panel Boards	
Elec. System	Original electrical wiring
Lighting	Fluorescent fixture in common area
Fire Alarm	None
